Comments following a site visit to the breach in the American Wall, Lantern Marshes, on 7th October 2015

Professor Kenneth Pye ScD PhD MA FGS CGeol

ANNEX 1

ANNEX 2

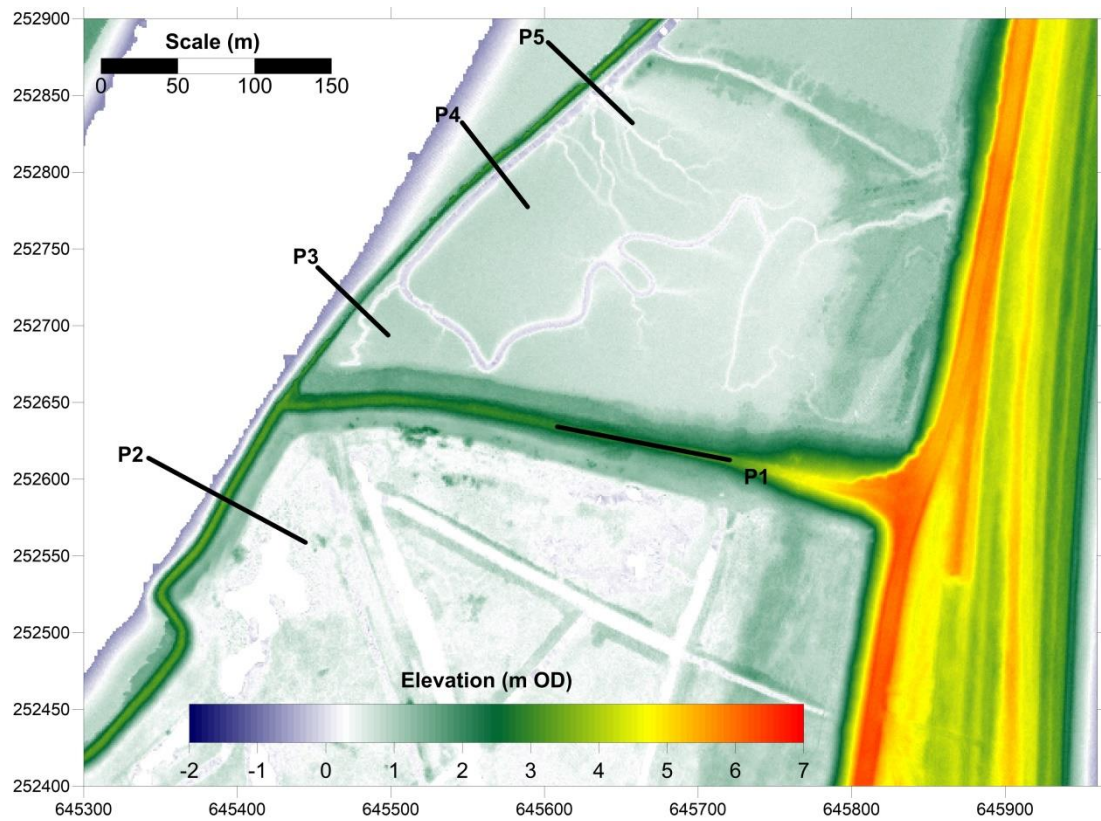
the crest level was lowest (c. 2.7 m OD; Profile P1 in Annex 1 Figure 11 and Annex 2 Photograph 2).

Figure 11. LiDAR DEM of the American Wall and Lantern Marshes, flown December 2012

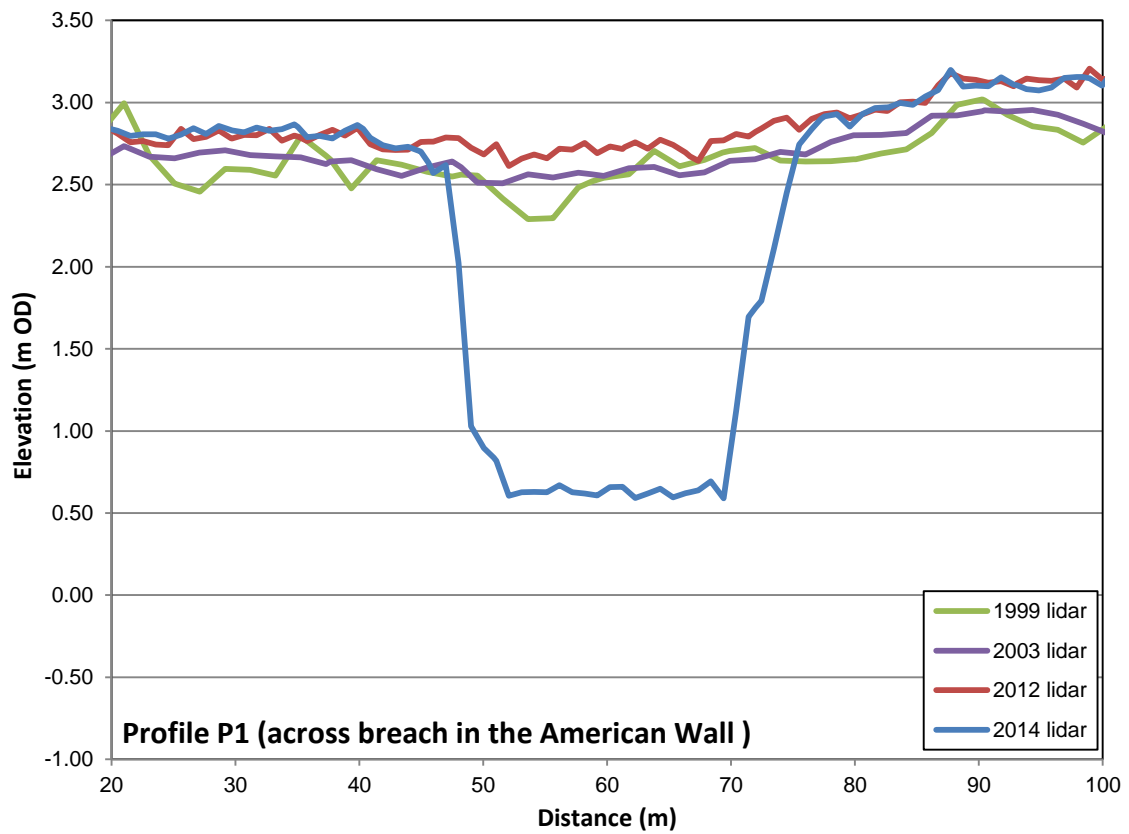
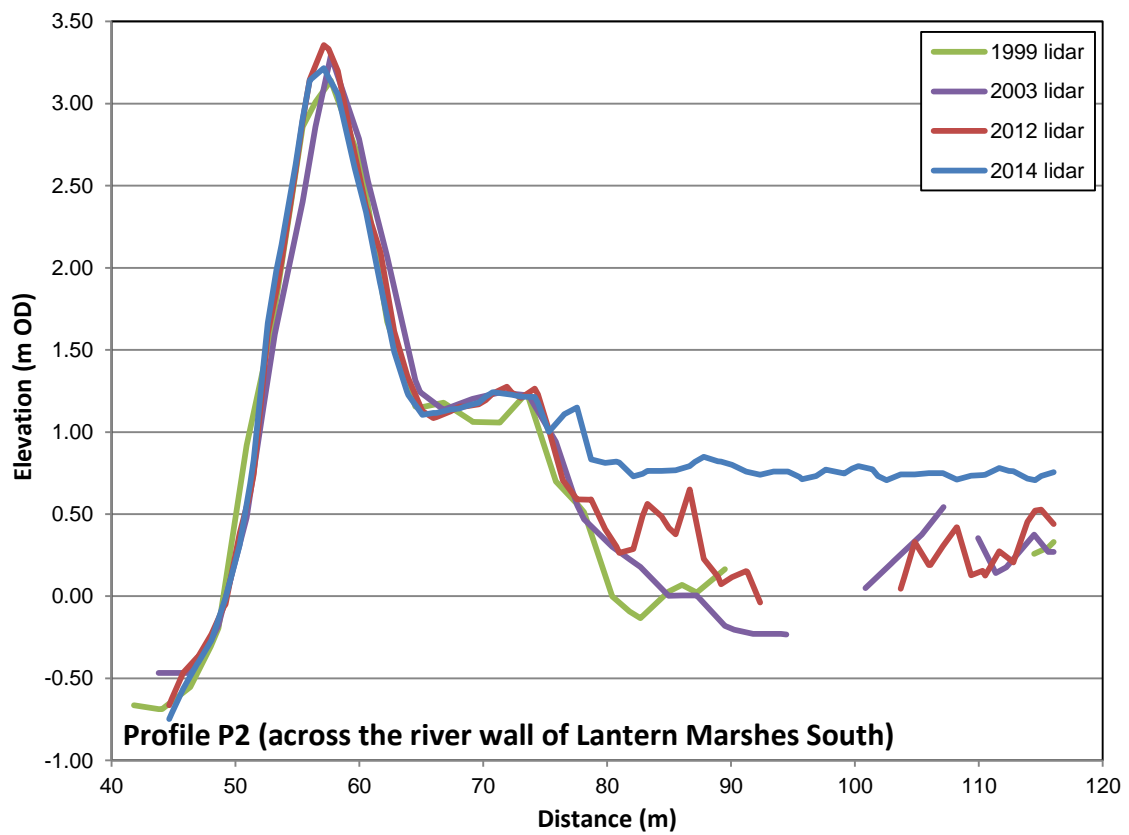
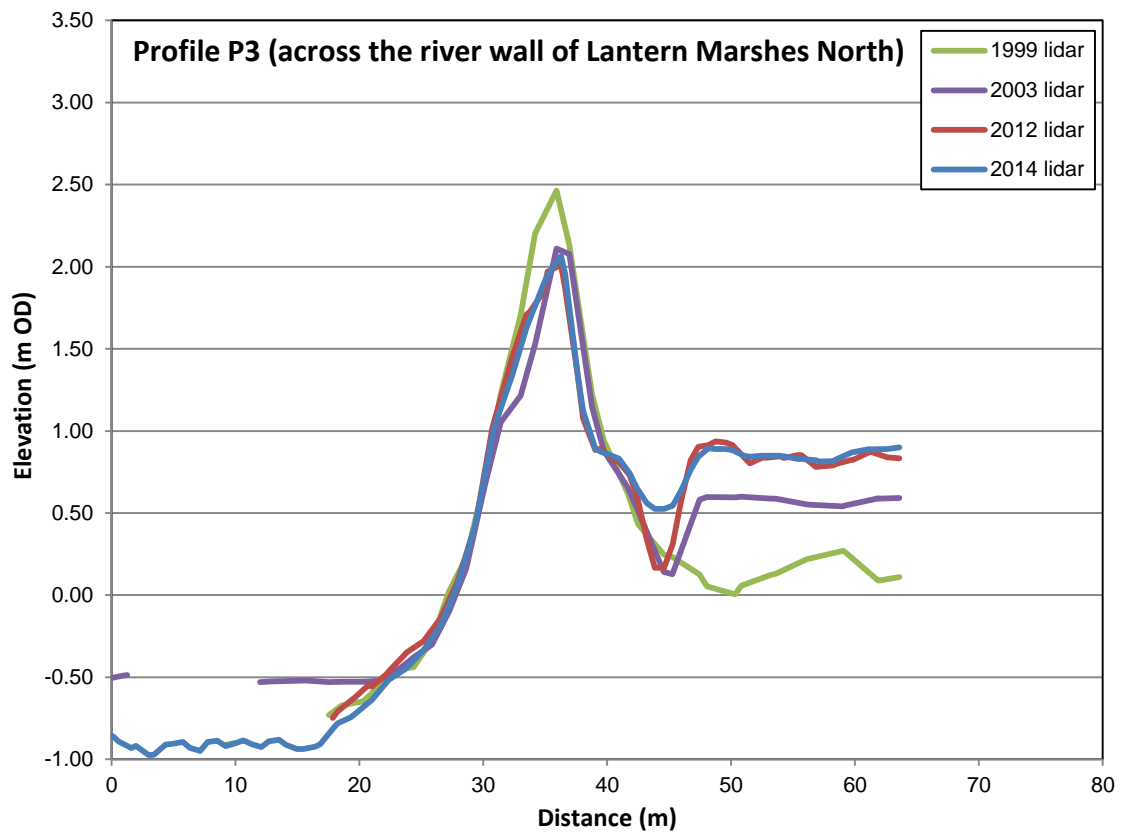
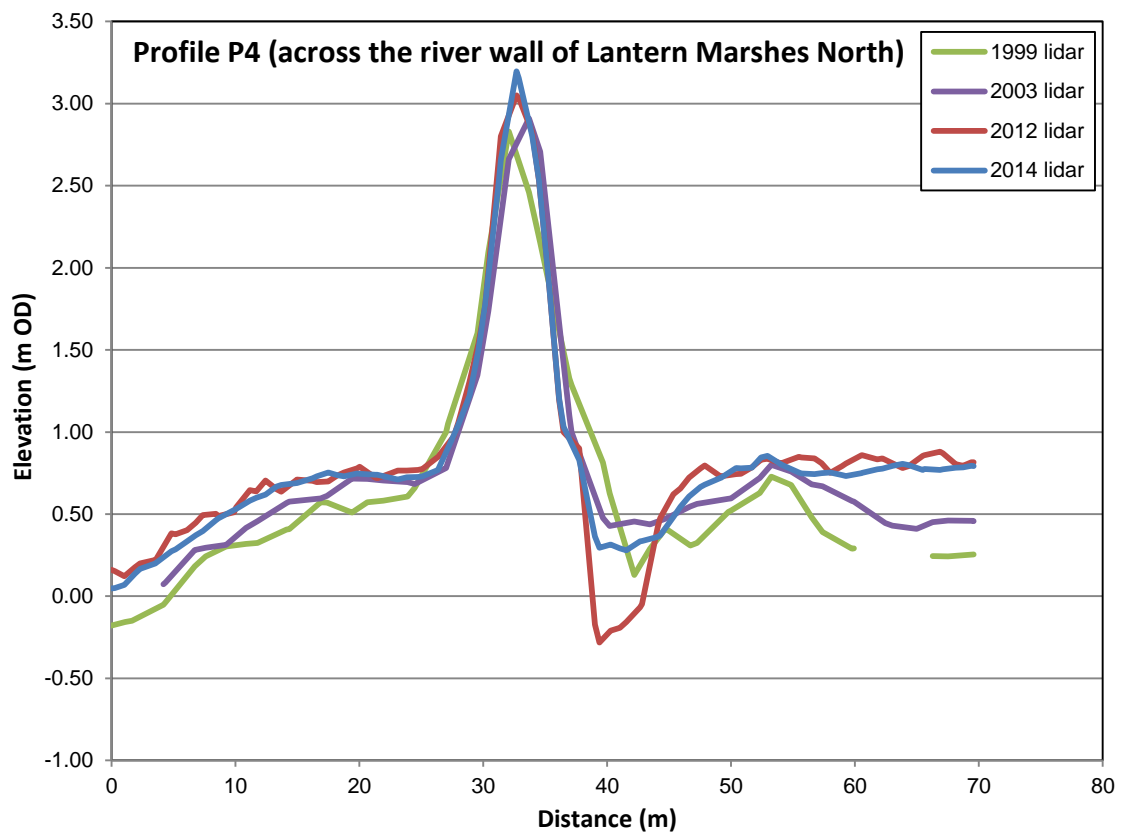
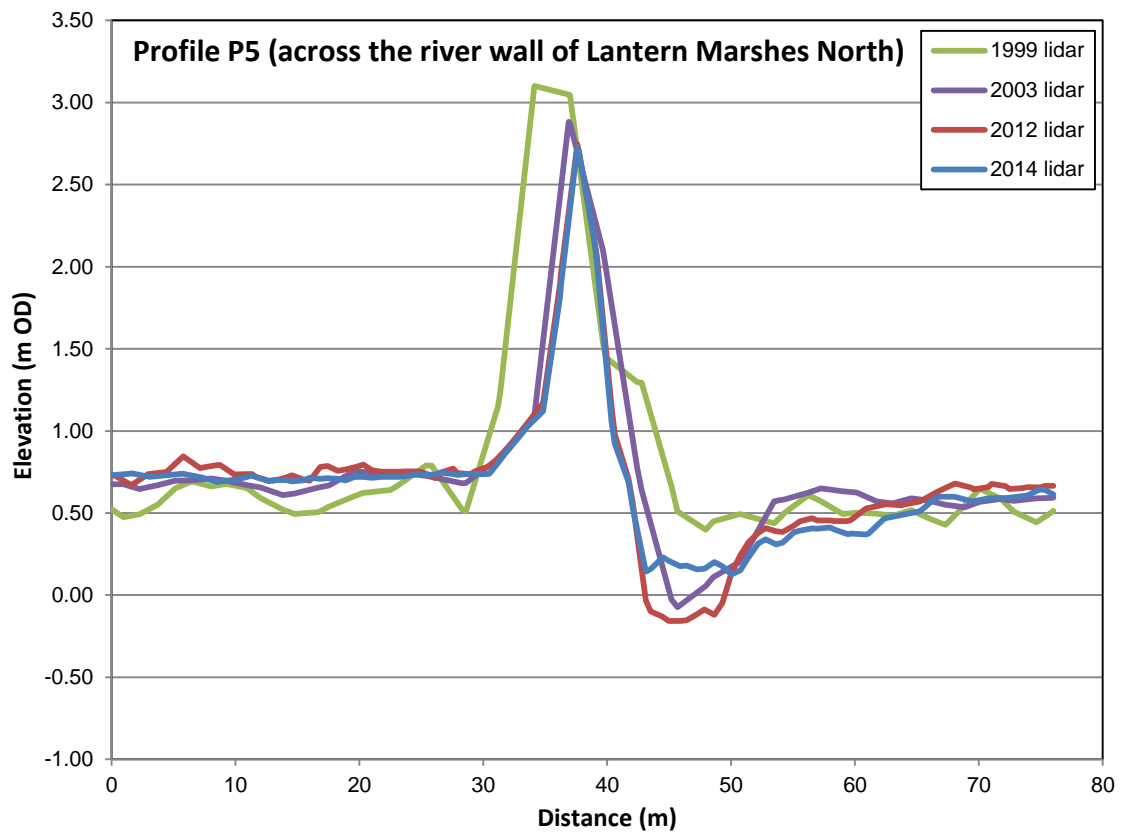
Figure 13. Cross sections of the American Wall and river walls, from LiDAR digital surface models flown 1999-2014

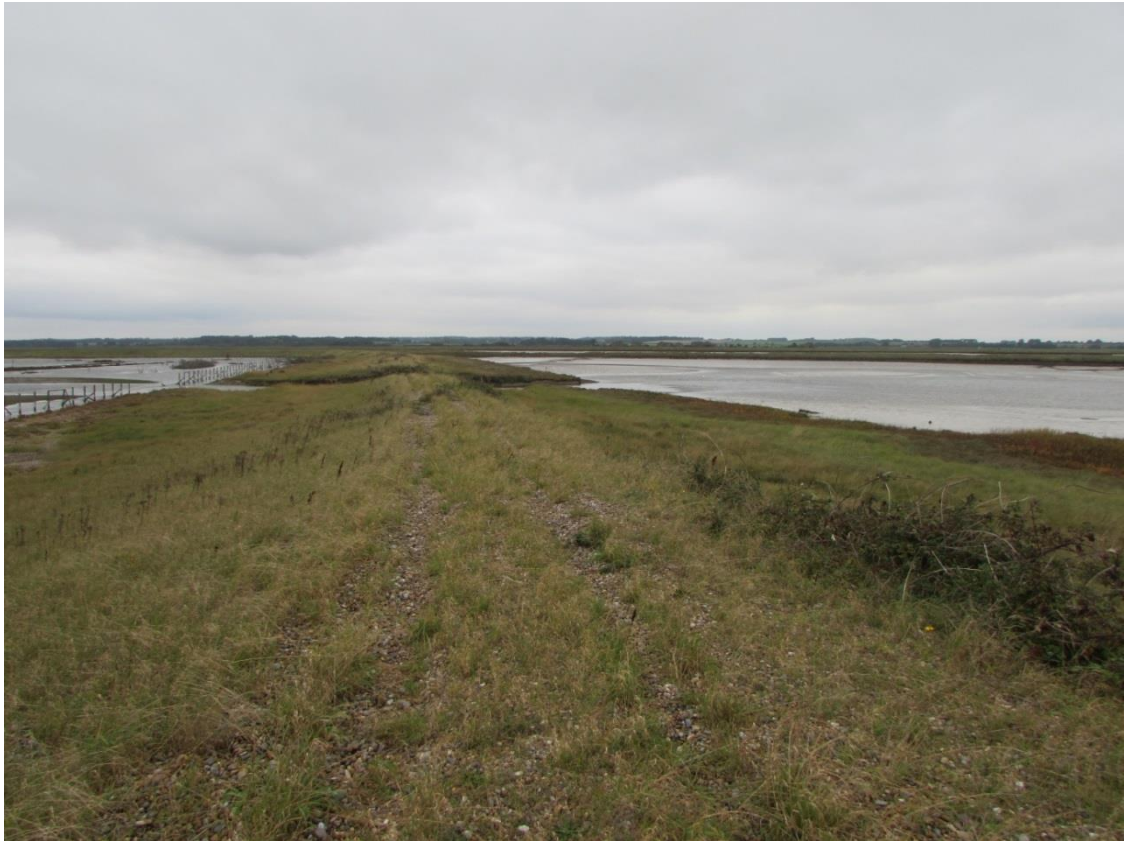
Photograph 1. View along the American Wall towards towards the breach, 7 October 2015

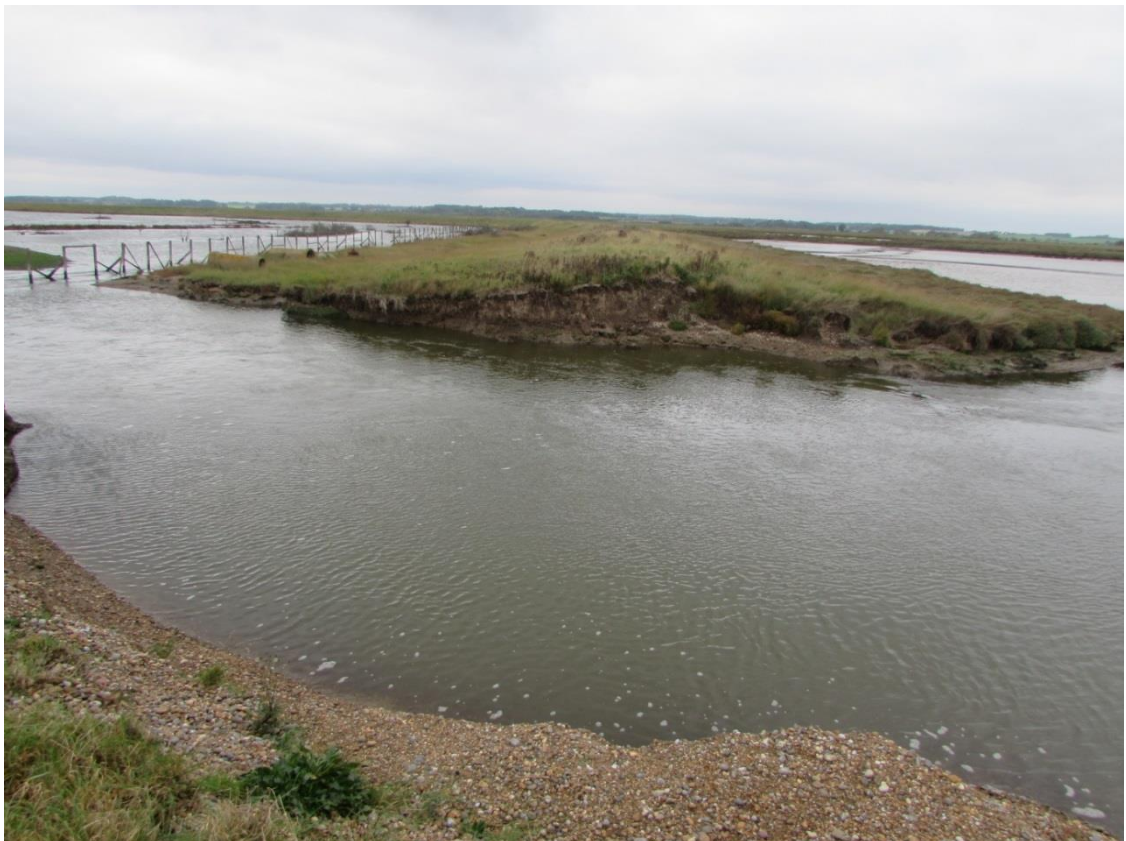
6. Field inspection on 7 October 2015 suggested that the December 2013 breach occurred at a point where there is a change in the composition of the bank and where

Photograph 2. The breach in the American Wall viewed from the east side, 7 October 2015

12. Considerable efforts were made to clear the area of bombs and other debris before the Cobra Mist facility was constructed. However, it will be desirable to minimise sediment erosion (e.g. due to channel widening / deepening) within the area in order to lower the risk of release of contaminants into the wider estuary. It was evident during the site visit, and from examination of the LiDAR DEM, that some erosion has already occurred due to scouring on both sides of the breach in the American Wall. For this, and other, reasons, measures should be taken as soon as possible to repair, or partially repair, the breach.

13. Installation of a sill or sluice at the location of the breach in the American Wall would provide an opportunity for regulated tidal exchange, providing additional flood storage on high spring or surge tides, permitting the raising of levels within the site through sedimentation and saltmarsh development, and providing time intervals when the surface sediments would dry out sufficiently to gain strength and permit other potential land-uses.

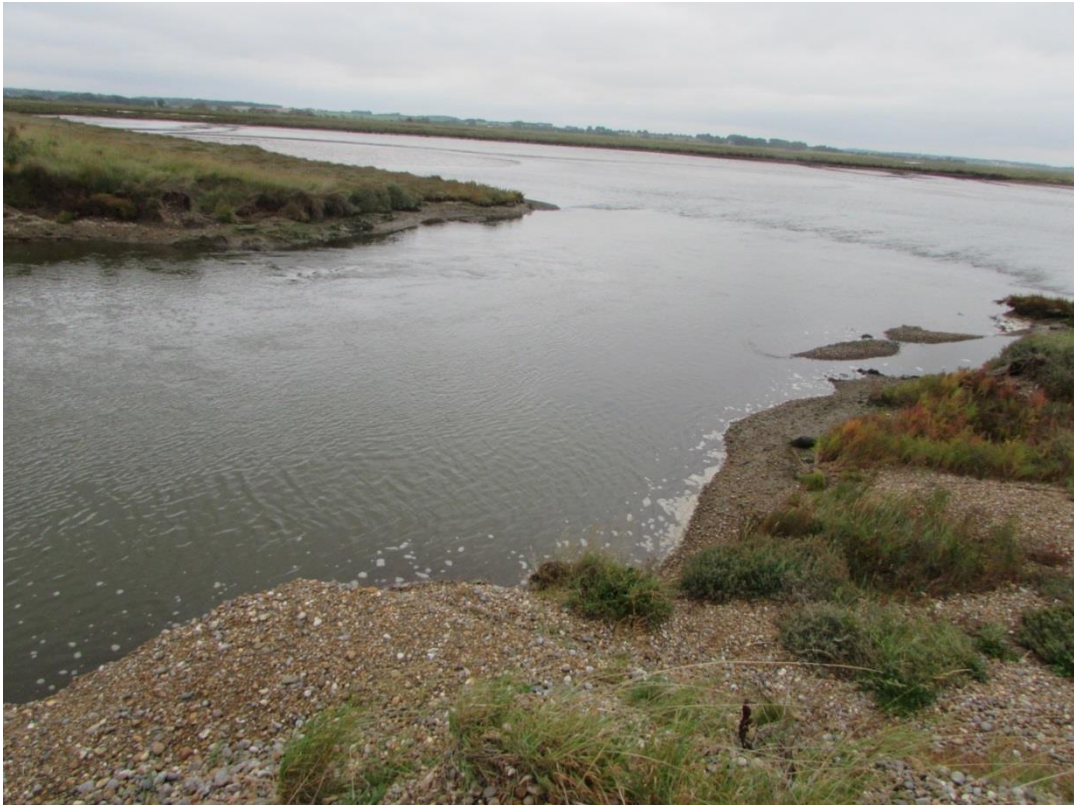
Photograph 3. The breach in the American Wall, view looking northwest, 7 October 2015

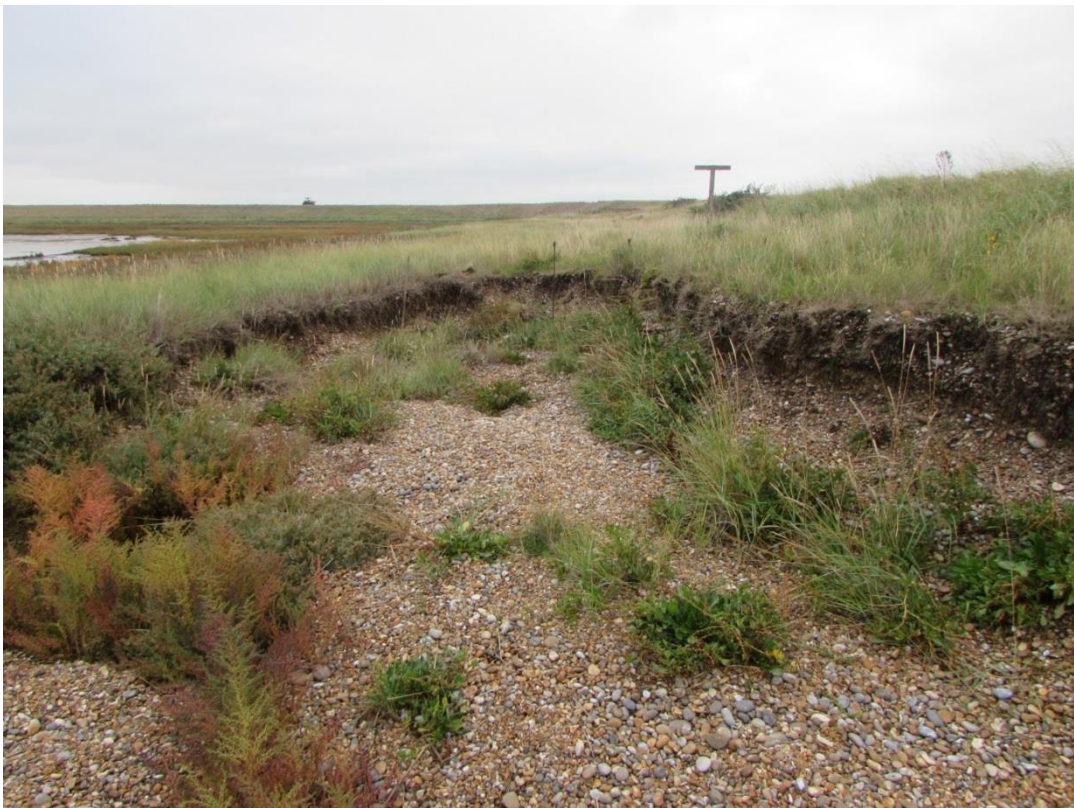
5. The walls surrounding Lantern Marshes South were raised and widened prior to construction of the Anglo-American 'Cobra Mist' site between 1968 and 1971. A new wall. 'The American Wall' was built at the northern end of the facility, effectively separating it from Lantern Marshes North. The eastern half of the wall was largely built of gravel extracted from the north-eastern part of Orford Ness, while the western part appears to have been built mainly of earth.

Photograph 4. The eastern side of the breach, showing largely gravel composition of the eastern part of the American Wall, 7 October 2015

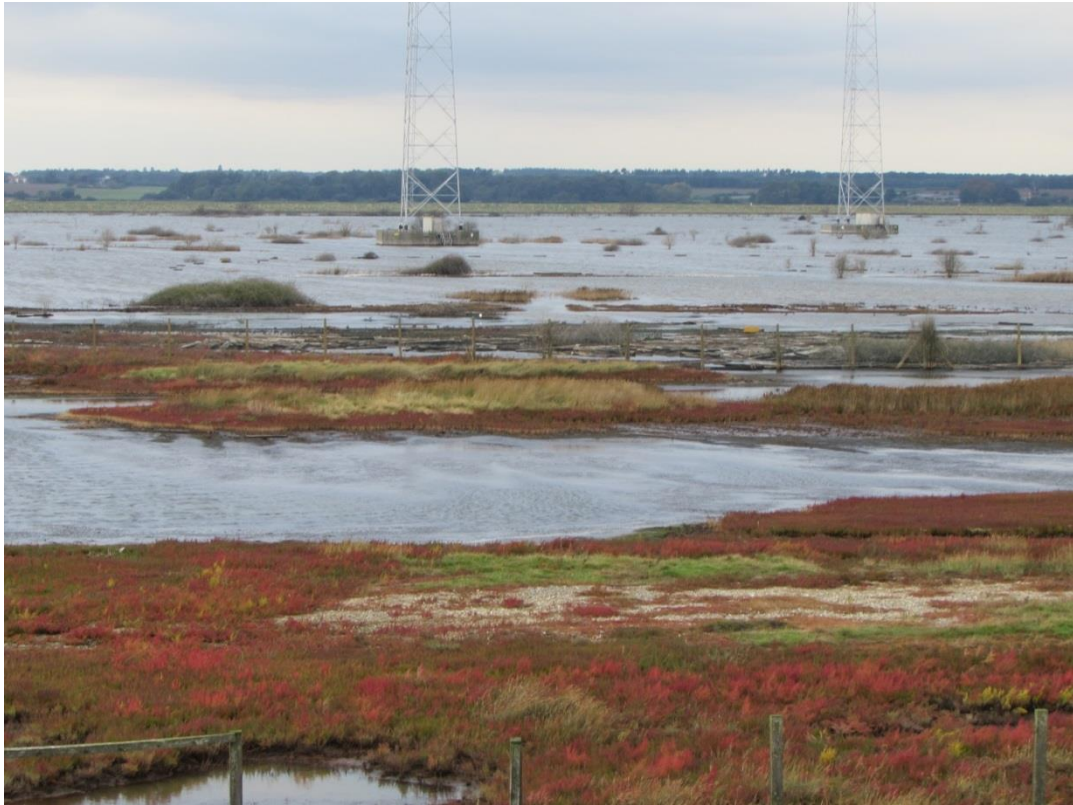
11. Saltmarsh communities have already become established around the fringes of the flooded area and on areas of higher ground within the Lower Lantern Marshes compartment. However, plant colonization is unlikely in areas where tidal or rainwater remains ponded, and where the surface soils become anaerobic. The potential for saltmarsh / brackish marsh growth, and the strength of the surface

Photograph 5. View across Lower Lantern Marshes ('Cobra Mist site'), showing ponded water and marginal saltmarsh development, 7 October 2015

sediment, could be enhanced by breaching of some of the internal sediment barriers which cause ponding, and possibly by direct pumping.

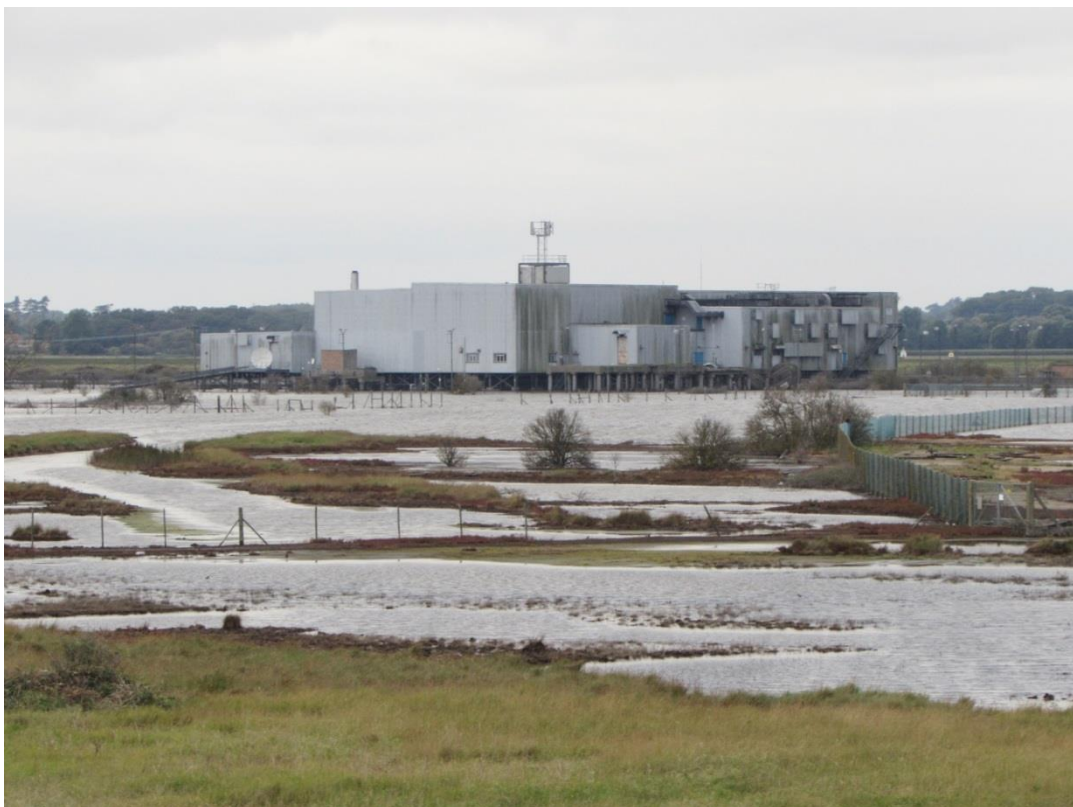
Photograph 6. View across partially flooded Lower Lantern Marshes towards the 'Cobra Mist' control building, 7 October 2015

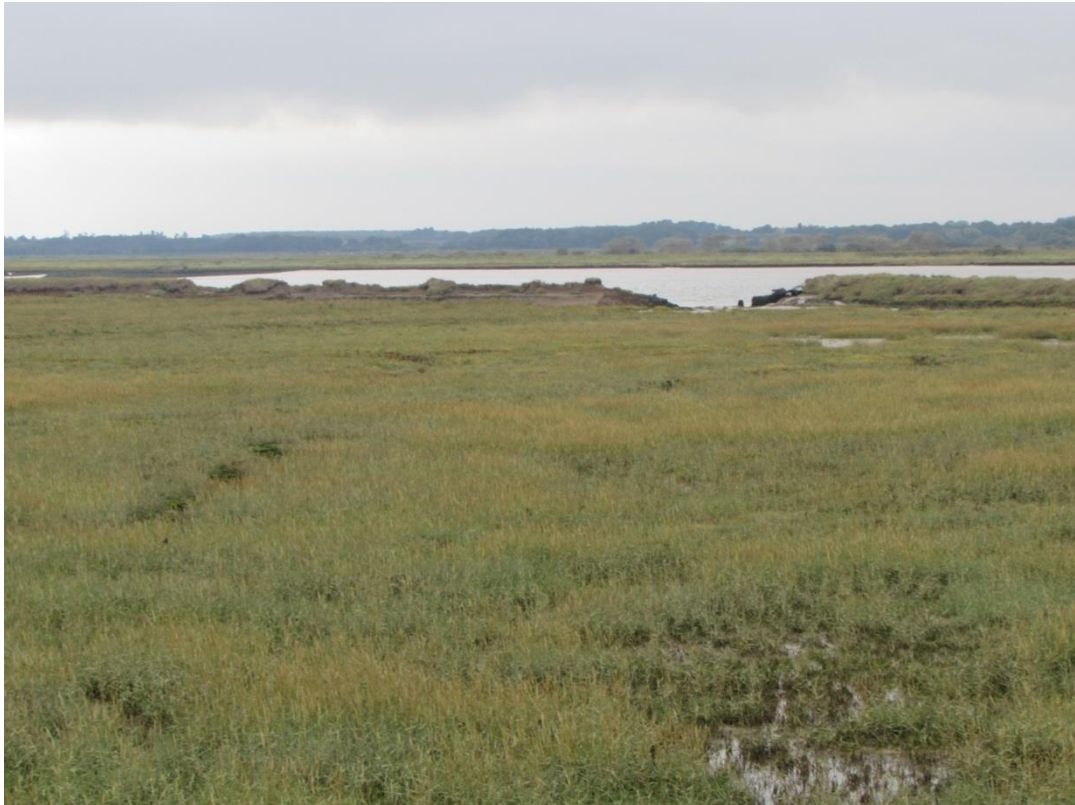
Photograph 7. View westwards across Upper Lantern Marshes towards the breach in the River wall, 7 October 2015

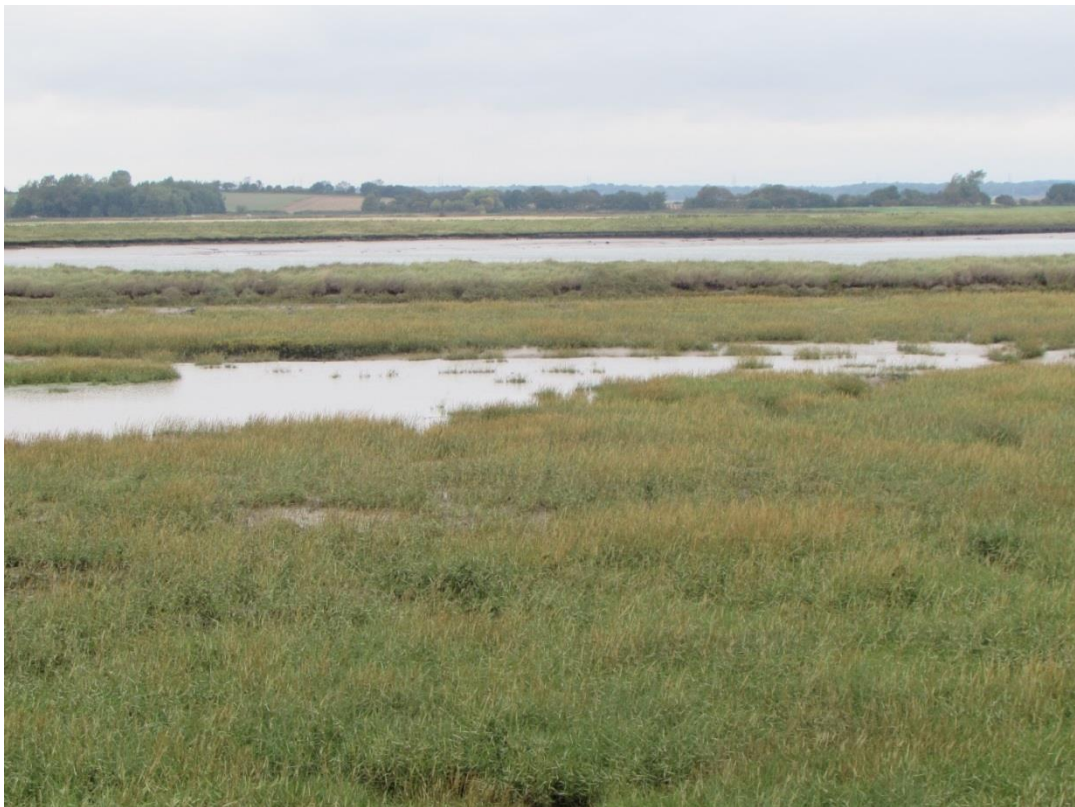
4. Since 1999 significant vertical accretion of mud has occurred within the area but many of the rejuvenated tidal creeks within the developing marsh have enlarged and there has been some erosion of the eastern side of the river wall, induced both by tidal flows and internally generated waves. The main tidal channel runs almost parallel to the river wall for much of its length, linking a series of former borrow pits, and is unnaturally straight.

Photograph 8. View westwards across the mid-part of Upper Lantern Marshes North eastern side of the breach, showing partially eroded landward side of the River Wall, 7 October 2015
