THE ALDE & ORE ASSOCIATION

ALDE AND ORE ESTUARY ASSESSOR'S REPORT

NAME: Brian Johnson	DATE OF INSPECTION April 2017
LOCATION: Flood Cell 1	March Equinox
Area of Assessment: Shingle Street to Butley Mills	Send to

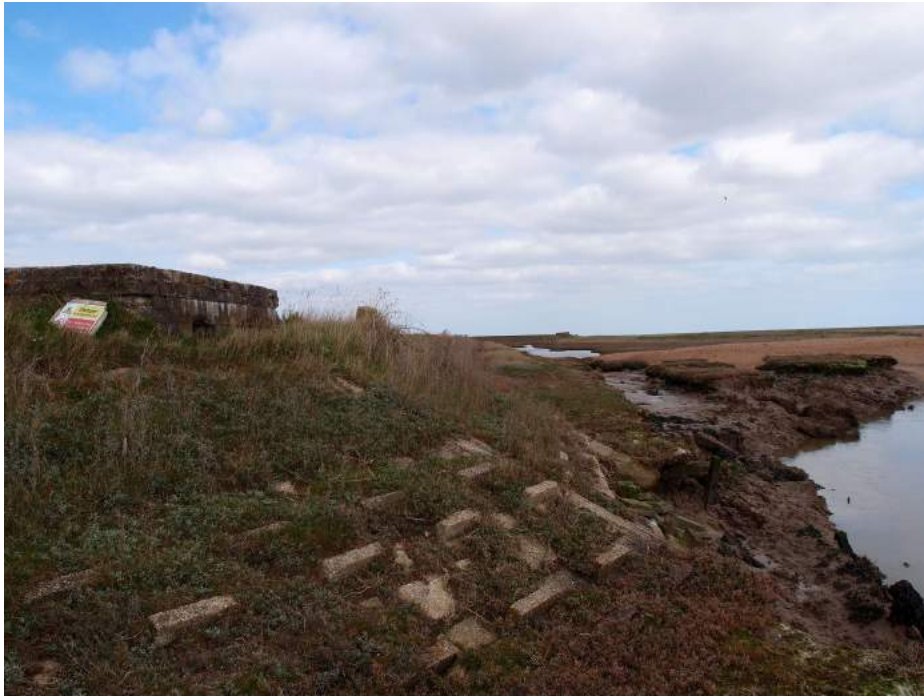
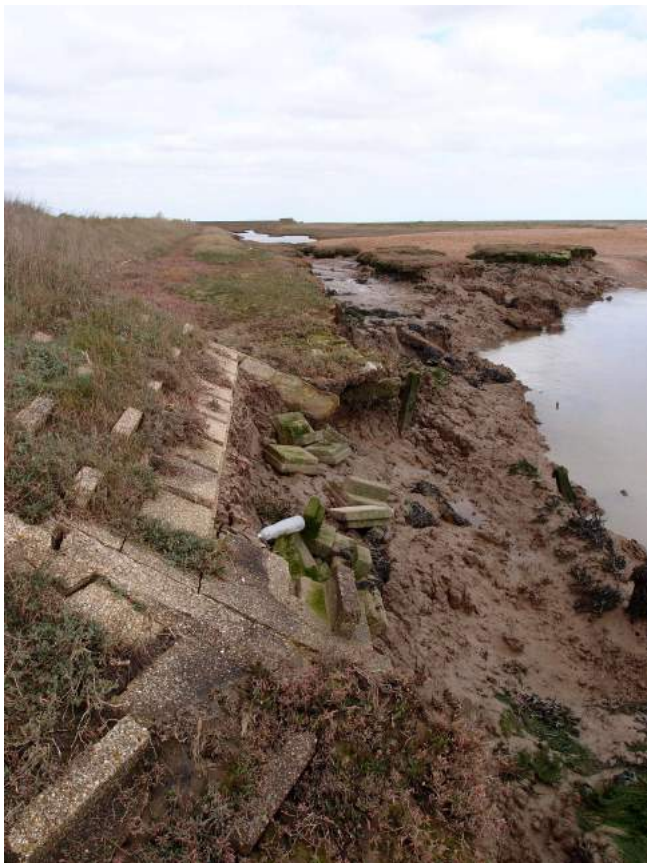
CHAINAGE 1000

The greatest change is over a short length at the mouth of Barthrop's Creek, near its mouth with the main river. At this point the levee has been built up around a WW11 pill box. The outer face is armoured. As reported during the last two years the foot of this armouring is unsupported. Undercutting of this and adjacent salting has been considerably increased during the last year. See photographs 1 and 2 below.

The mouth of the creek is almost opposite the tip of north Weir Point on the Ness and is therefore subject to wave action. (This is the only point on the estuary which is open to direct wave action because of the northward movement of North Weir point).
