## THE ALDE & ORE ASSOCIATION

## ALDE AND ORE ESTUARY ASSESSORS REPORT

NAME:	DATE OF INSPECTION	
Alison Andrews with Roger Baxter	April 2017	
LOCATION :	MARCH/Equinox Spring tide	
Brick Dock to Martello, river side		
TM 450565 to 463548		
Part I River walls		
All map references from OS Explorer 2012		
CO-ORDINATOR: Roger Baxter	Send to email: John Grayburn

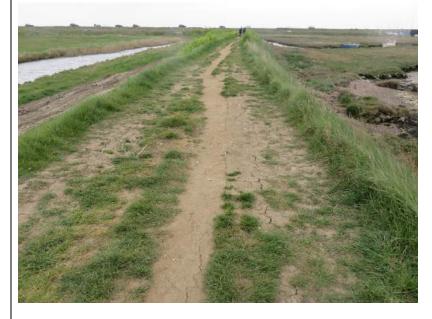
1. Footpath- Slaughden Road to next steps onto the marsh T M464556 to TM459558. This stretch has been yet further degraded, and broadened. In the winter months it becomes a near impassable quagmire and walkers have trodden down the edges further. The 'path' width is now some three times that of the original hoggin plank contained path. Also there is concern that the vulnerable low part which was overtopped in 2013 is getting lower and broader and other parts are beginning to be similarly degraded. Several places where the bordering wood planks had been broken in earlier years are now further dilapidated.

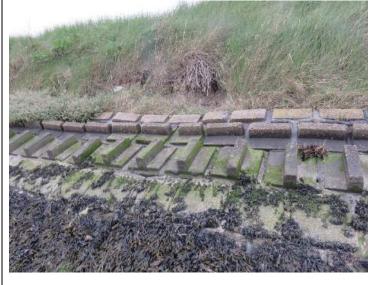
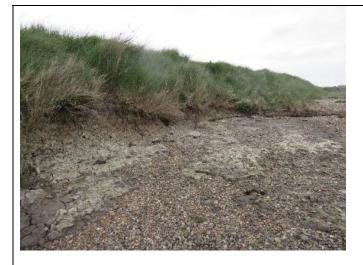
**2. Bank east of Aldeburgh Sluice.** TM 459557. This stretch shows two new sections of deterioration, First the armoured section (Essex block?) is getting worn away above the block (the repaired section to the west still looking good). Second the earth bank next to the armoured section, above a mini shingle beach is getting washed away at the base, These are new areas of wear.

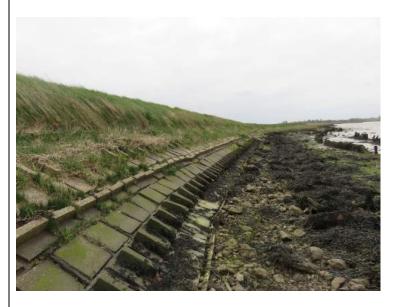
**4. Brick Dock surrounding wall.** This was fully repaired some three years ago. In a few places the armour is beginning to dip as the earth behind is washed out. There is no substantial deterioration at present but these slight slumped parts will need to be monitored carefully over the next few years and could be dealt with when Phase 2 of the Aldeburgh Marsh project is done. TM448563

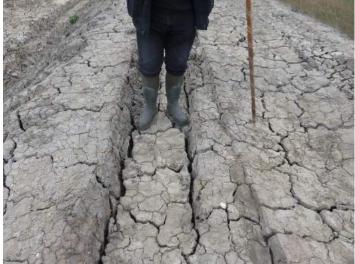
5. Wall in process of being heightened and broadened. While recognising the work is still in progress, it

may be worth pointing out that because of the near drought the newly laid clay top has extensive cracks, some 7 inches deep.

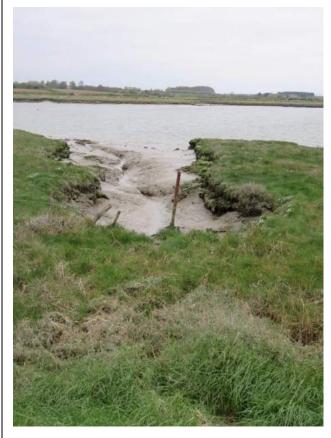
**6.** The sluice opposite Stanny. TM445560. This has noticeably been eroded/ widened/deepened further (result of the surge?)

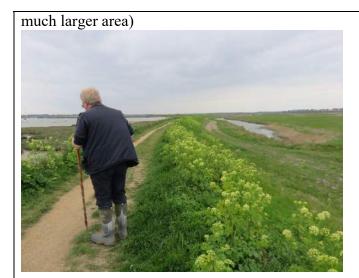
**8. Extensive growth of Alexanders:** much of the wall sides from Slaughden Road to the first public footpath steps are now covered in Alexanders, *Smyrnium olustram*. This plant has become far more widespread in the last two years (indeed in all this part of Suffolk): it has deep roots and smothers out any grass or other plant growth. Confirmation is needed that this is not damaging to the structure of the walls, both in terms of sucking out moisture, preventing rain entry into the bank, the deep root structure being a central core as opposed to the extensive web like structure of grass roots, and leaving the bank more exposed to weather in the winter when the plan dies down. Should this plant be mowed/cut down before reaching seed formation? ( see photo taken before Alexanders in full growth 3-4 feet high and covering a

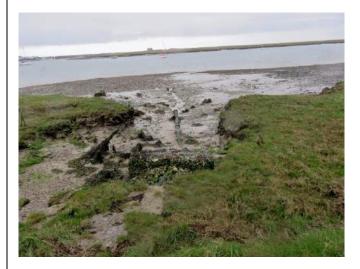
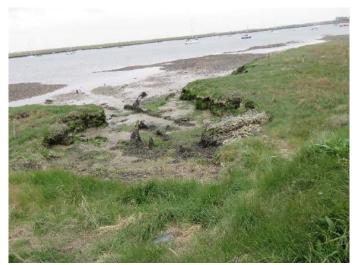
7. Comparison of Aldeburgh Sluice outlet. 2016 then 2017
