THE ALDE & ORE ASSOCIATION

ALDE AND ORE ESTUARY ASSESSORS REPORT

NAME:	John Grayburn Roger Baxter	DATE OF INSPECTION:	1st May 2017
LOCATION:	Flood Cell 3		
AREA OF ASSESSMENT:	Chillesford Marshes		March Equinox

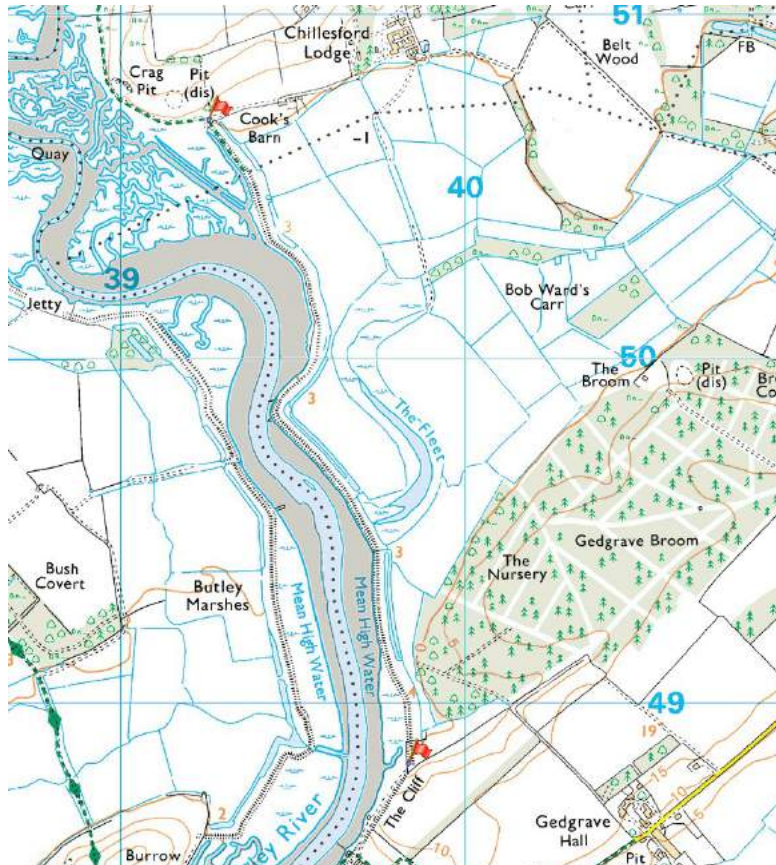
River bank surveyed:

- Good saltings rising to hill/cliff behind.
- Low debris line. Wall good with a perfect back slope.
- No change in armour. Some break up of revetments, but not a concern.
- Strong vegetation on top of wall.
- At the point, old revetment blocks giving protection with a build up of silt within.
