THE ALDE & ORE ASSOCIATION

ALDE AND ORE ESTUARY ASSESSORS REPORT

NAME: Andrew McDonald	DATE OF INSPECTION 28 th June 2017, low tide approx 10:30 am BST
LOCATION: Flood Cell 4	
Area of Assessment Butley River and Gedgrave Marsh TM 39677 48583 to 41591 48472 OS Explorer 212

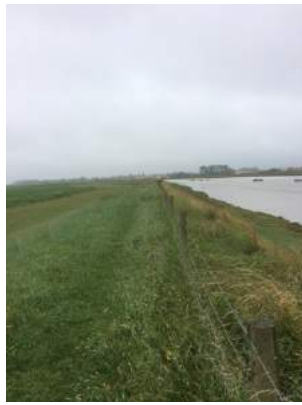
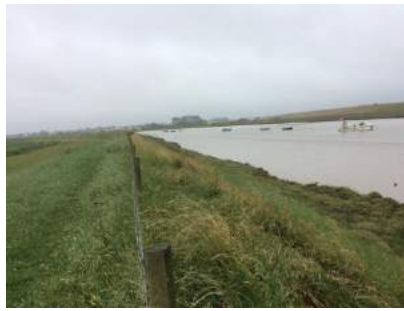
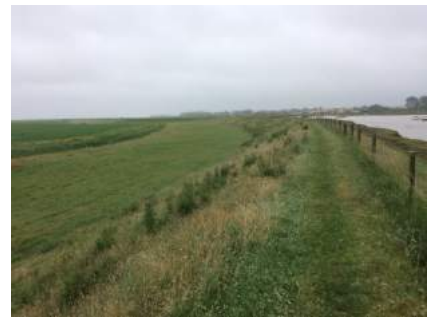
General view of pathway at 397486, start of inspection by Ferry Cottage. No signs of damage since 2016 inspection, well grassed and no slippage; landward wall in good order with good grassing, low slope, some cracks evident but all grassed over.

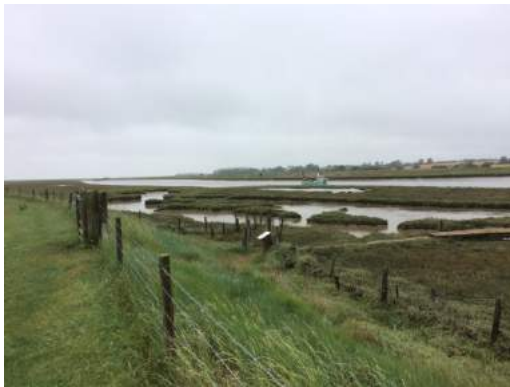
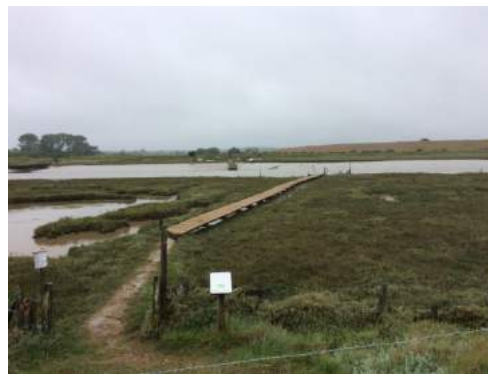
Saltings opposite Butley Ferry jetty (394 483), general view – no apparent changes since last year (except of course smart new walkway to ferry pontoon).

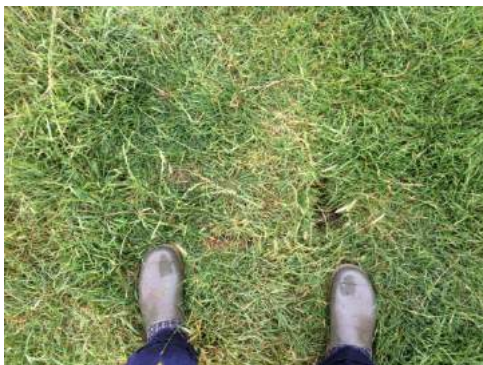
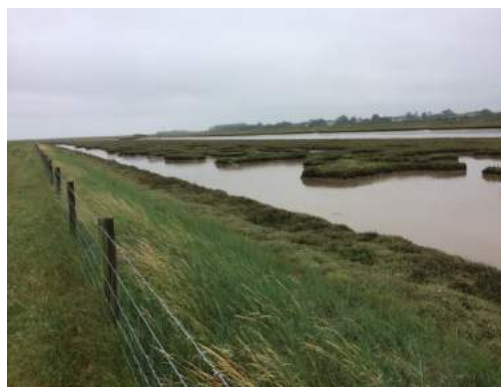
A example (394 483) of pitted/cracked damage to pathway, relatively frequent this year; and some apparent widening of the 'inner channel' between Ferry and Boyton Dock (394 480). Landward side of wall opposite Boyton Dock (394477) all in good order.

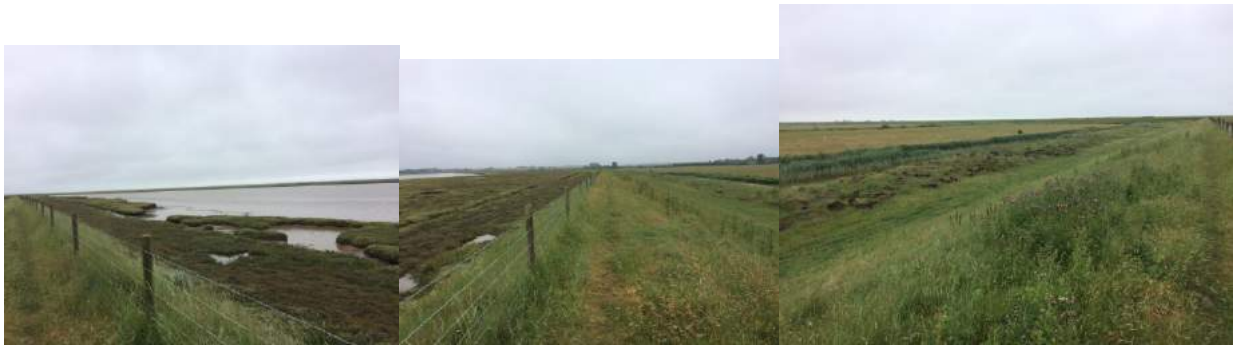
Saltings, pathway and landward wall at 406 473, past Boyton Dock. Saltings unchanged, landward side and path in good order, no evidence of previous slippage on landward side.

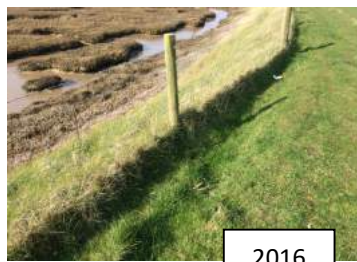
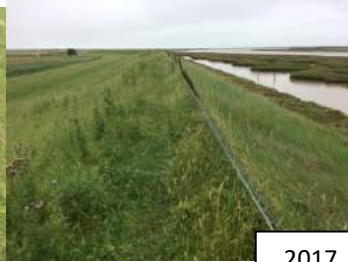
The path at 406 473, 2015-2017 – continued stumping by posts, and some evidence of slippage on wall facing river; no significant deterioration though.

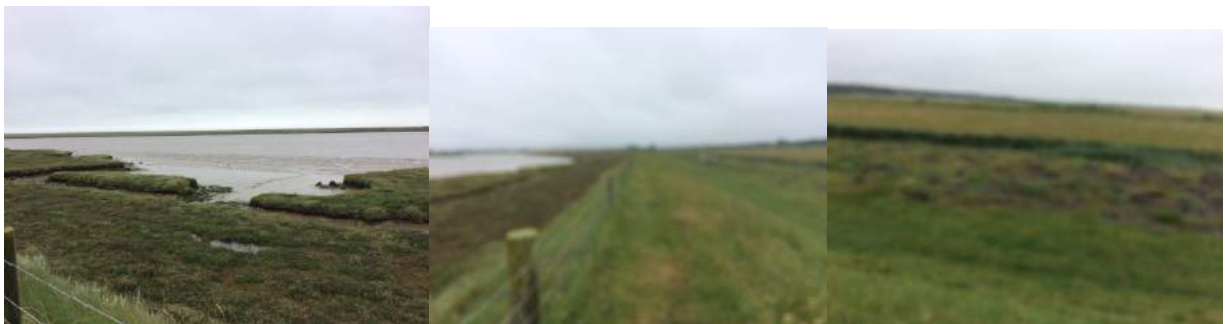
Towards Inset Point, at 405 471 – saltings unchanged, path still worn and damaged but better grassed than 2016, spoil berm by ditch on landward side now completely grassed over.

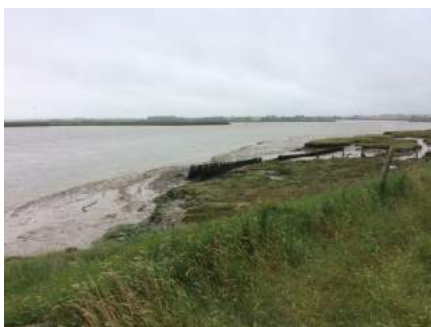
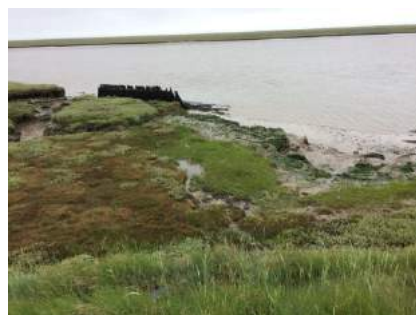
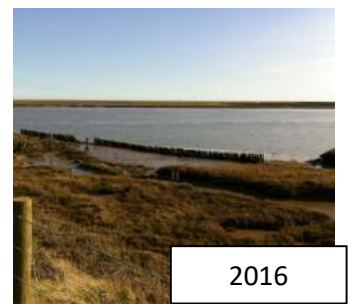
At 407471, Inset Point – saltings looking slightly battered at the point and more cut away than last year. Path slightly damaged but well grassed. 2016 photo included for comparison.

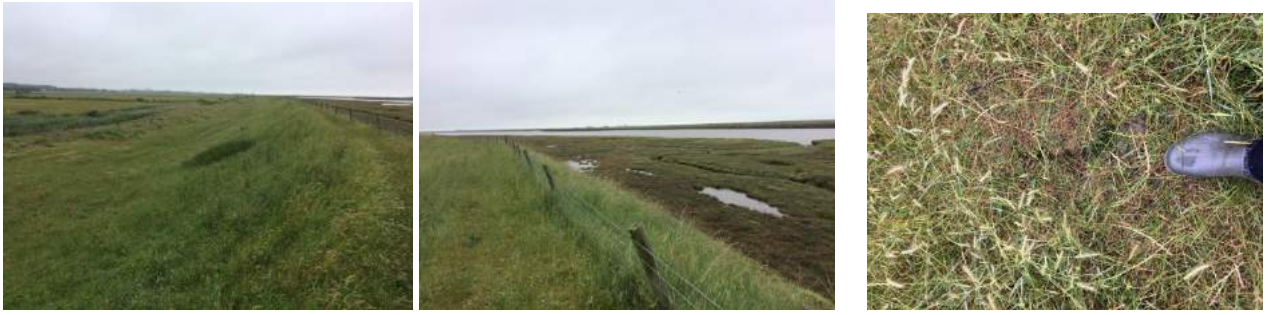
At 408 473, path towards the pumping station – landward and river-ward walls both in good condition, but some serious cracks and fissures in the path.

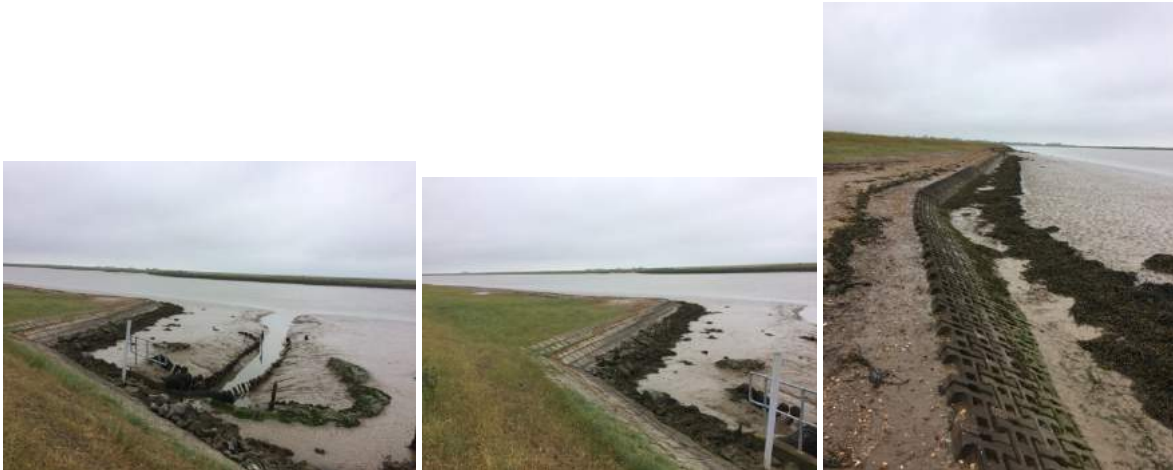
At the pumping station inlet, 411475. No significant change since 2015& 2016, river wall revetments all in good order here and further along.

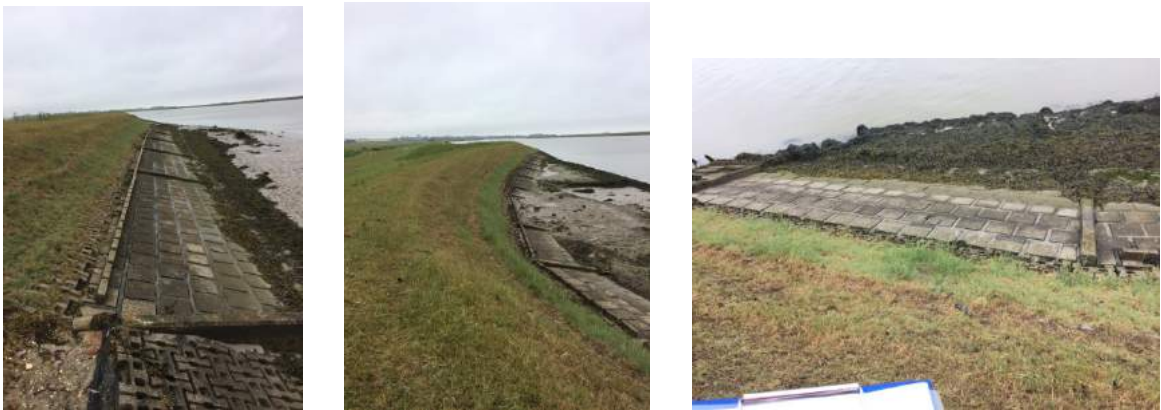
River wall revetment from 411 476 towards 412 477. Reasonable condition along this section.

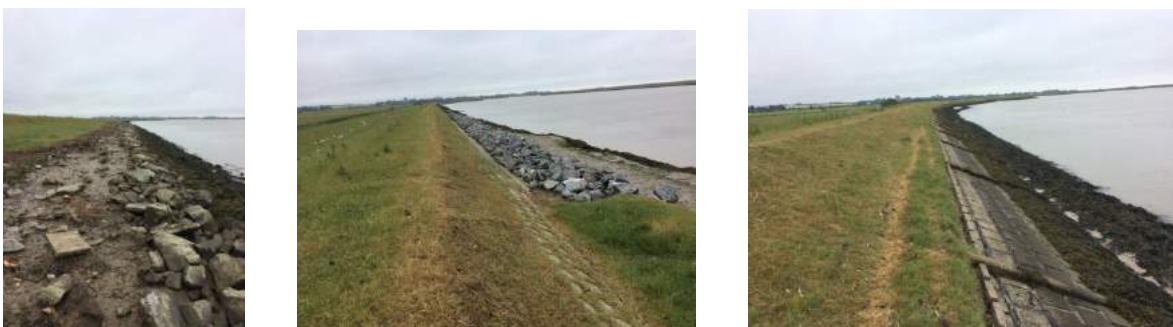
Boulder and shingle defences at 412477, revetment and (at 414 482) new lower path appearing at foot of

river wall. Quite a lot of animal (sheep) activity apparent along this stretch.

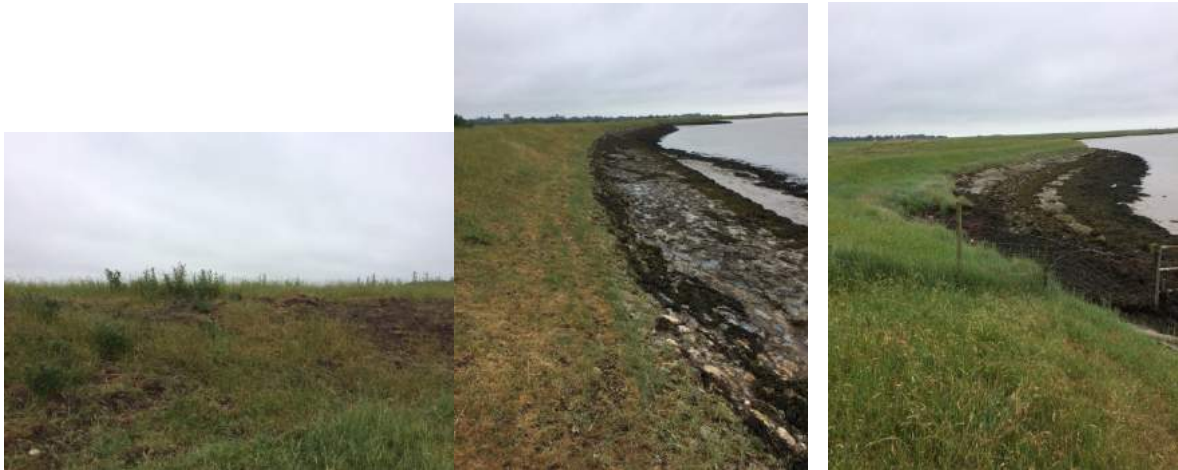
Coming towards Chantry Point – bare patches at 412 477, trodden pathway at foot of river wall (again) and seaweed covered revetments at the corner 415 484.

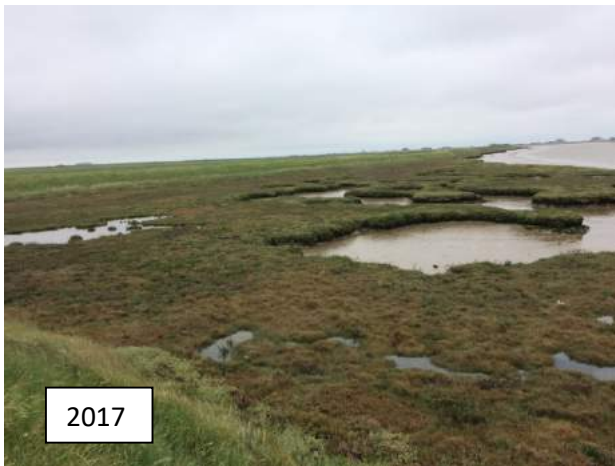
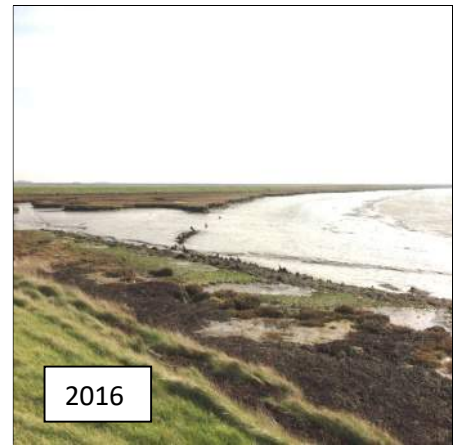
General view of saltings at Chantry Point, 415 484, last year and this year – path is worn but no significant change from last year, no visible deterioration in saltings or river wall/slopes.
