# THE ALDE & ORE ASSOCIATION

## ALDE AND ORE ESTUARY ASSESSORS REPORT

<b>NAME:</b> Frances Barnwell	<b>DATE OF INSPECTION:</b> 31st March 2017
<b>LOCATION:</b> Flood Cell 4-2	
<b>AREA OF ASSESSMENT:</b> Chantry Marshes to Orford Quay	March Equinox

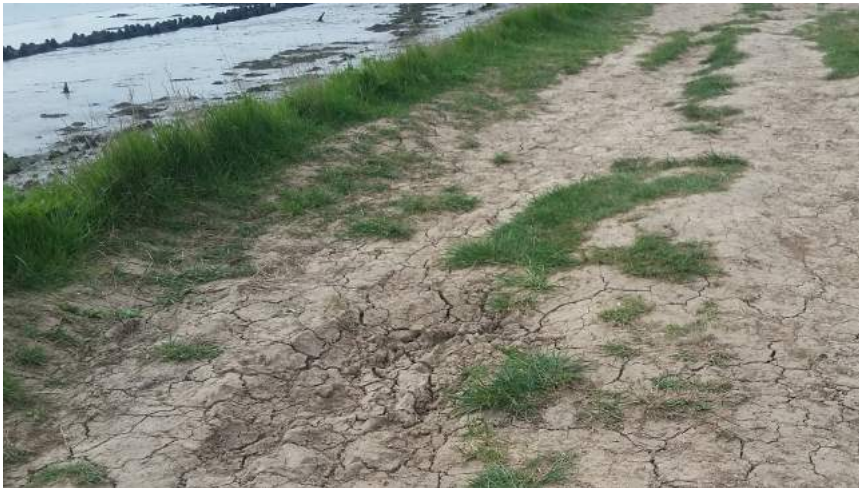
Photograph 1

- Overuse of wall top. A secondary path is developing on the river face (see Photograph 1). Continuing deterioration, with puddling, dips and cracking where there is no vegetation.
- Mesh exposed, uneven and a trip hazard.
- Manhole at sewage outlet is in a dip. Channels of erosion now more apparent (overtopping here reported in 2013).
- Armour broken in places (see Photograph 2). There appear to have been some repairs.
- Salting trial section covered in seaweed. Little evidence of accretion.
