ALDE AND ORE ESTUARY ASSESSORS REPORT

NAME: Roger Baxter John Grayburn Tim Dudgeon Alison Andrews Diana Paterson	DATE OF INSPECTION: 5th May 2017
LOCATION: Flood Cell 4-4	
AREA OF ASSESSMENT: Chapmans Creek to Pump House	March Equinox

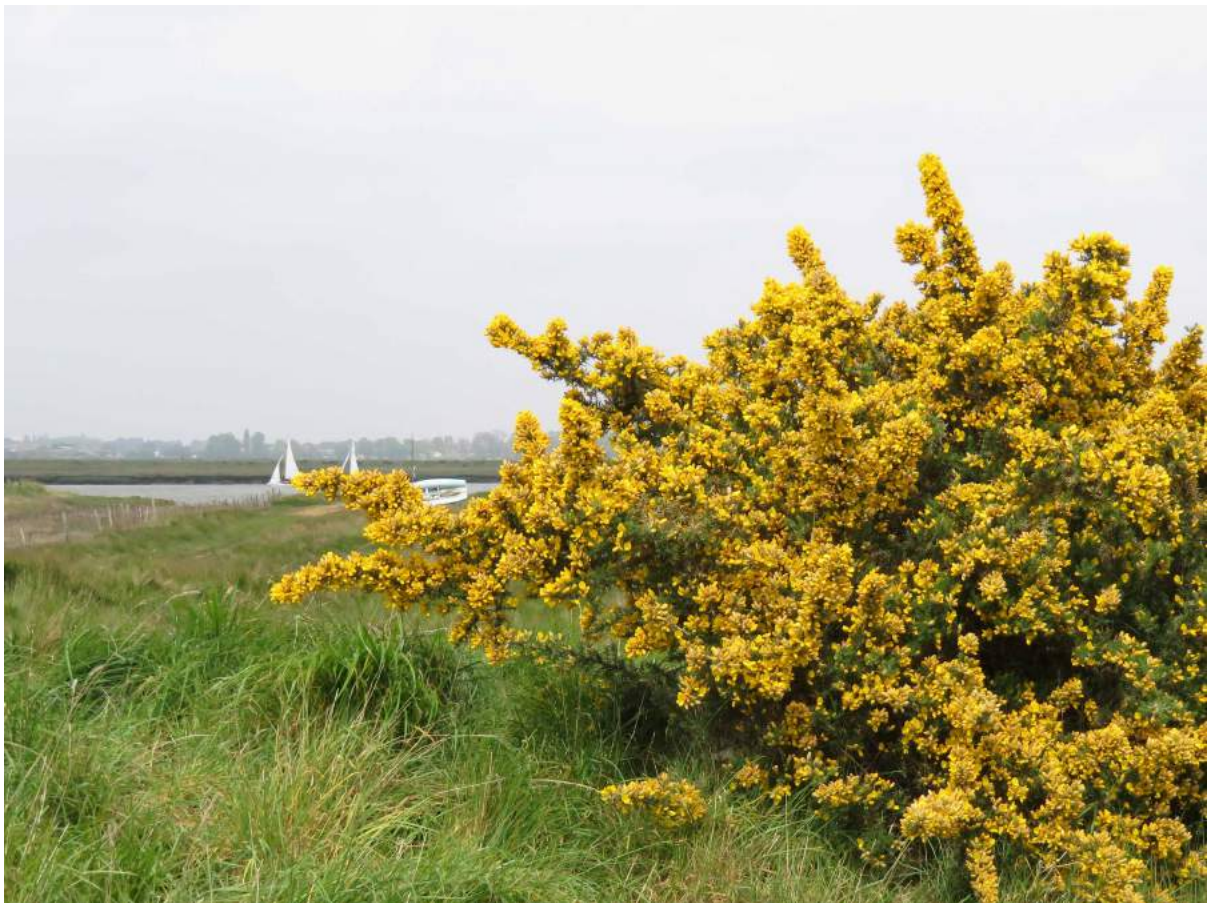
Photograph 1

- First section of wall needs cutting.
- Gorse bushes growing on top (see Photograph 1).
- 300m of poor saltings north of Pump House behind electric fencing (see Photographs 2 & 3).
- Attenuation system requires upgrading. Partial collapse of mesh preventing accretion.
- Walls generally robust, top well cropped where sheep have grazed.
- Debris - where there is any - is well below wall and top (see Photograph 4)
- Saltings with old defence posts (see Photograph 5)
