# THE ALDE & ORE ASSOCIATION

## ALDE AND ORE ESTUARY ASSESSORS REPORT

<b>NAME:</b> Simon Barrow / Keith Martin	<b>DATE OF INSPECTION:</b> 21 April 2017
<b>LOCATION:</b> Flood Cell 5	<b>AREA OF ASSESSMENT:</b> <u>Chapmans Creek to Anchorage, Iken</u>

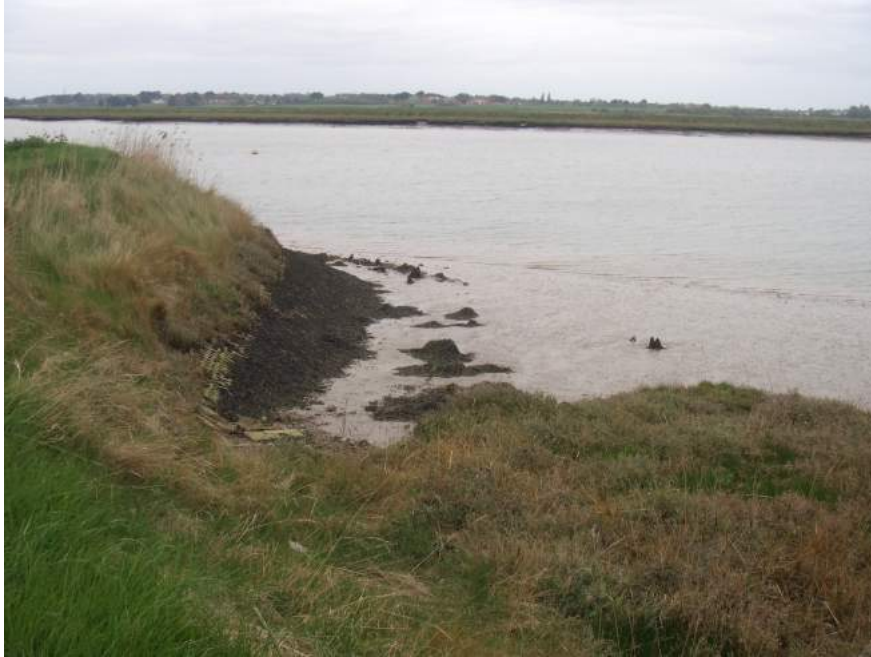
Grid ref	River Wall/Armour	Saltings	High Tide Debris Line
Paul Cook			
552 453	Seems height lower than to the west (1.5m area) Check: LIDAR	Nil in gap. Needs stakes to help build up	20cm below path

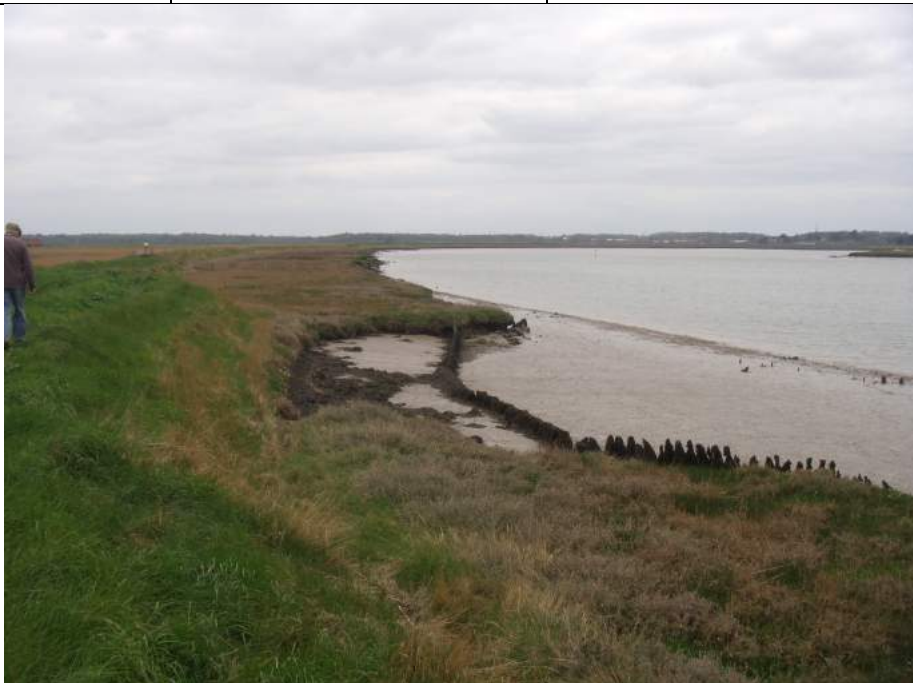
555 444	Ok	Salting 'bay' in place. Mud filling and vegetation growing. Good result of stakes	ok
---------	----	--	----

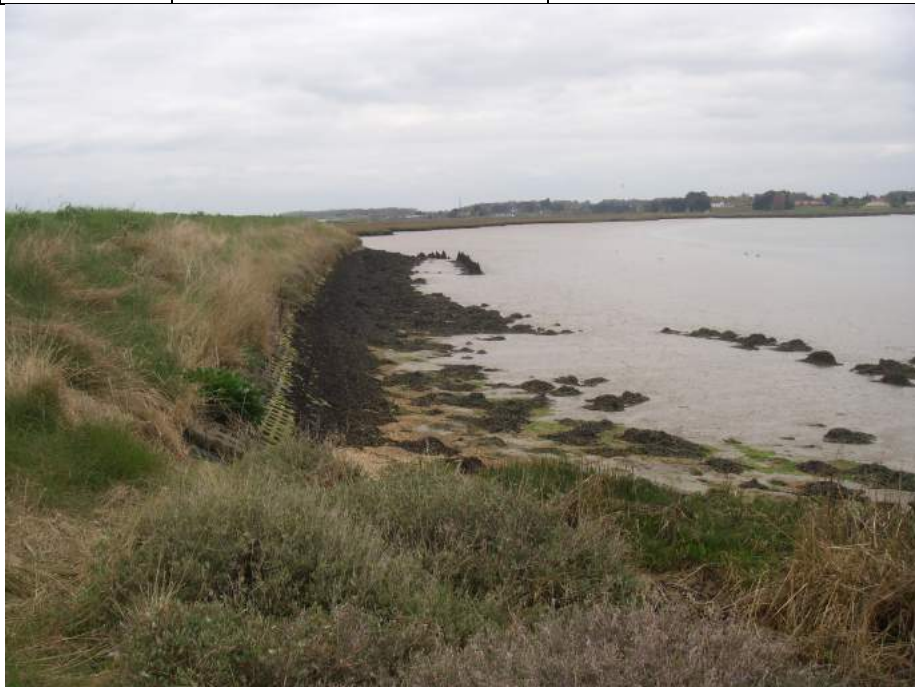
558 442			0.8 metres below
559 442		Needs new stakes. Existing ones hardly visible but have done good – see vegetation

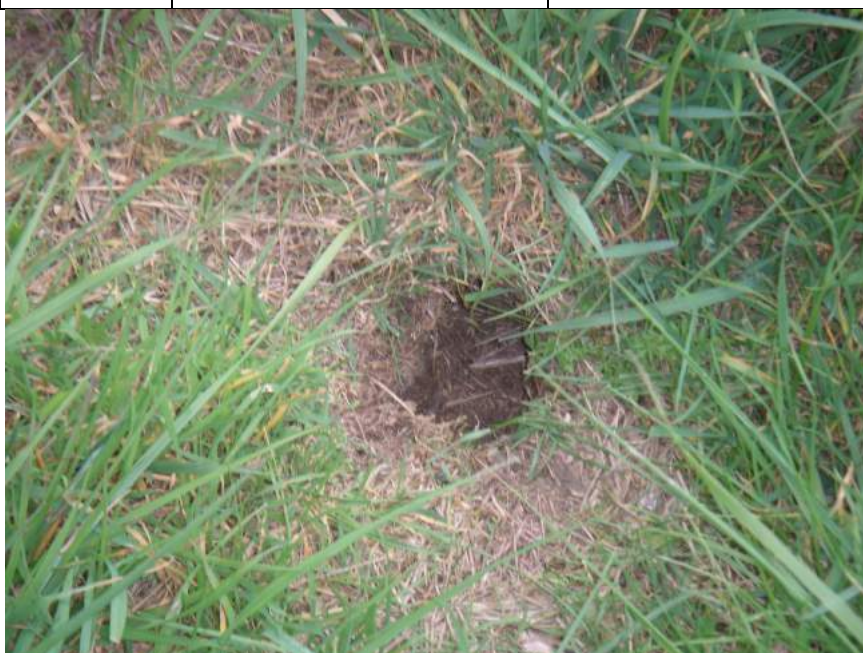
560 442	✓	15 m	0.3 metres below
562 442	✓	Excellent	10cm very close
564 443	Hole on top of river wall – several on this stretch	✓	1.5 metres plus

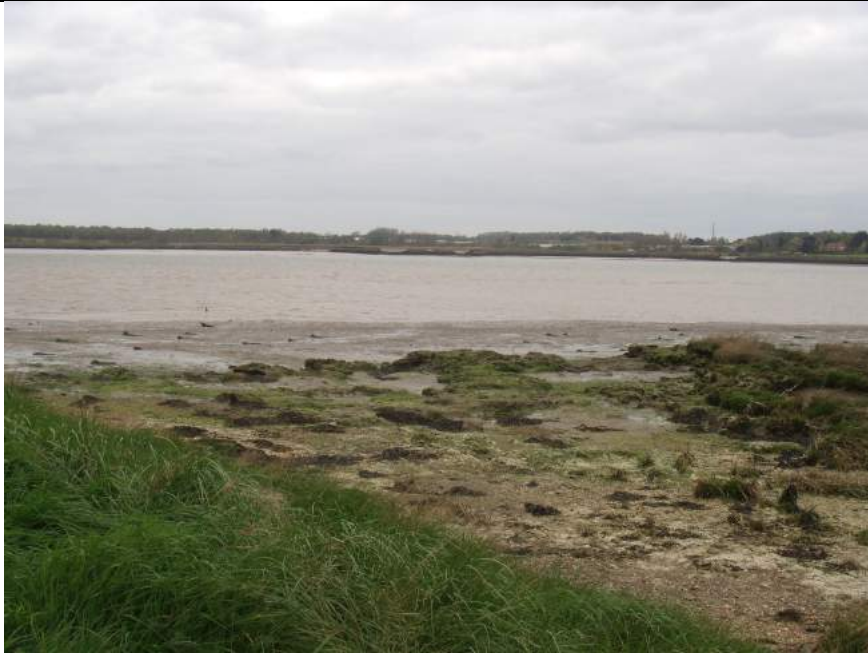
566 441	First notice – mole hill on top	✓	1.5 metres plus
568 441		Opp Hazelwood new stakes needed – big defenceless bay visible	1.0 metres

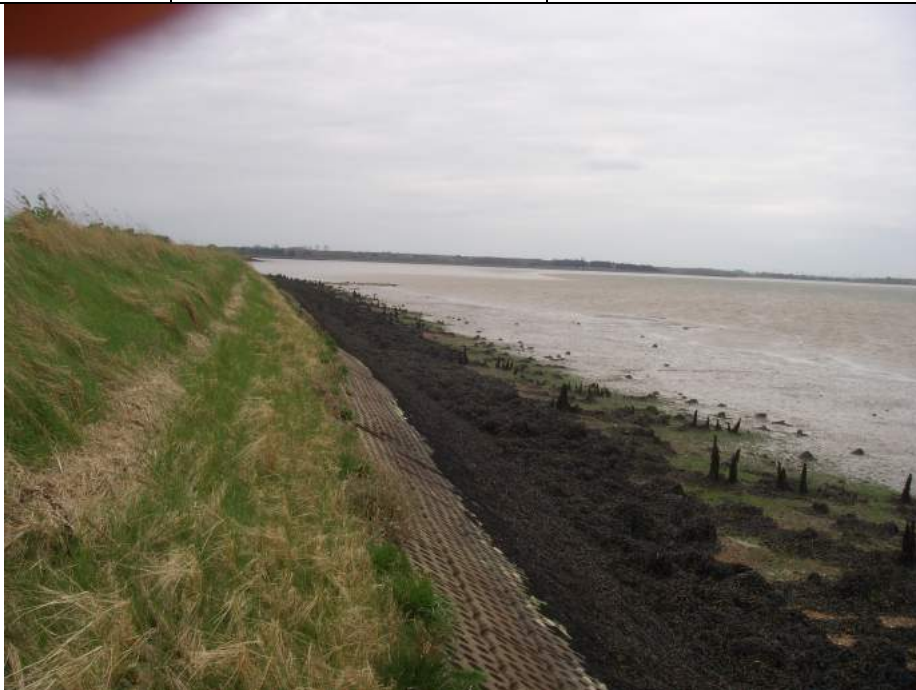
568 440	✓	Old stakes need replacing all along this stretch	1.6 metres
---------	---	--	------------

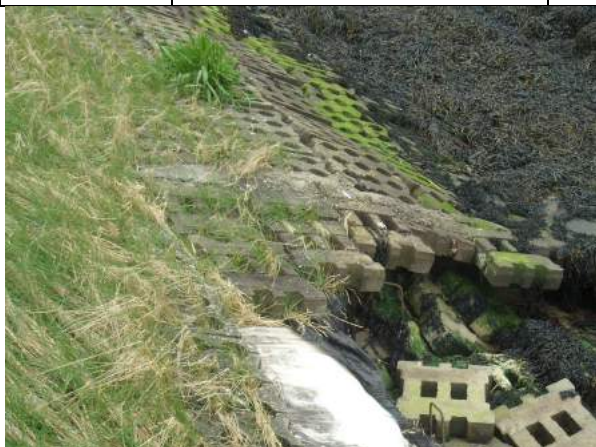
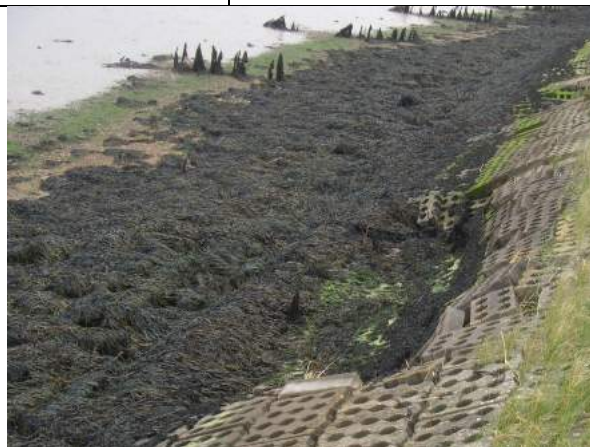
567 438	Serious damage to armour and several to the west of it	Stakes worn	1.0 metres
---------	--	-------------	------------

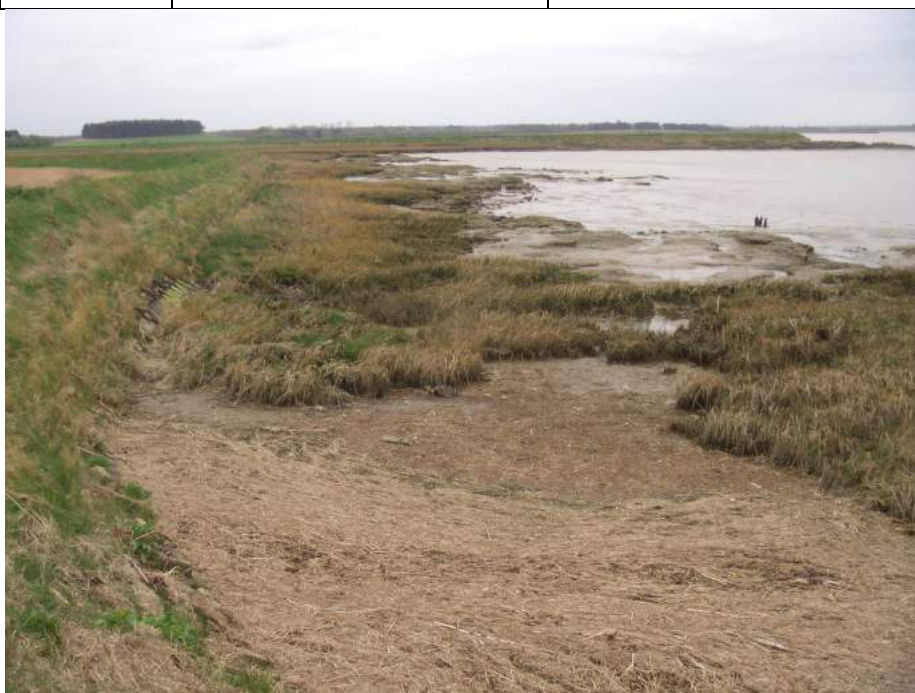
565 437	✓	Stakes across the bay	1.2 metres
---------	---	-----------------------	------------

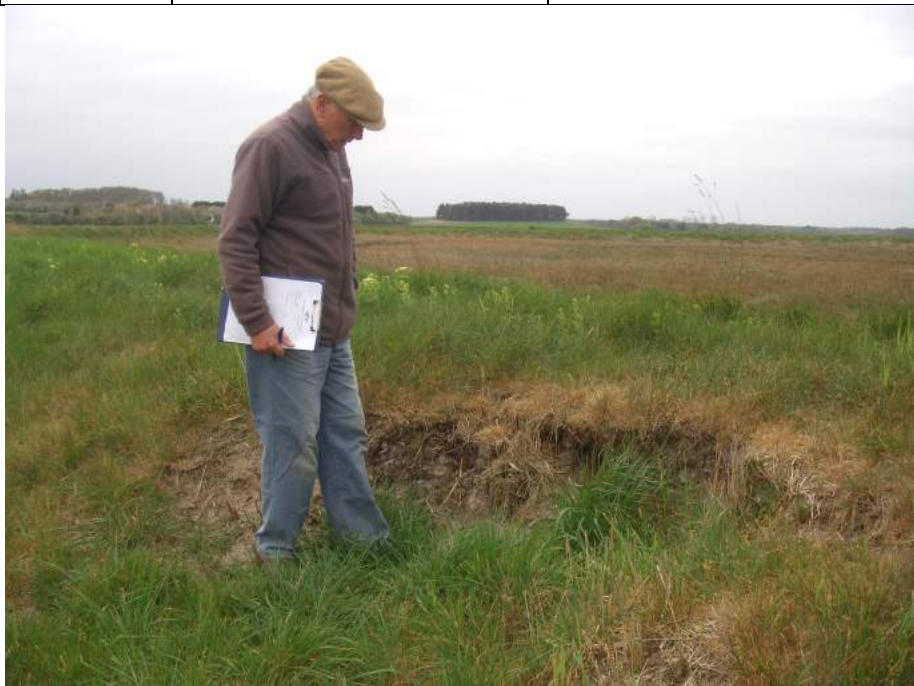
564 437	Big hole on land side	✓	1 metre
---------	-----------------------	---	---------

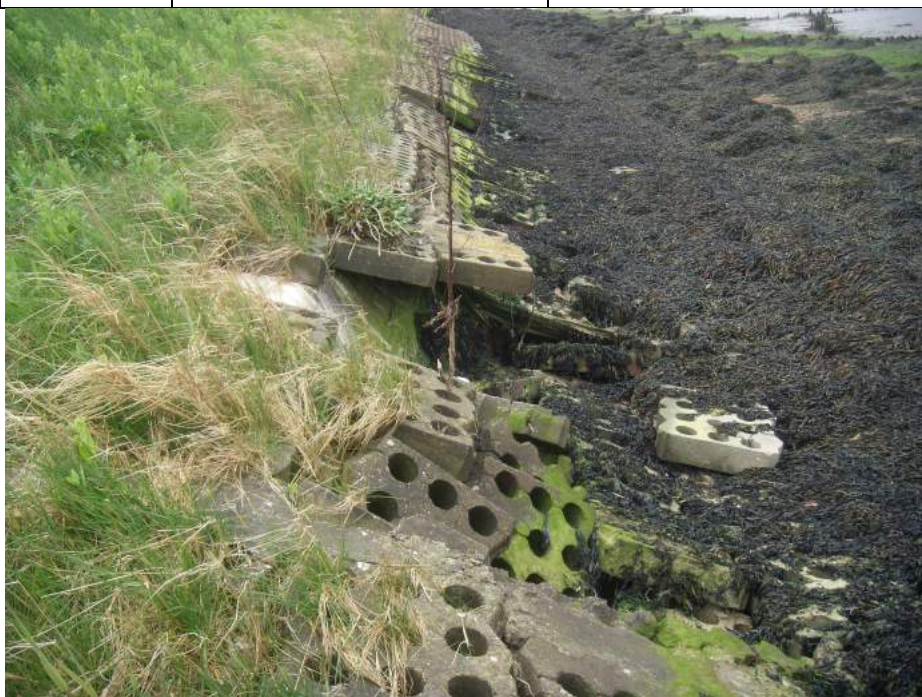
565 433	Serious buckle, much worse than before	Old stakes in diamond shape	0.5 metres
---------	--	-----------------------------	------------

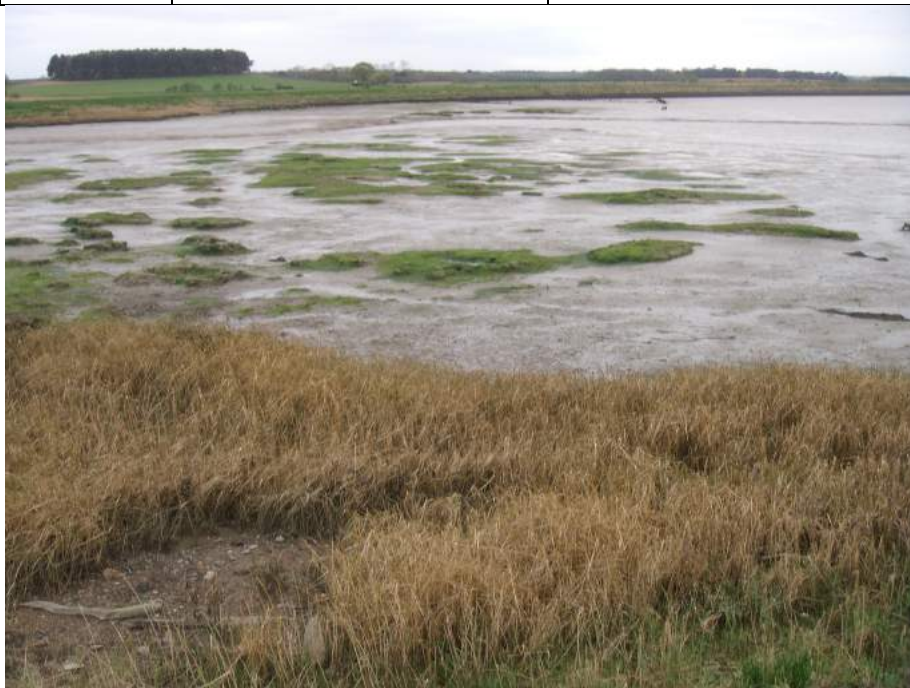
562 433	✓	Why are the saltings so brown? Looking dead	1.5 metres
---------	---	---	------------

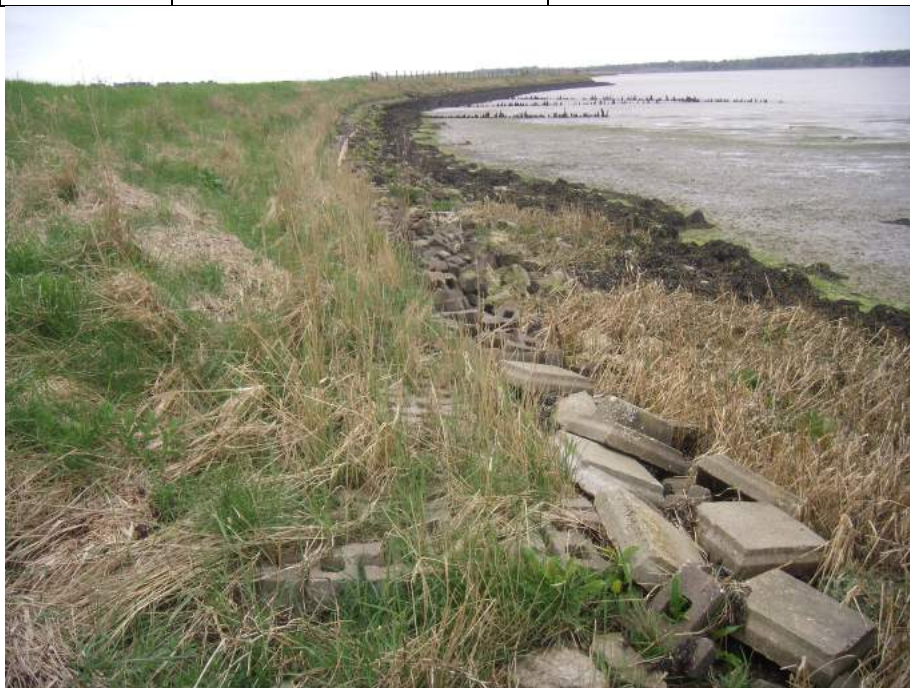
562 431	<b>West of pumphouse</b> <b>Loose armour stones.</b> <b>Dumping of spares or real damage?</b> <b>20 m further west broken armour (yet quite recently put in place)</b>	<b>Nil – stakes worn and not across the bay</b>	0.5 metres
---------	---	---	------------

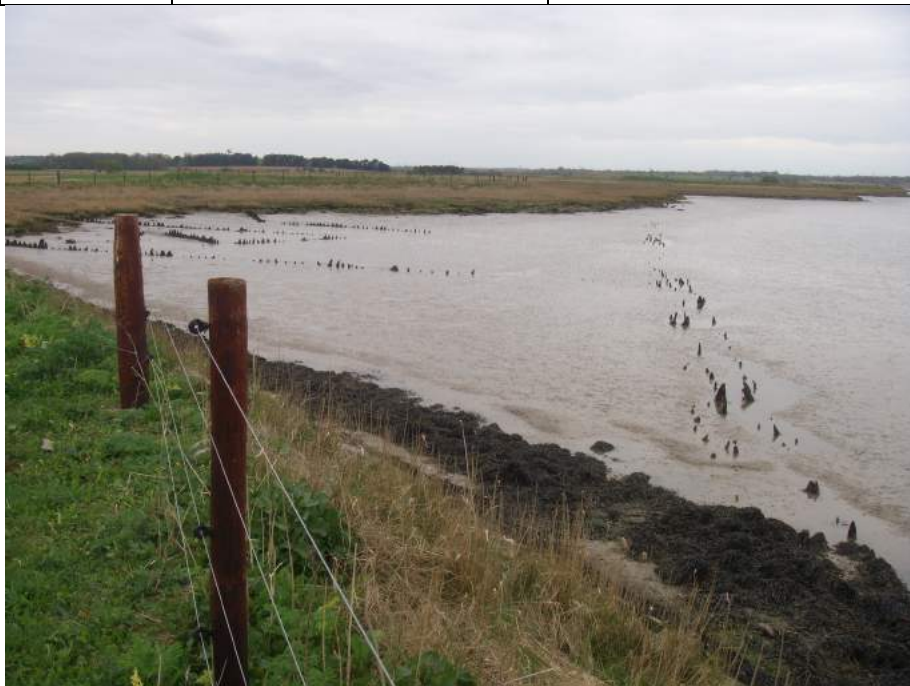
<b>Richard Mann</b>			
<b>563 429</b>	✓	<b>Only a little vegetation</b>	<b>0.3 metres</b>

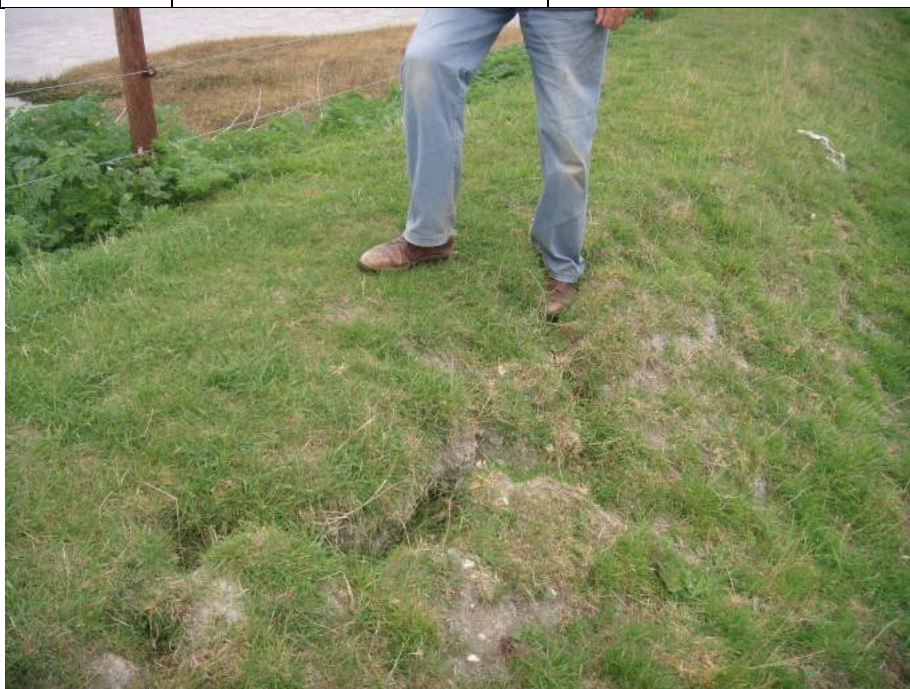
<b>563 428</b>	<b>Mole hills landwards</b>	<b>Bay is protected but very old stakes. Need replacing.</b>	<b>OK</b>
<b>564 424</b>	<b>Cracking on top</b>

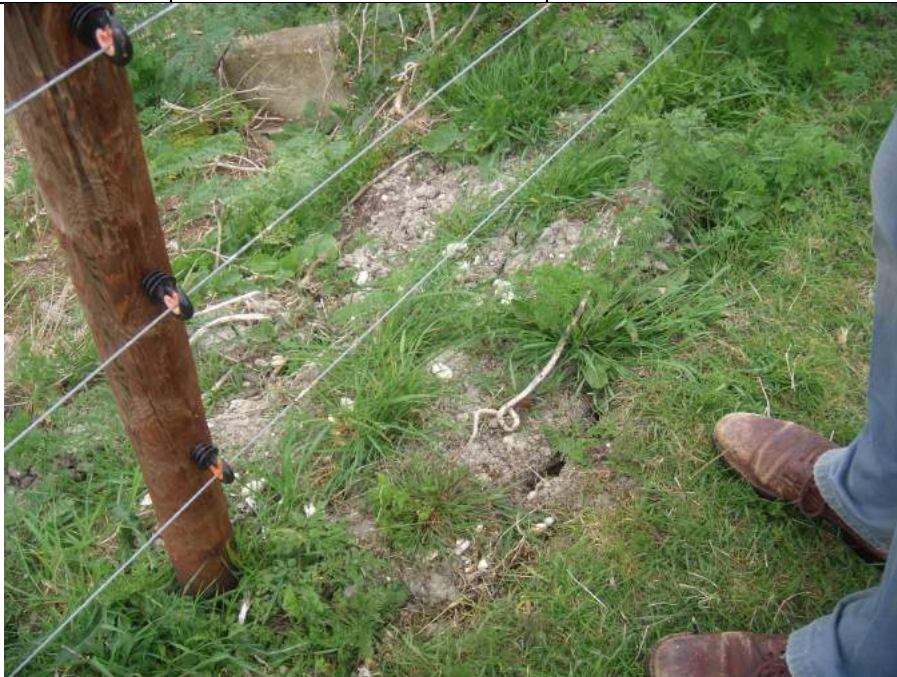
<b>John Hailes</b>			
<b>567 425</b>	<b>Hole on top of wall Mole damage</b>		<b>OK</b>
<b>567 426</b>	<b>One gorse bush! Needs removing. West 200m bramble growing</b>		<b>OK</b>

<b>568 422</b>	<b>Multiple serious cracks on landside over 200m Decaying tops on river side and fall on land side too steep</b>	<b>10 metres of salting</b>	<b>OK</b>
----------------	--	-----------------------------	-----------

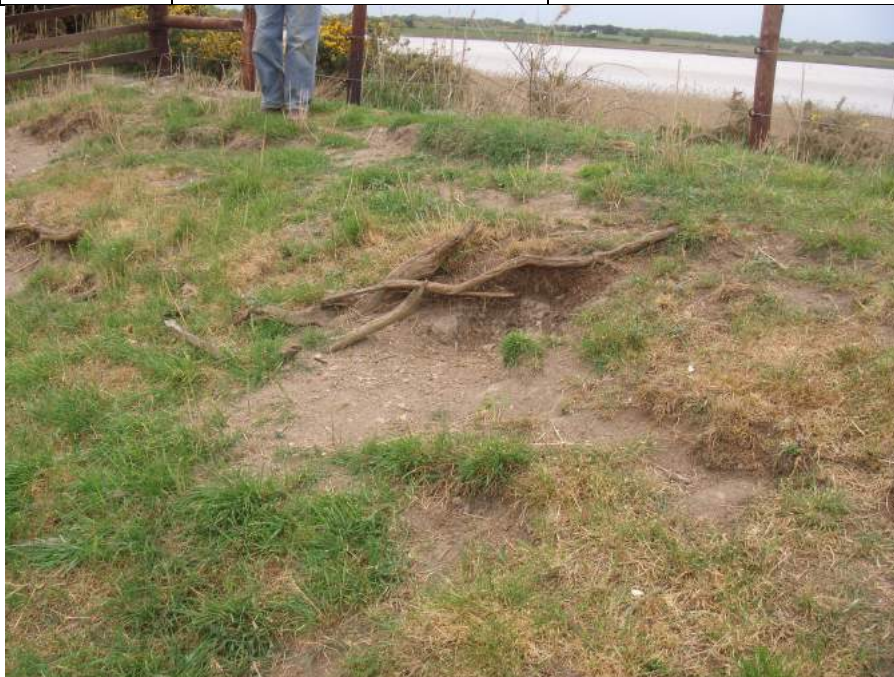
568 421	Dip in top of wall 2.5m width, 0.3m deep	4 metres	0.2 metres
568 415	✓	4 metres	2.5 metres, excellent!
568 413	Old root damage and gorse on riverside	✓	✓
