ALDE AND ORE ESTUARY ASSESSOR'S REPORT

NAME: John Grayburn	DATE OF INSPECTION Spring 2017
LOCATION: Flood Cells 6 and 7	SPRING 2017
Area of Assessment: FC6 South bank from tidal sluice to end of Maltings defences at TM393 573 FC7 North bank from tidal sluice to rising ground at TM401 576	Send to

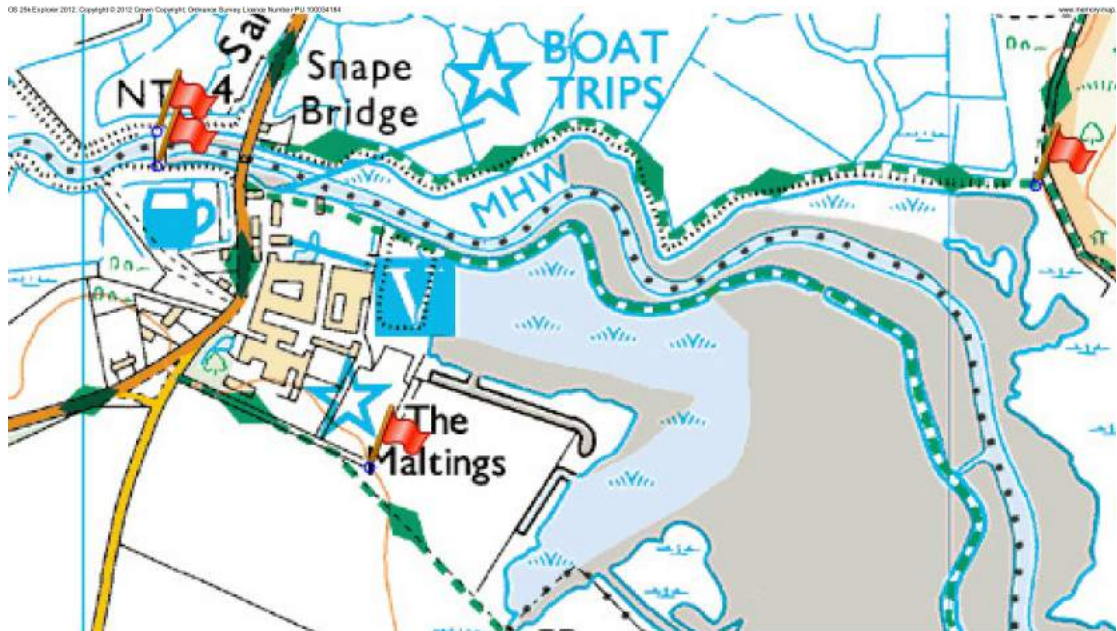
1. South Bank
From Snape tidal sluice to end of Maltings defences at TM393 573
2. North bank.
From Snape tidal sluice to higher ground at the wood at TM401 576.
