# THE ALDE & ORE ASSOCIATION

## ALDE AND ORE ESTUARY ASSESSORS REPORT

<b>NAME:</b> Roger Baxter	<b>DATE OF INSPECTION:</b> April 2017 [Photos June 2017]
<b>LOCATION:</b> Flood Cell 9	
<b>AREA OF ASSESSMENT:</b> Brick Dock to Hazlewood Marsh	March Equinox

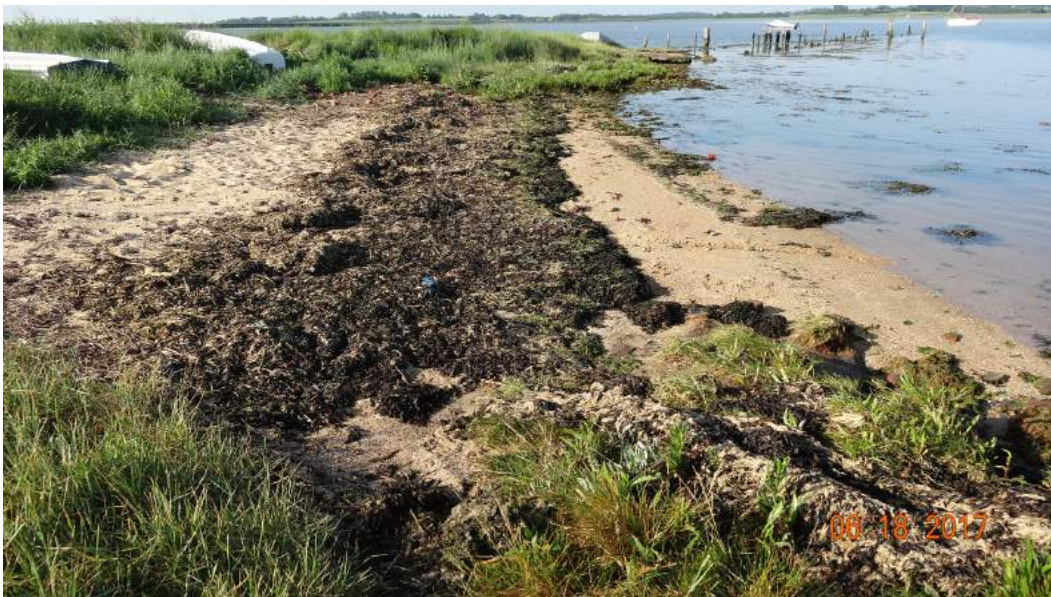
Photograph 1

Salting depth varies, as the beach area (Photograph 1) is suffering from vegetation root washout (Photograph 2). However, the area behind is rising ground. Saltings are deeper towards Roundhill and in good condition (Photograph 4).

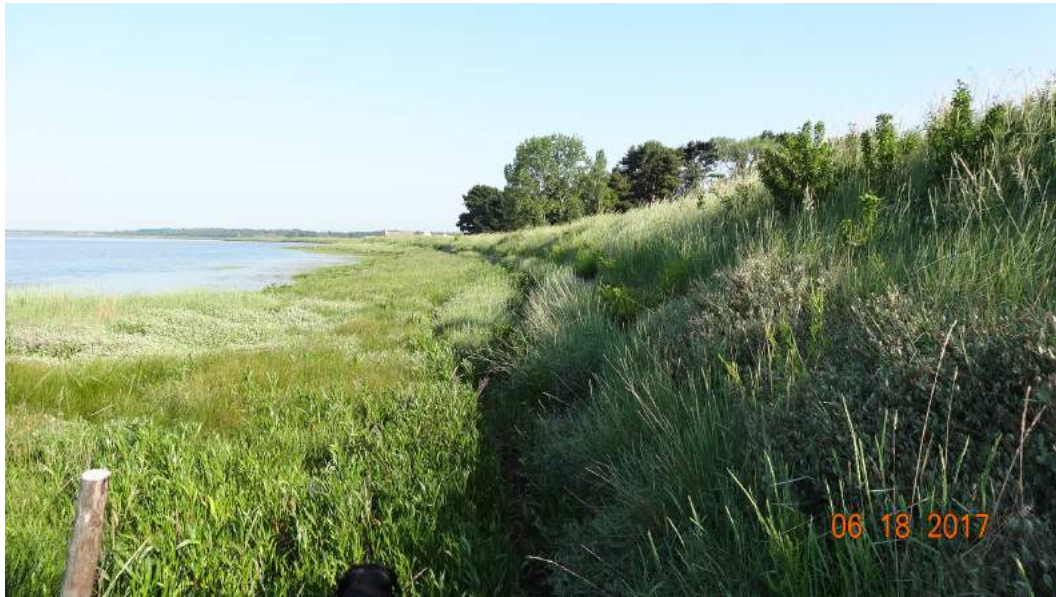
Photograph 3

River wall from Brick Dock to Roundhill is in good repair, with thick vegetation. However, Roundhill to the breach on Hazelwood Marsh has several areas where revetment is breaking up at the water line. Above the armour the wall is robust with good vegetation (Photograph 3).
