# THE ALDE & ORE ASSOCIATION

## ALDE AND ORE ESTUARY ASSESSOR'S REPORT

<b>NAME:</b> John Grayburn	<b>DATE OF INSPECTION</b> Spring 2016
<b>LOCATION:</b> Flood Cells 6 and 7	<b>SPRING 2016</b>
<b>Area of Assessment:</b> FC6 South bank from tidal sluice to end of Maltings defences at TM393 573 FC7 North bank from tidal sluice to rising ground at TM401 576	<b>Send to</b>

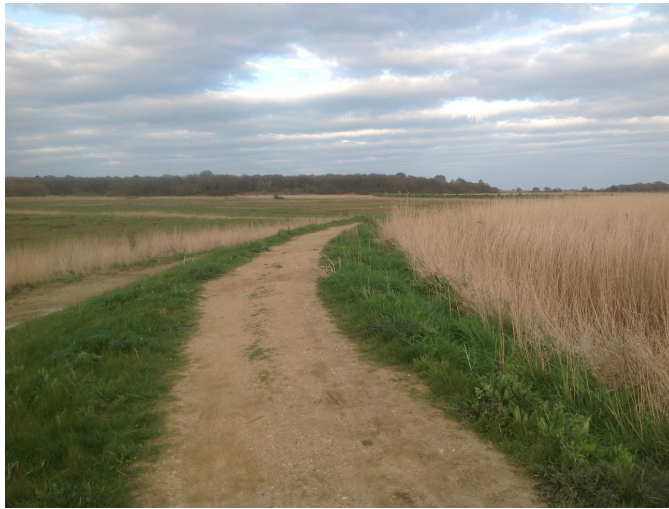
Repairs to the wall from the B1069 at Snape bridge to the higher ground at TM401 576 following the December 2013 surge have been completed. The repairs are standing up well but there is some slippage of the regraded rear face as evidence by the lateral slope in the top footpath (see picture 1).

Picture 1: TM396 577 looking East Slope in footpath

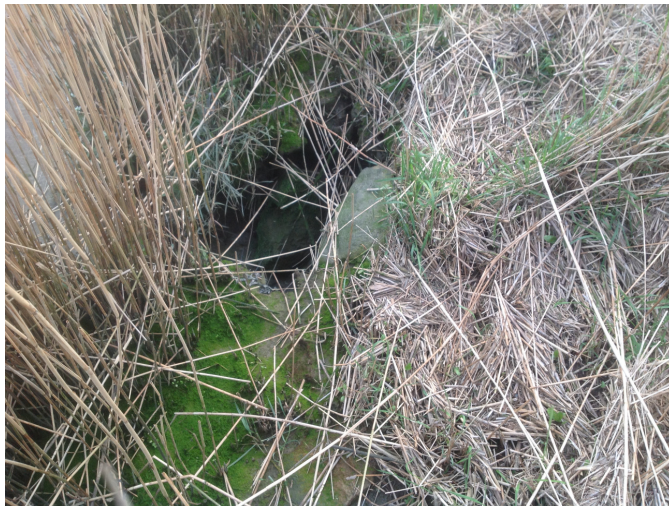
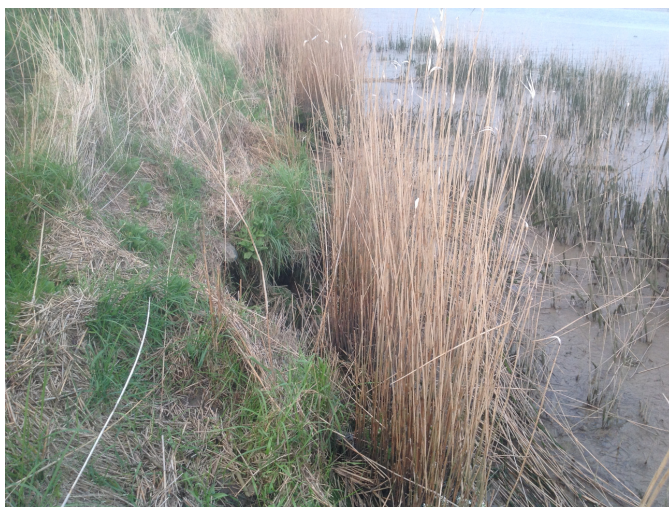
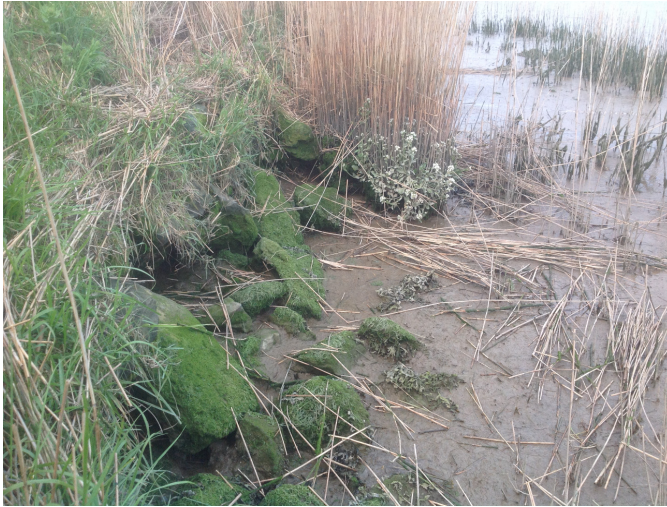
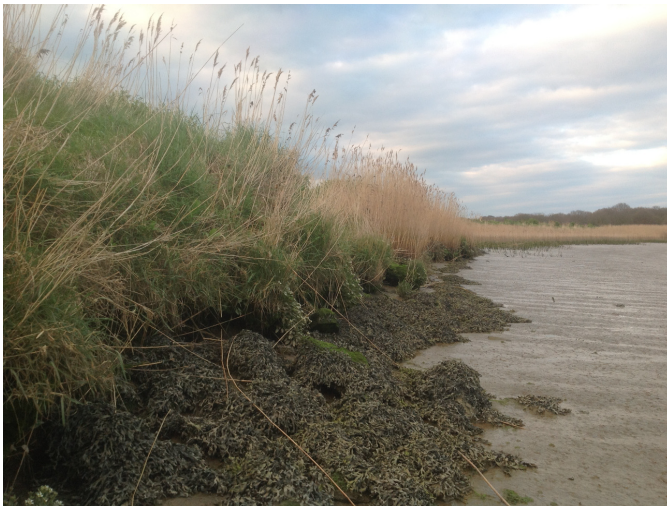
There has been no change to the river side of the bank which in some places is steep. From Snape Bridge to Blackheath Sluice, the bank is protected by reedbeds and from TM398 576 eastwards to the higher ground at the wood it is again protected by reedbeds and saltings. However, as noted in previous years, there is erosion on the river side both downriver and upriver of the point at TM397 575. (see pictures 2 to 5)

Pictures 2-5 TM397 575 Erosion of front face of wall

It is understood that further works are planned to increase the height of the wall.
