THE ALDE & ORE ASSOCIATION

ALDE AND ORE ESTUARY ASSESSOR'S REPORT

NAME: Brian Johnson	DATE OF INSPECTION April 2016
LOCATION: Flood Cell 1	March Equinox
Area of Assessment: 366440 to Butley Mills	Send to

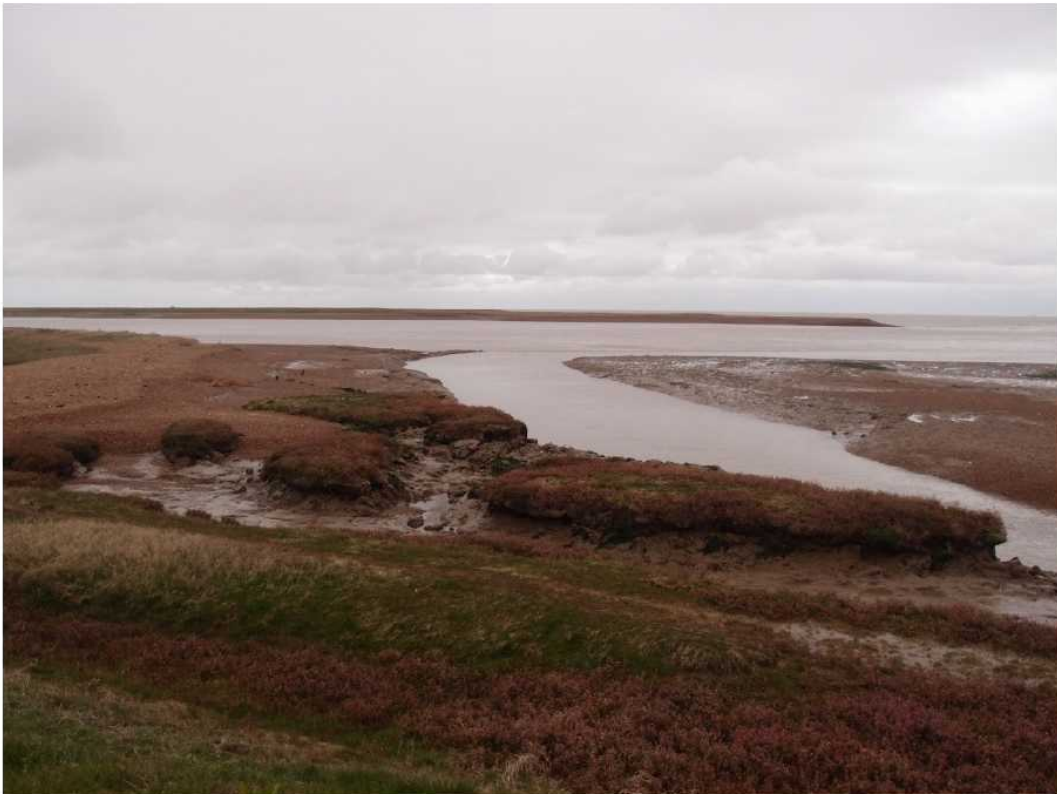
CHAINAGE Mouth of Barthrop's Creek. North Bank, break up of salting highlighted in 2014 and 2015 reports has increased, sections fallen away, bottom of concrete armouring below pill box is no longer supported.

Close to the mouth the saltings have been covered with shingle.

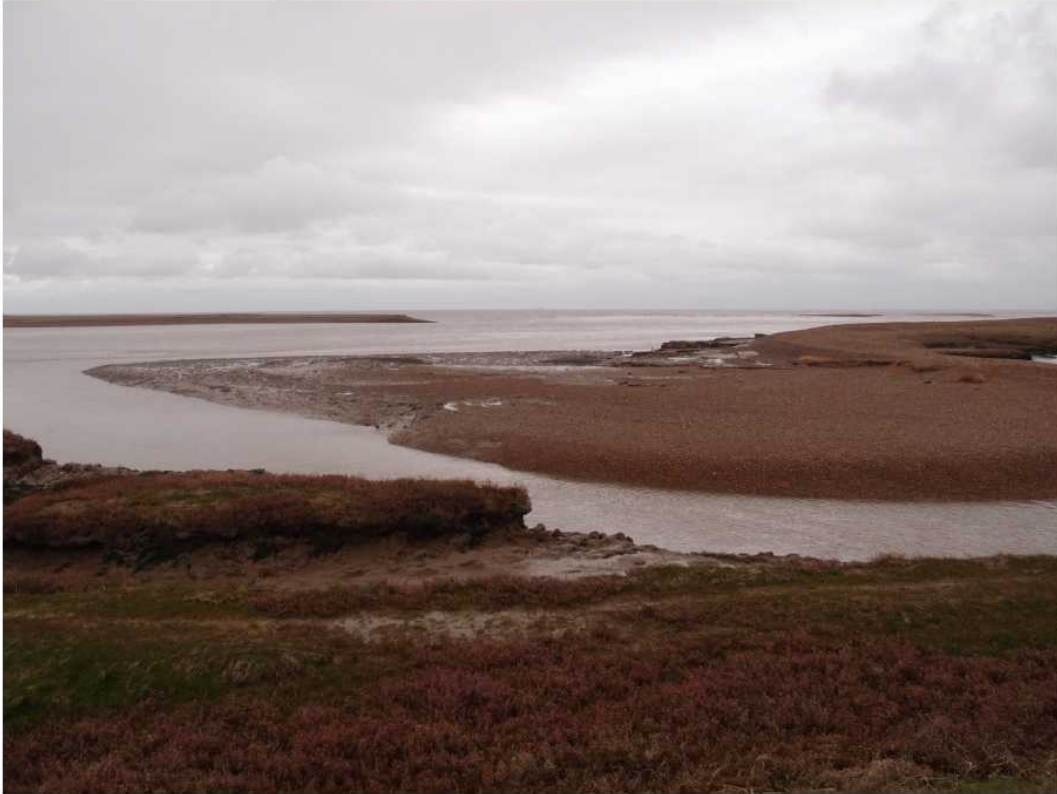
South side of creek large area covered with shingle on top of salting.

This overtopping with shingle most likely caused by retreat northwards of North Weir Point on Orfordness rendering landward bank open to wave action. (see above photograph)
Evidence of the river bank southwards from Creek being pushed up and onto edge of salting over 100metres length. Coastal squeeze ? This latter is strictly flood cell 0.

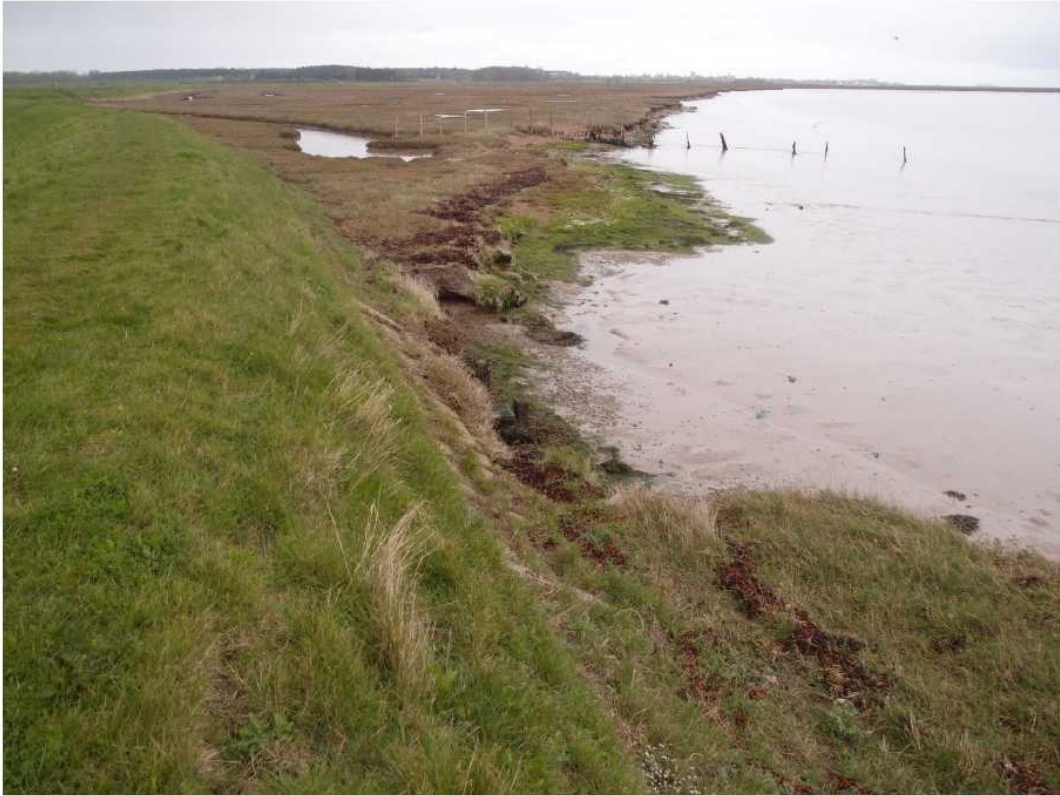
SIMPSONS SALTINGS (Suffolk Wildlife Trust) Fence broken down entirely in parts, in poor condition elsewhere. Reduces protection of saltings if stock is loose.

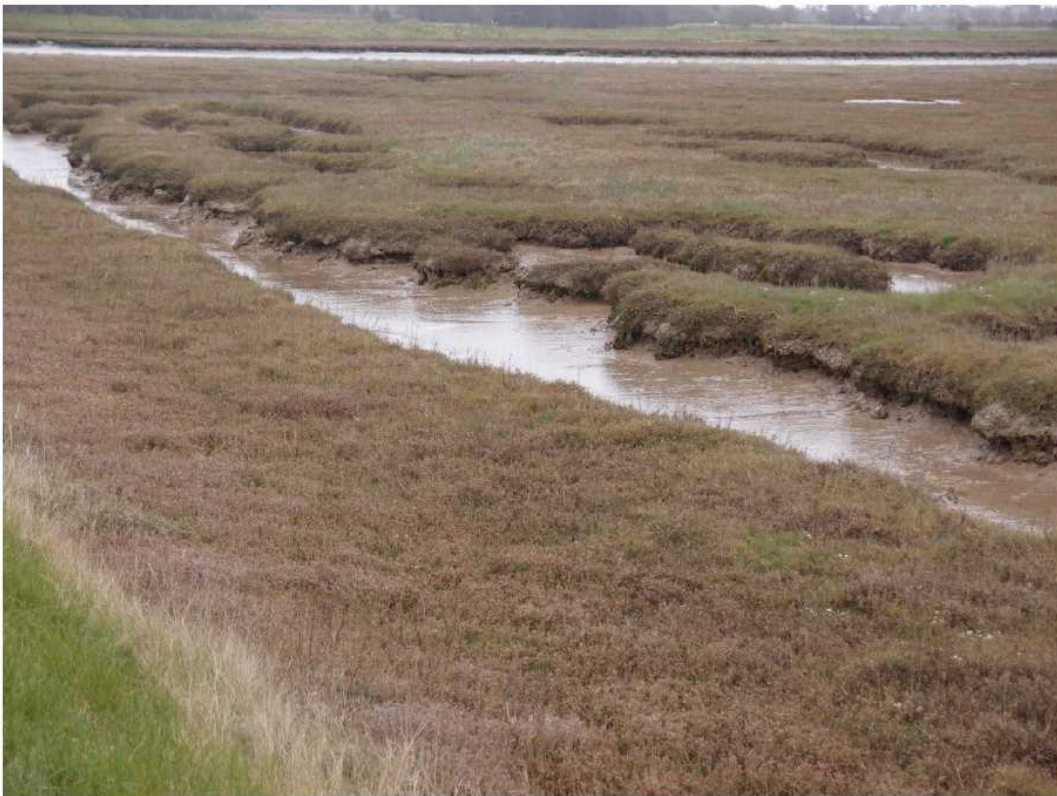
CHAINAGE 5000 At junction of Ore and Butley Rivers there is a large area, roughly triangular in shape, which is effectively an island, being cut off from the land by a channel about 4m wide. It runs from Butley River southwards, almost to Flybury Point where narrow piece of salting closes off this channel. (see above photograph) There is evidence that the salting on the 'island side' of the channel is being undermined. Would there be any future in Saltings Group reducing the flow in this channel at its mouth ? (see photograph below)
