THE ALDE & ORE ASSOCIATION

ALDE AND ORE ESTUARY ASSESSOR'S REPORT

NAME: Alison Andrews (with Roger Baxter and Simon Reed)	DATE OF INSPECTION 12 April 2016
LOCATION : Flood Cell 10 Brick Dock to Martello, river side TM 450565 to 463548 All map references from OS Explorer 212	MARCH/Equinox Spring tide
CO-ORDINATOR: Amanda Bettinson	Send to email: John Grayburn

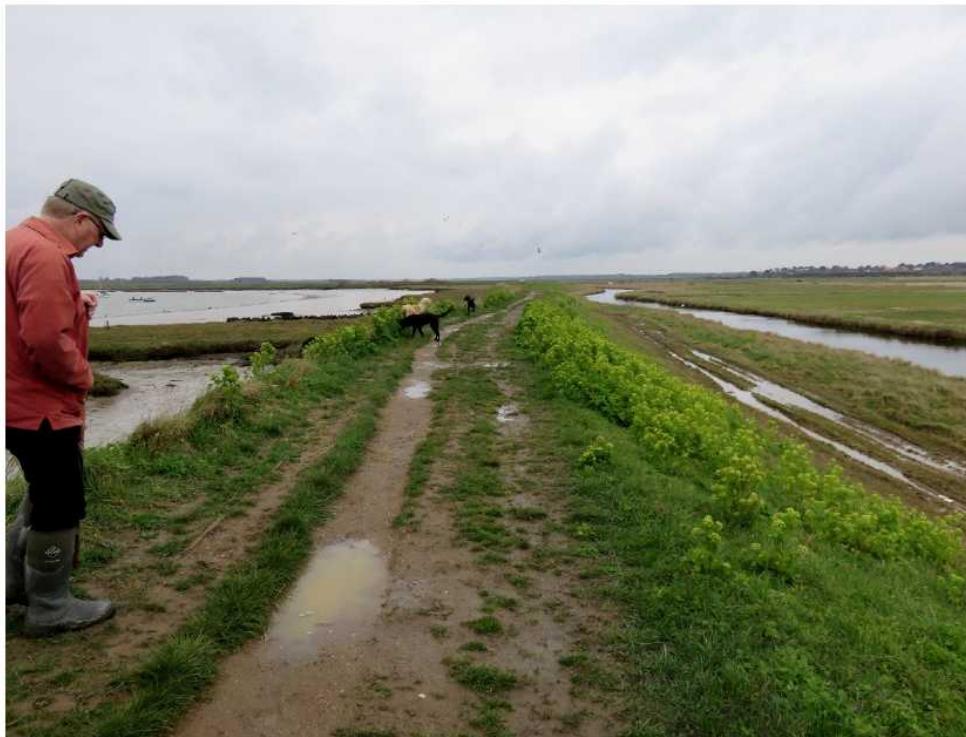
1. Footpath- Slaughden Road to next steps onto the marsh T M464556 to TM459558. This stretch has been yet further degraded as over the winter months it becomes a quagmire and people who still choose to walk along it are broadening the path (over double the width of the narrow hoggin path some 5 years ago and now there is almost no grass margin) by treading down the edges, taking surface away on their boots and what boarding was there is very broken and intermittent. There is real concern that the part that is already lower and was overtopped in 2013 is getting lower and broader and other parts are beginning to be similarly degraded. Several places where the bordering wood planks had been broken in earlier years are now further dilapidated.

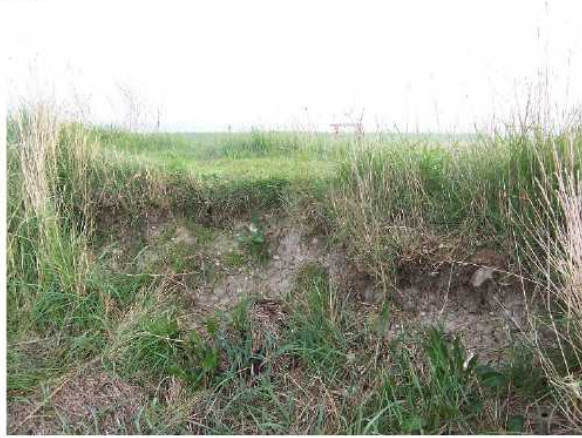
2. Bare face of wall previously reported in 2013, 2014 and 2015 This 20 yard long stretch is protected from the river by saltings but the erosion is increasing and in one place is beginning to undercut the path **TM 445559**

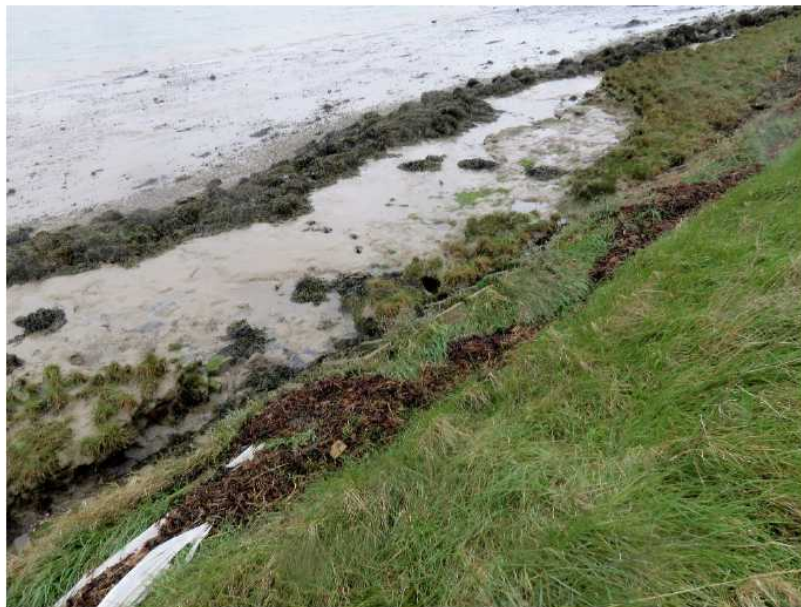
Photo at TM448555 below

General comment- as last year along the entire stretch the vegetation on the saltings appears to have been more severely battered by the tides, which have been noticeably higher covering the saltings around the spring highs more than in previous years. At numerous points the saltings are also eroding at the edges

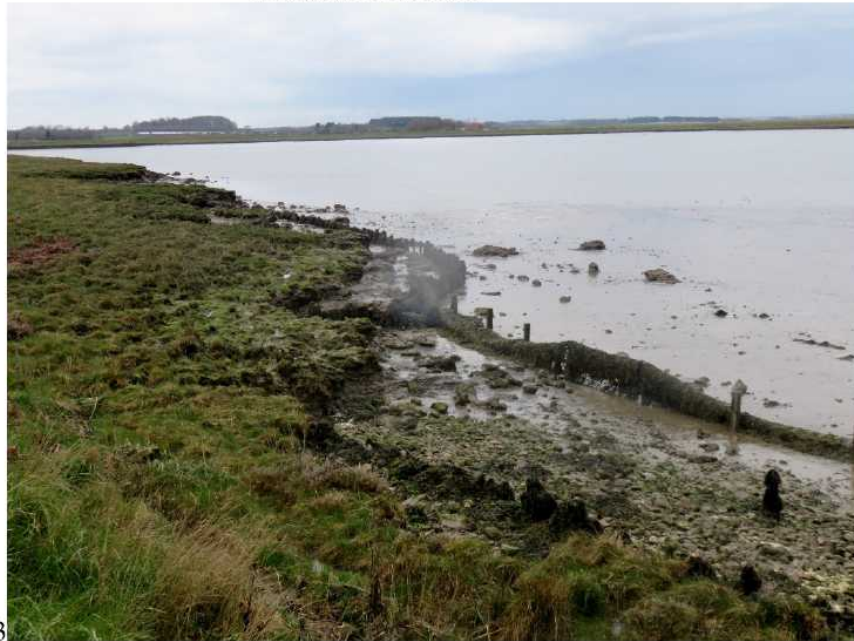
Photo at Brick Dock

Saltings projects: that near Brick Dock, again the tensar plastic netting has been lifted off its posts where the stretch is most exposed to winds and waves. Reported to D. McGinity

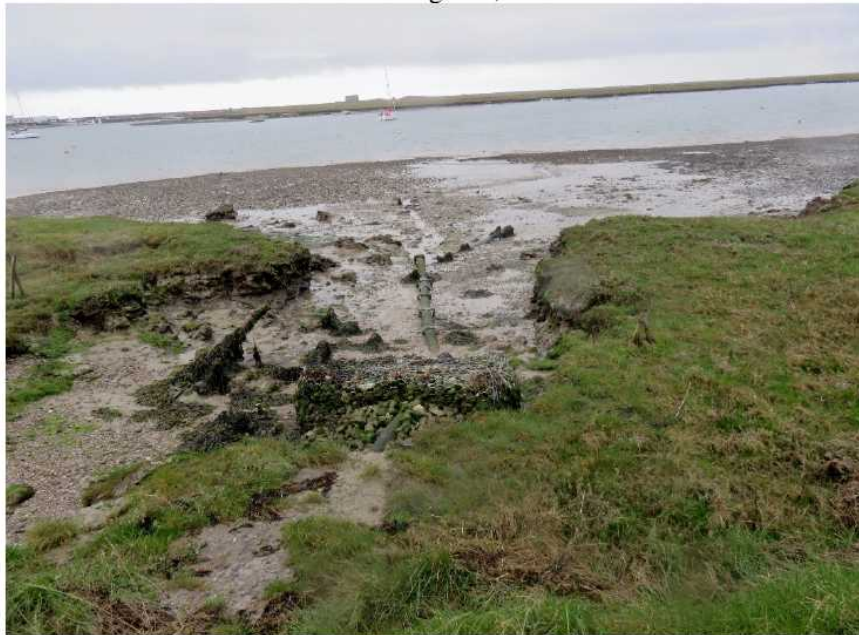
Concern also on the need to monitor the edges near new Aldeburgh Sluice outflow. It appears there has been more salting loss, TM458556
