THE ALDE & ORE ASSOCIATION

ALDE AND ORE ESTUARY ASSESSORS REPORT

NAME: Amanda Bettinson	DATE OF INSPECTION: 7 th April 2016
LOCATION: Flood Cell 2	March Equinox
AREA OF ASSESSMENT: Butley Mills, Mill Lane, Butley

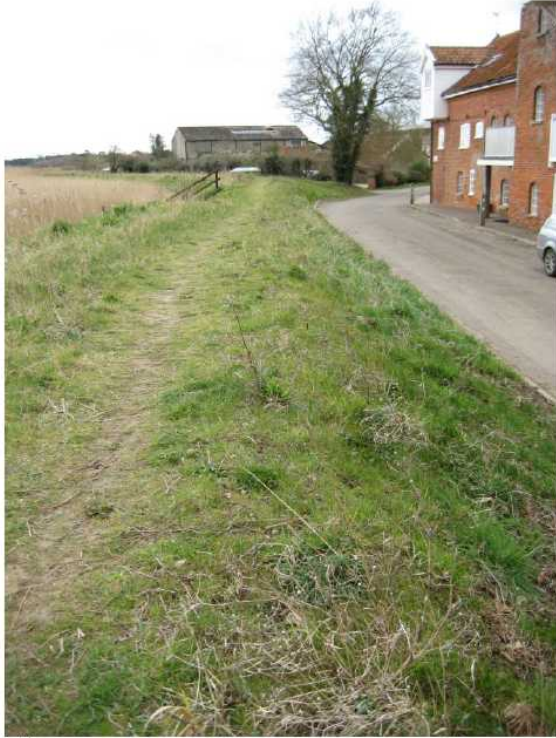
1st 100 mtrs by Mill in reasonable condition

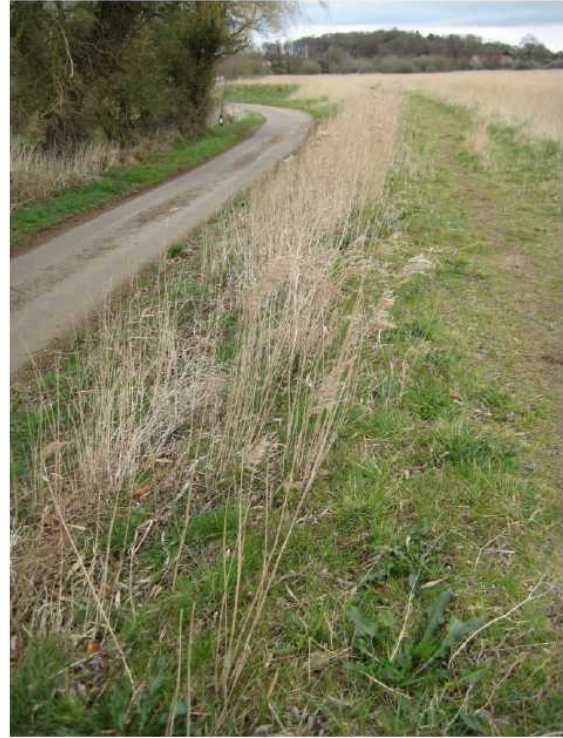
Reeds establishing on road side

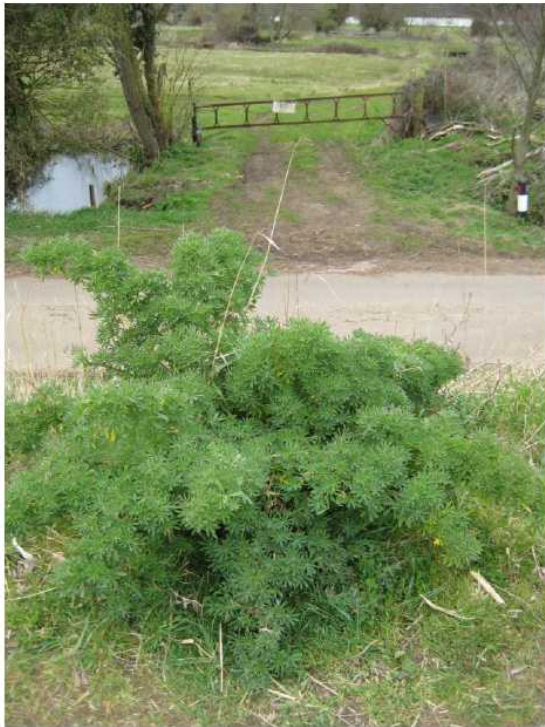
Wild lupin bush opposite farm gate

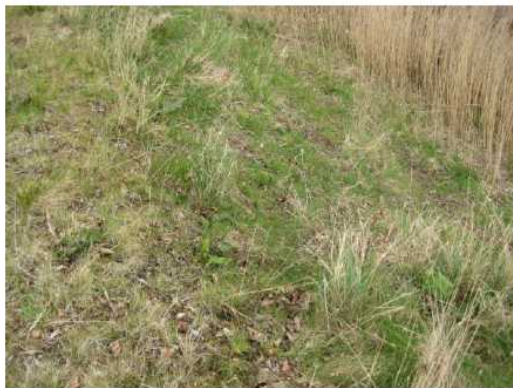
North of No1 Sluice: settlement

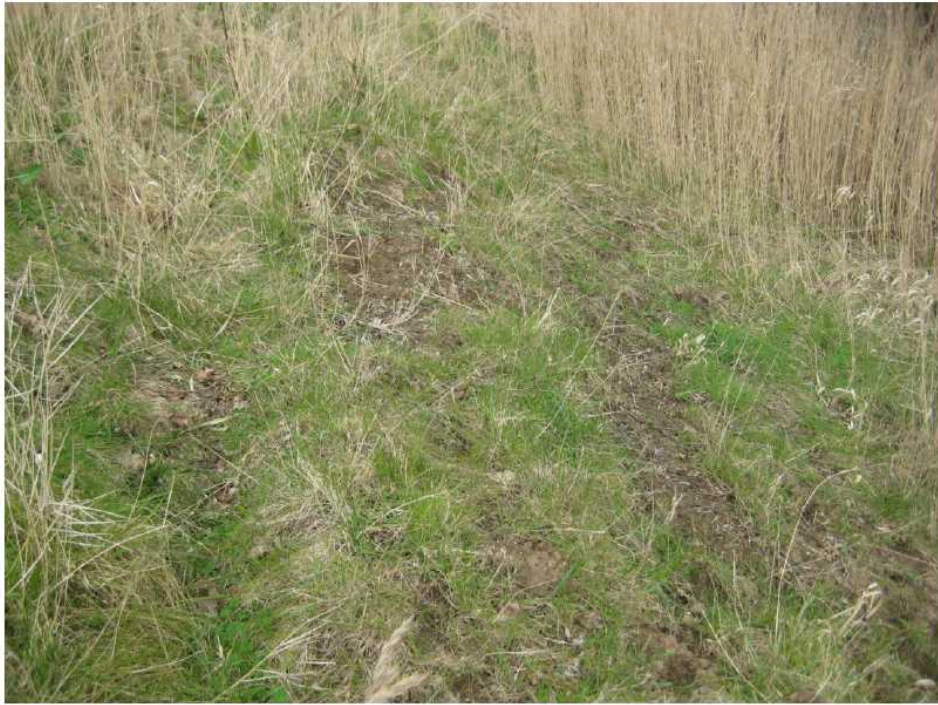
North of No1 sluice bare earth on 'river' side

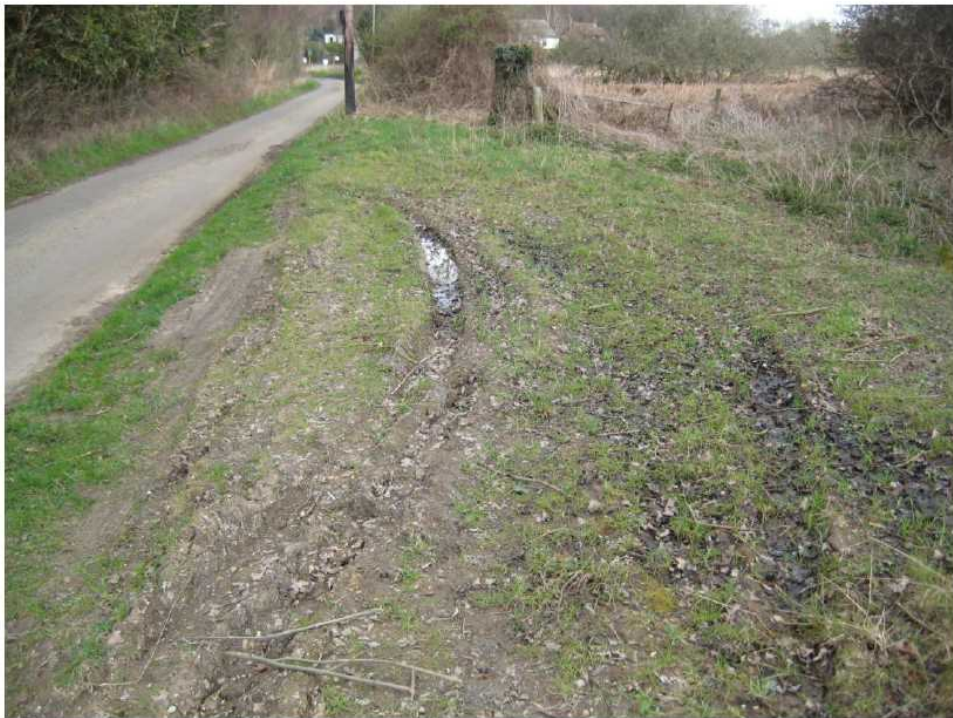
Chillesford end of wall: tyre tracks at the start of the defence.
