THE ALDE & ORE ASSOCIATION

ALDE AND ORE ESTUARY ASSESSORS REPORT

| LOCATION: Flood Cell 4 | MARCH equinox |
| Area of Assessment Butley River and Gedgrave Marsh TM 39677 48583 to 41591 48472 OS Explorer 212 | |

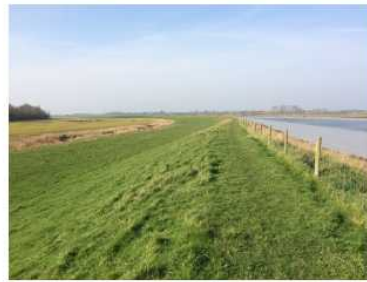
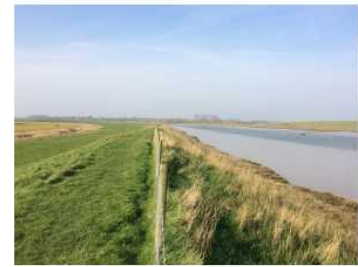
General view of pathway at 397486, start of inspection by Ferry Cottage. Better grassing than 2015, some evidence of past slippage and a few cracks on inward side; no signs of damage since 2015 inspection; landward wall in good order with good grassing, low slope, some cracks evident but all grassed over.

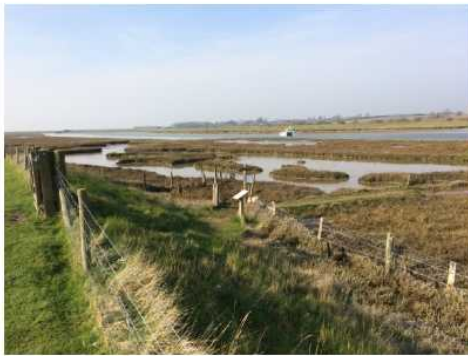
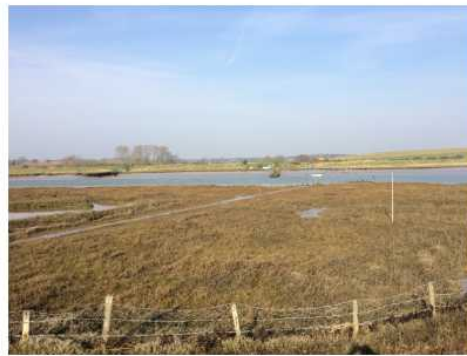
Saltings opposite Butley Ferry jetty (395484, 394482), general view – no changes since last year.

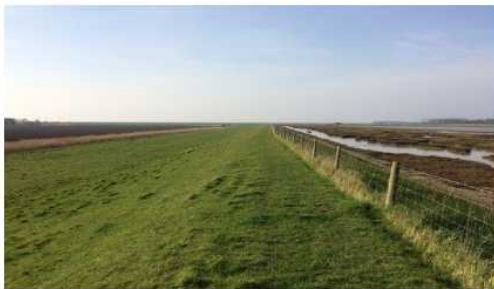
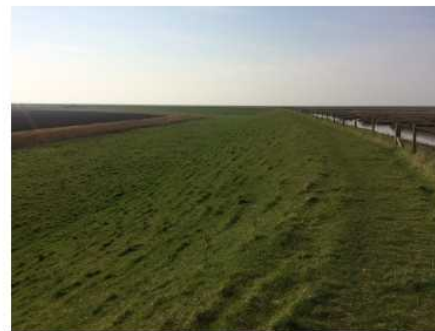
Some gulleying underneath the line of the fenceposts at 394481, towards Boyton Dock, unchanged since 2015; landward side of wall opposite Boyton Dock (394477), all in good order. Pathway worn in places but no concern.

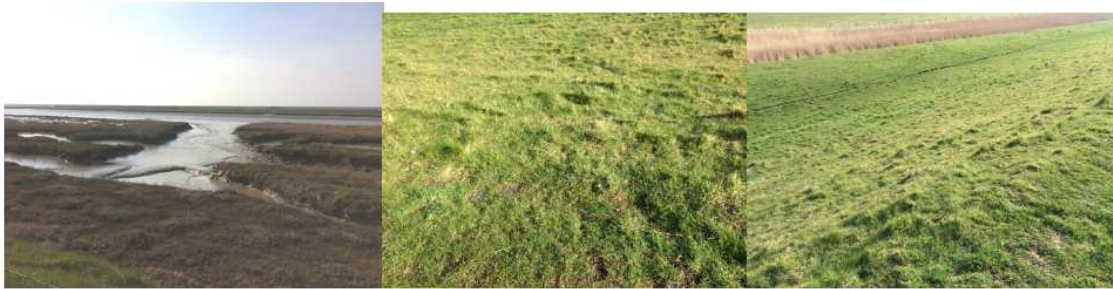
Saltings, pathway and landward wall at 394474, past Boyton Dock. Saltings unchanged, landward side and path apparently in better order than 2015, damage to path grassed over and no evidence of previous apparent slippage on landward side.

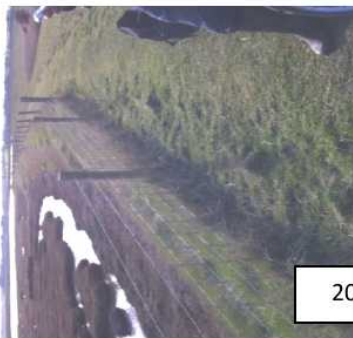
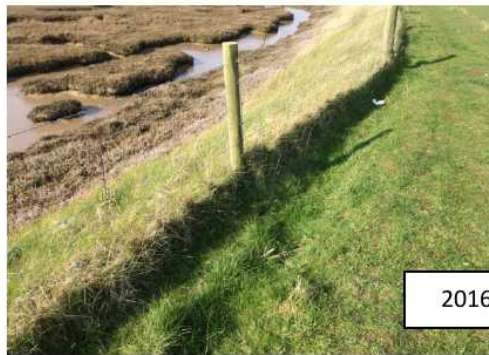
The path at 400473, in 2015 and 2016 – continued slumping by posts, and some evidence of slippage on wall facing river, but not worse than last year.

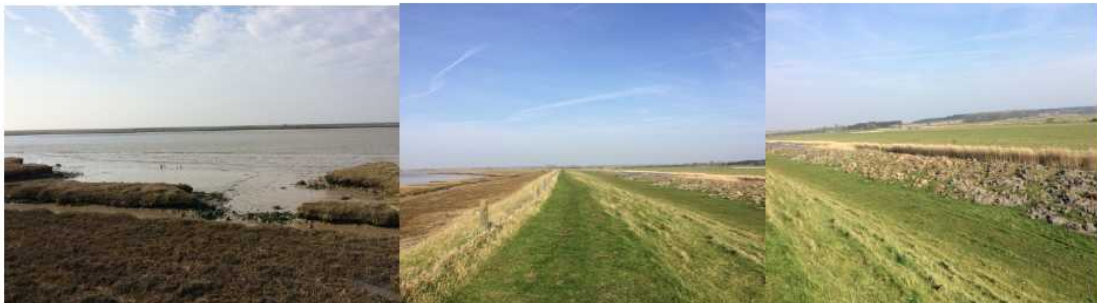
Towards Inset Point, at 405472 – saltings unchanged, path still worn and damaged but better grassed than 2015, spoil berm by ditch on landward side grassing over well.

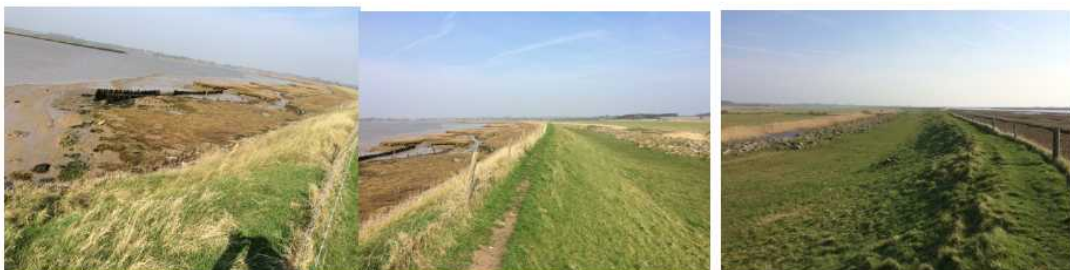
At 407471, Inset Point – saltings slightly cut away over winter (??); path still damaged and narrowed

and some apparent slippage on inside of the corner but well grassed.

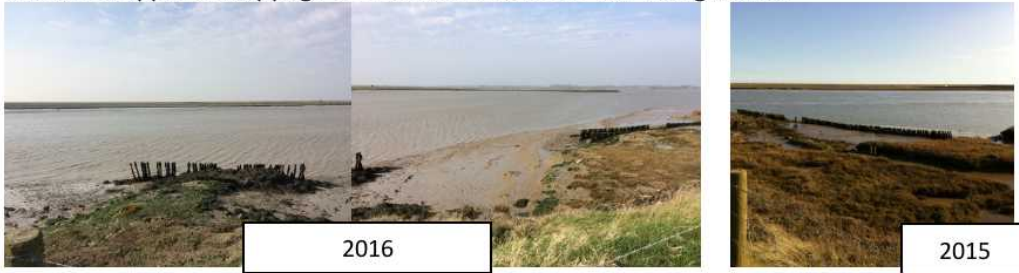
Still at Inset Point, 407471, looking out at saltings and badly eroded protecting stakes – see 2015 photo for comparison.

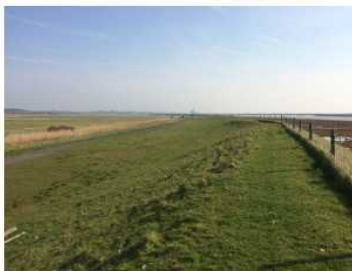
Towards pumping station, at 408473 - pathway and landward slopes all in good order, no visible changes; slope is occasionally quite steep though; saltings unchanged

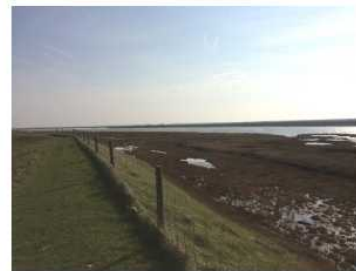
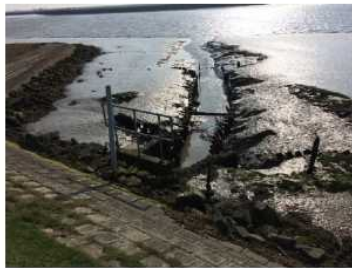
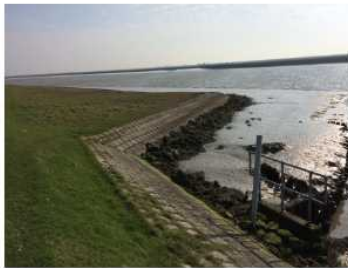
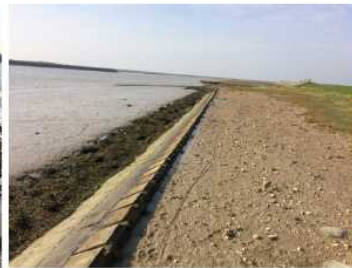
At the pumping station inlet, 411475. No significant change since 2015, river wall revetments all in good order here and further along – but see next photo at 411476.

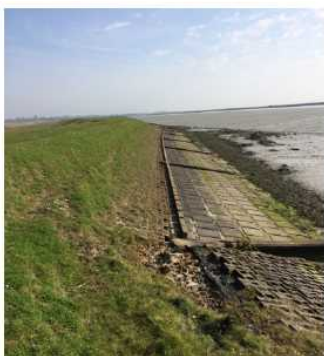
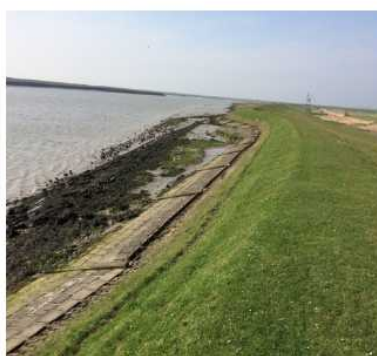
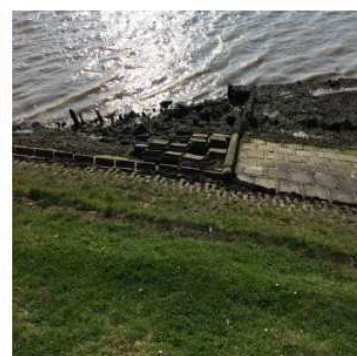
Possible damage (L) to upper edge of river wall revetment (?) 411 476 – this has been repaired since 2015 inspection I believe; better condition (C) further along at 412477; and loose slabs (from repair work??) piled up at edge of revetment at same place (412477).

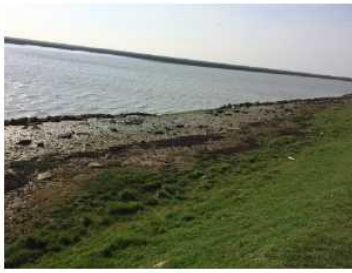
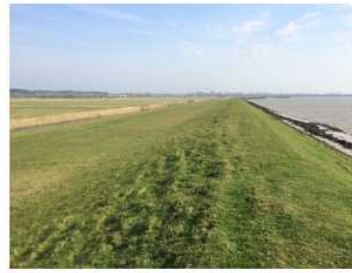
Boulder and shingle defences at 412478, revetment and damage (already grassed over) to river wall slope above at same place; lumpy landward slope well grassed over further along the pathway towards Chantry Point at 413479.

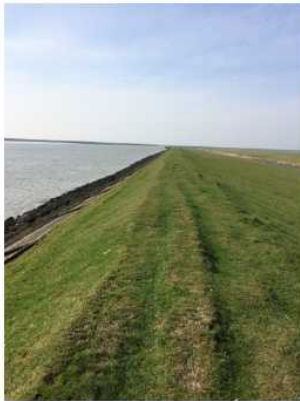
Pathway at 414483 / 415484 – very lumpy and uneven, some possible damage/slippage on river wall side
