THE ALDE & ORE ASSOCIATION

ALDE AND ORE ESTUARY ASSESSORS' REPORT

NAME: Frances Barnwell	DATE OF INSPECTION 31 st March 2016
LOCATION: Flood Cell 4.2	March Equinox
Area of Assessment: Orford Sailing Club to Chantry Point	Send to

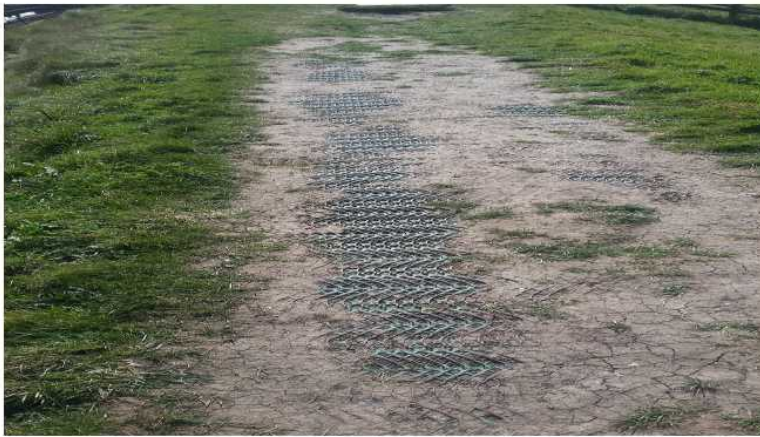
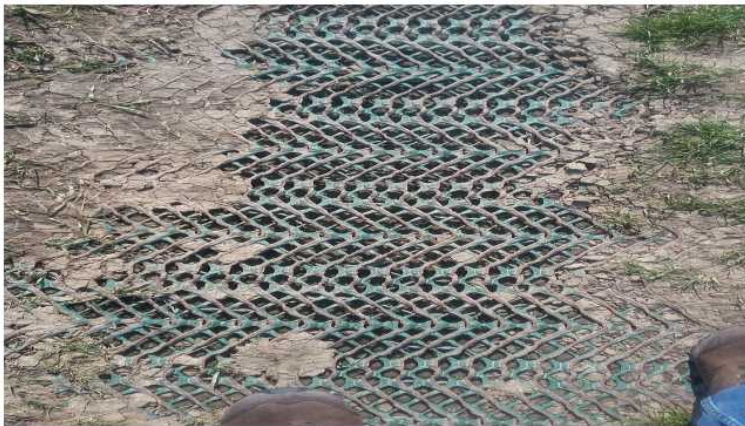
The mesh covering is exposed over a much greater area, with cut edges exposed in places. Without a grass covering, mud is washing away from under the mesh.

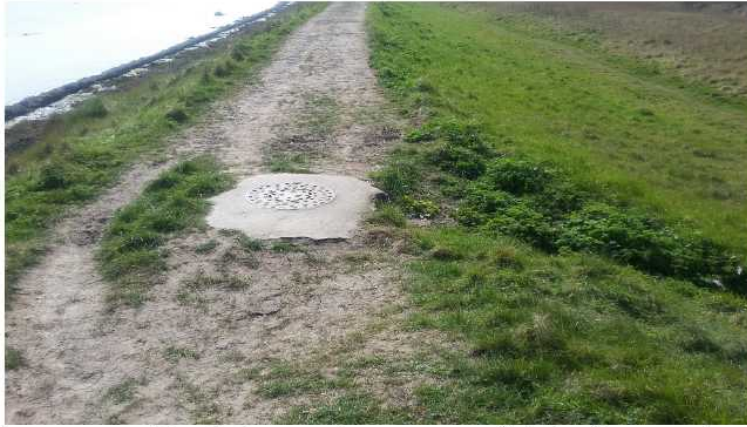
The area round the drain cover is more worn (this is of course where there was overtopping in 2013)

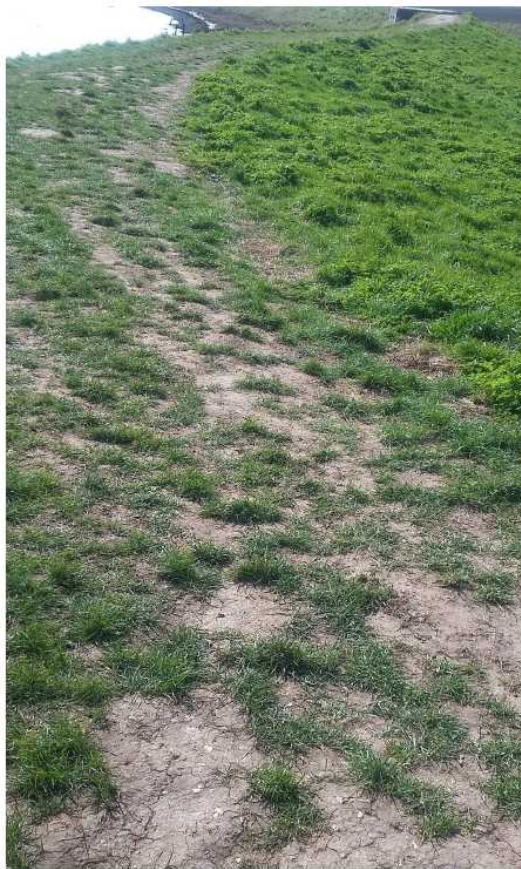
The top of the wall now has a significant slope away from the river as the wall bends toward the pillbox.

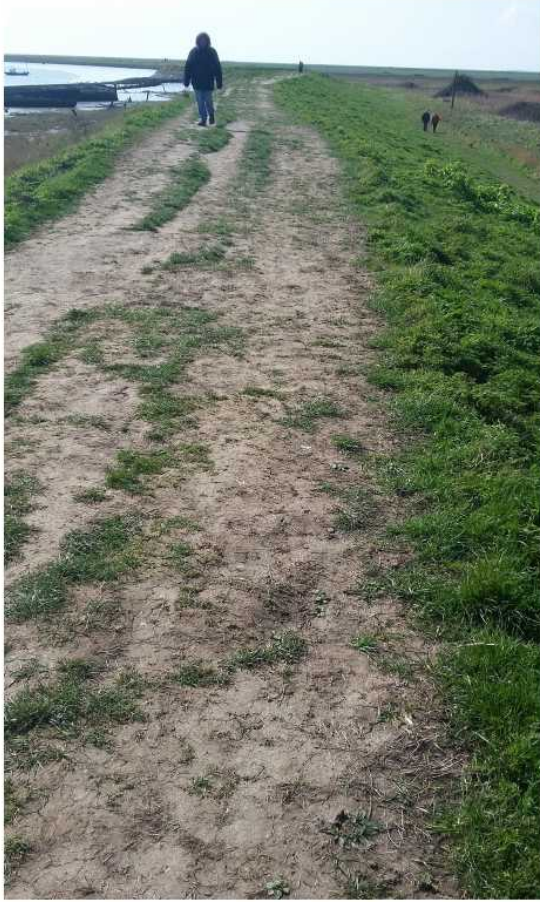
The section from the quay to the pillbox is showing increased signs of wear and erosion. It is now much wider (presumably at the expense of its height) and the grass covering has largely given way to mud which, it seems, all too easily washes away.
