ALDE AND ORE ESTUARY ASSESSORS' REPORT

NAME: Keith Martin and Simon Barrow	DATE OF INSPECTION 167th April 2016
LOCATION: Flood Cell 5	MARCH equinox
Area of Assessment Chapman's Creek to The Anchorage, Iken

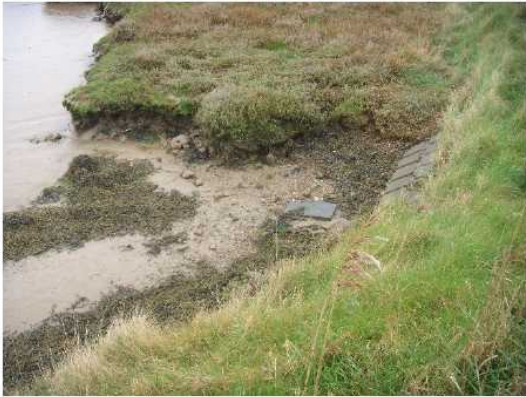
5540-4460 Bay at southern end of armour leads to base of the river wall. Needs salting development.

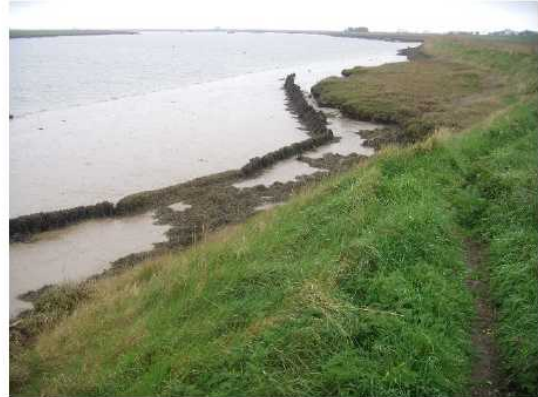
5530-4420 Good example of where new saltings encouraged and beginning to grow (contrast with a year earlier)

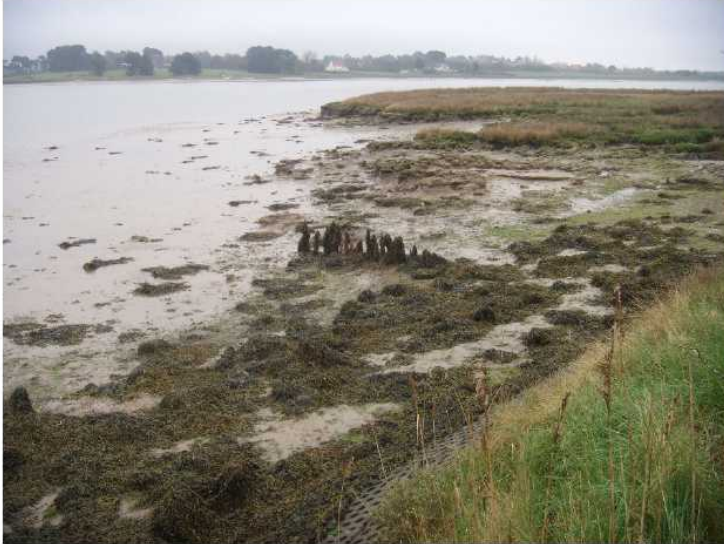
5670- 4410 (opposite Hazlewood Marshes when the wall turns west) Needs support for saltings development

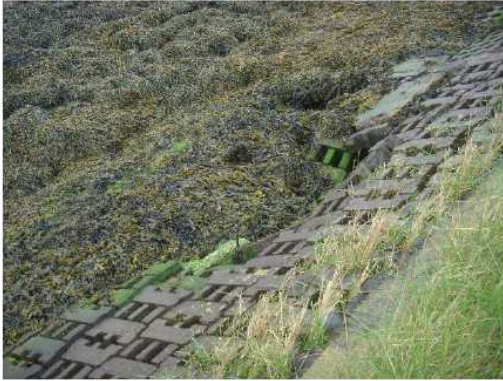
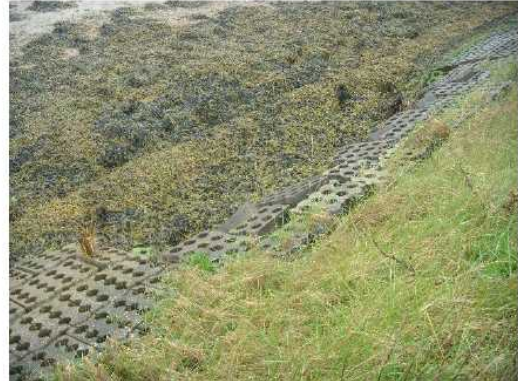
2016 Photographs

5620-4380 damaged and buckled armour in 11 places and little or no saltings

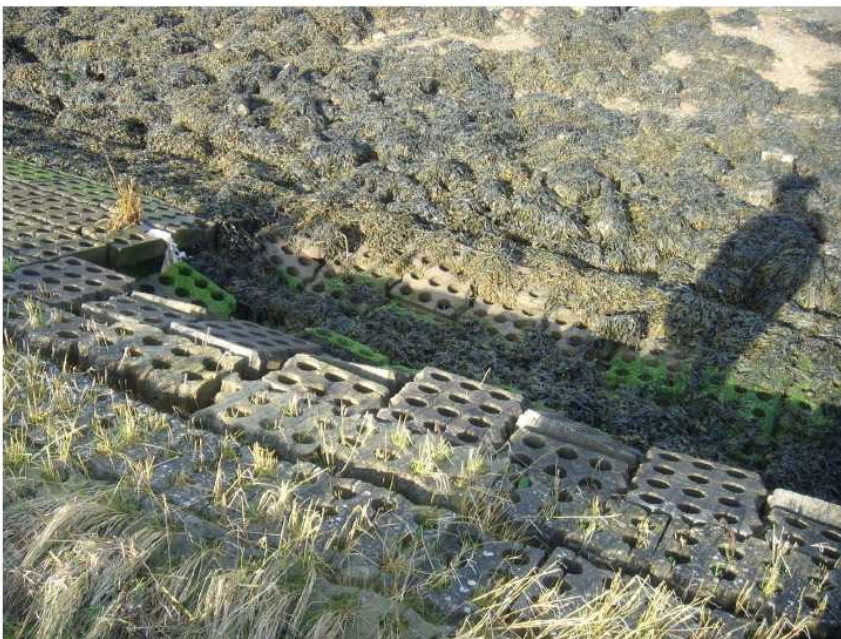
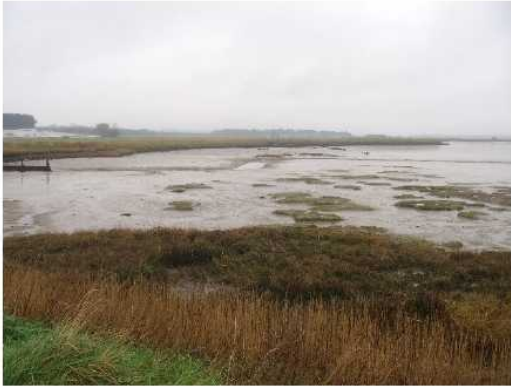
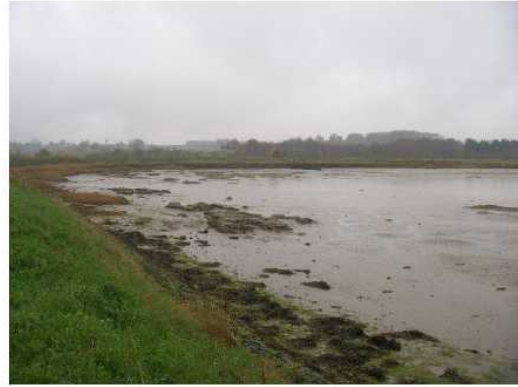
5640-4320 evidence of saltings erosion in the bays. We noted one occasion where a channel has formed between a good stretch of saltings and the wall. Is this a risk ? ie that the benefit of saltings can be lessened by such a channel?

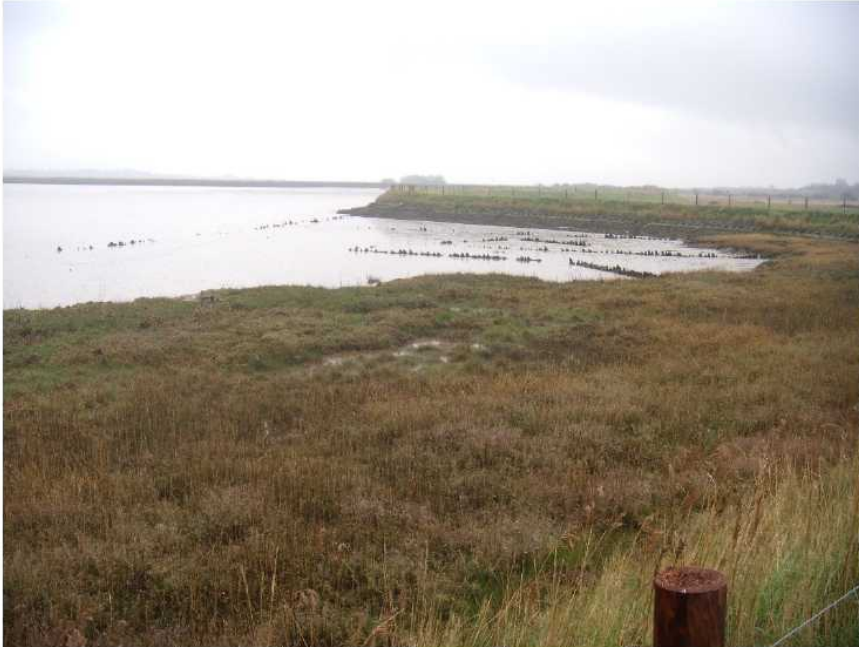
5640-4260 Bays need saltings regrowth help

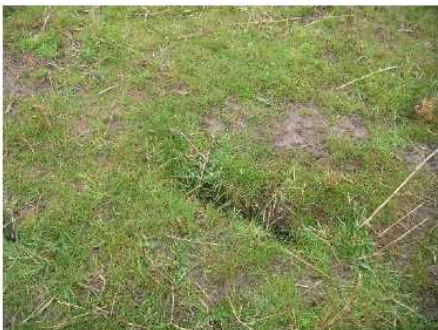
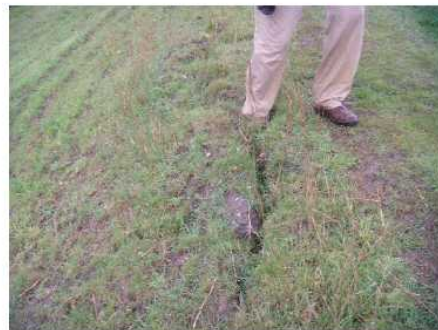
5670- 4140 several slippage examples near the top of the wall on the landward side. Any overtopping would rapidly develop these. What is the remedial action?
