THE ALDE & ORE ASSOCIATION

ALDE AND ORE ESTUARY ASSESSORS REPORT

NAME:	Tim Dudgeon John Grayburn Roger Baxter Peter Donaldson Simon Reid	DATE OF INSPECTION:	March 2016
LOCATION:	Flood Cell 8	March Equinox	
AREA OF ASSESSMENT:	Blackheath Estate, Ham Creek

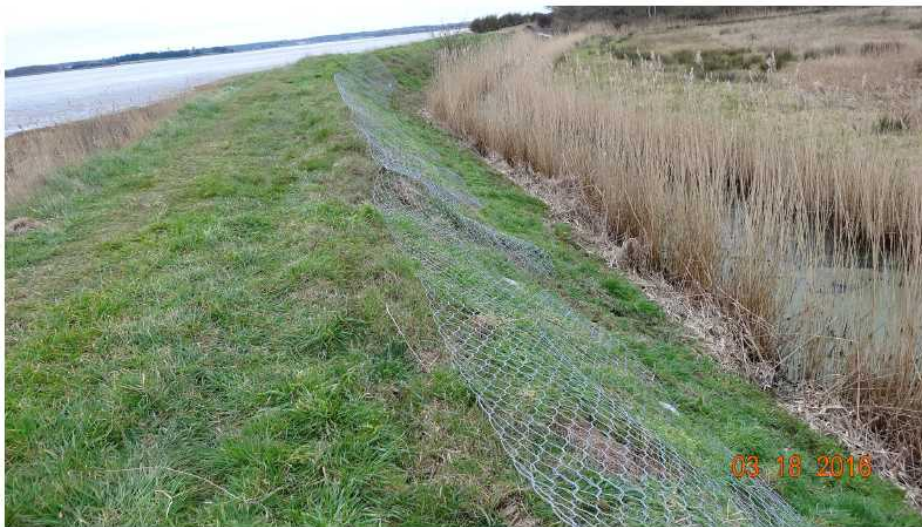
Ham Creek river wall with anchored mesh on the back slope.

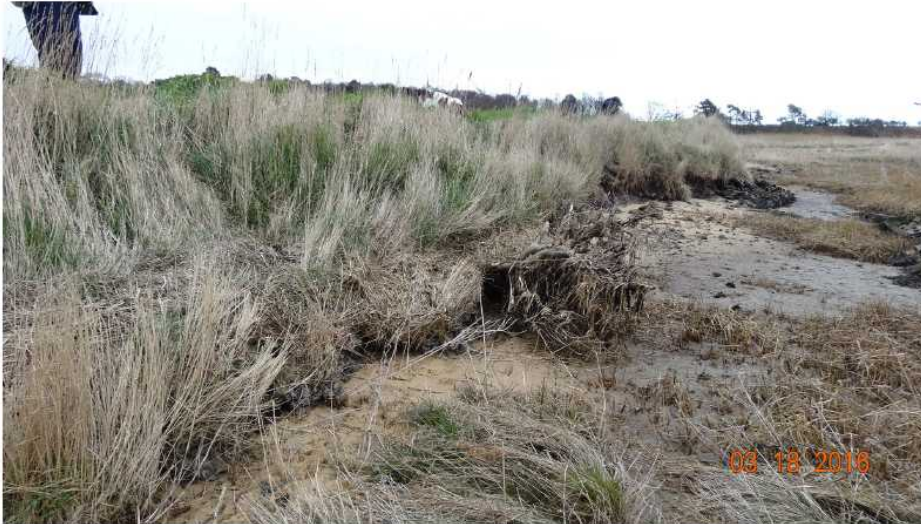
Ham Creek debris at toe of wall and saltings to the right.
