# THE ALDE & ORE ASSOCIATION

## ALDE AND ORE ESTUARY ASSESSORS REPORT

<b>NAMES:</b> Brian Johnson Susan Bowerman Clare Goodchild	<b>DATE OF INSPECTION:</b> 10th, 17th April & 1 <sup>st</sup> May 2018
<b>LOCATION:</b> Flood Cell 1	<b>AREA OF ASSESSMENT:</b> Shingle Street to Butley Mills (Boyton & Butley Marshes)

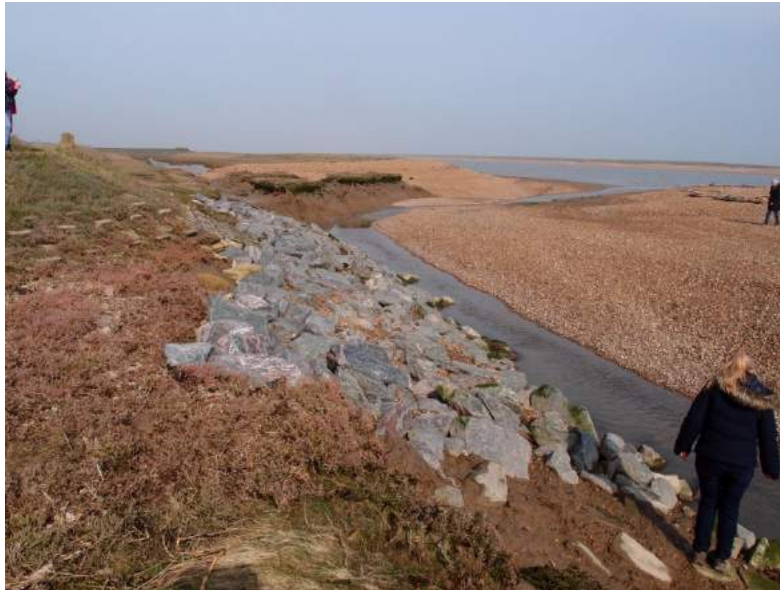
Photo 1

Mouth of Barthorpes Creek: The gradual breakdown of levee below pillbox - reported each year since 2014 - has been made good since last report with rock armouring (see photograph). Adjacent salting to north broken up by recent severe gales, shingle overtopped onto salting (see photos 1 and 2).

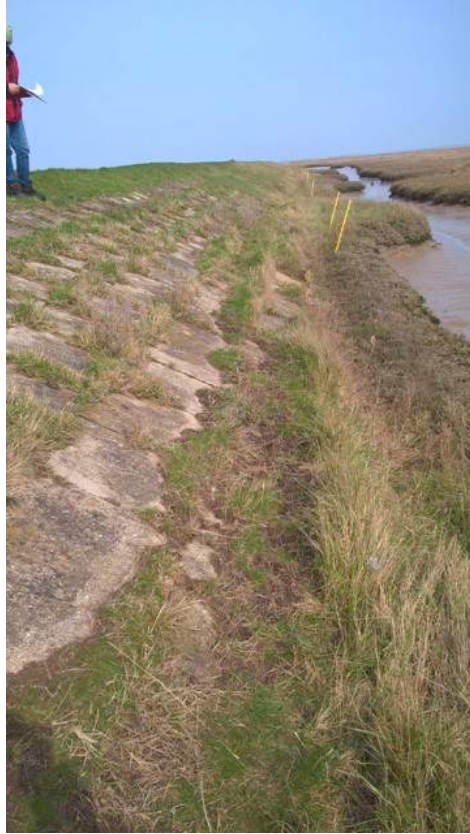
Photo 3

Chainage 3000: Saltings less than 2m wide - see photos 3 and 4.

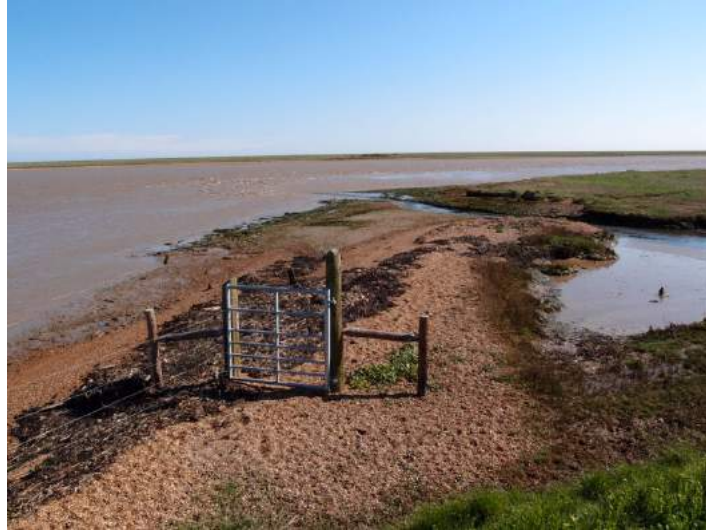
Photo 5

Flybury Point: New gate at north end of saltings, length of levee without saltings at bottom of levee under water every tide. Vulnerable area to watch - 5 and 6.
