THE ALDE & ORE ASSOCIATION

ALDE AND ORE ESTUARY ASSESSORS REPORT

NAMES: Alison Andrews Roger Baxter Jane Maxim	DATE OF INSPECTION: 13 April 2018
LOCATION: Flood Cell 10s	AREA OF ASSESSMENT: Brick Dock to Martello Tower

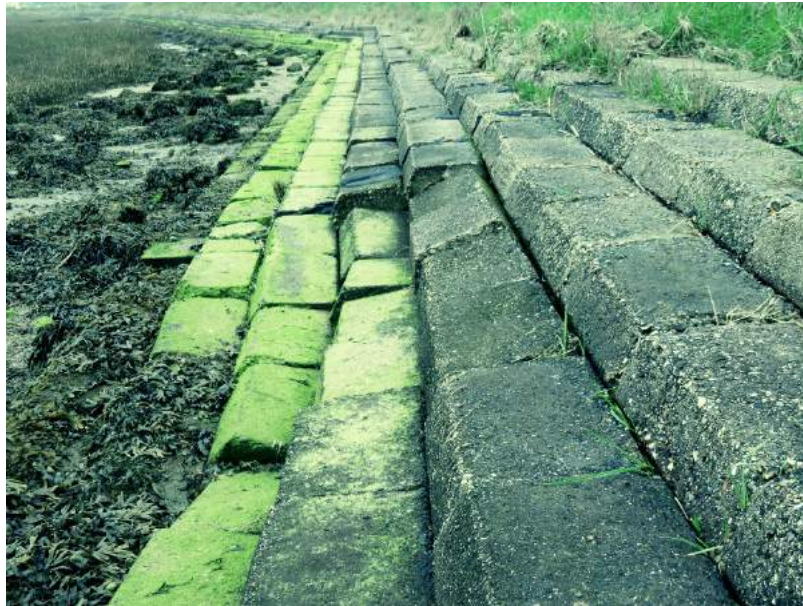
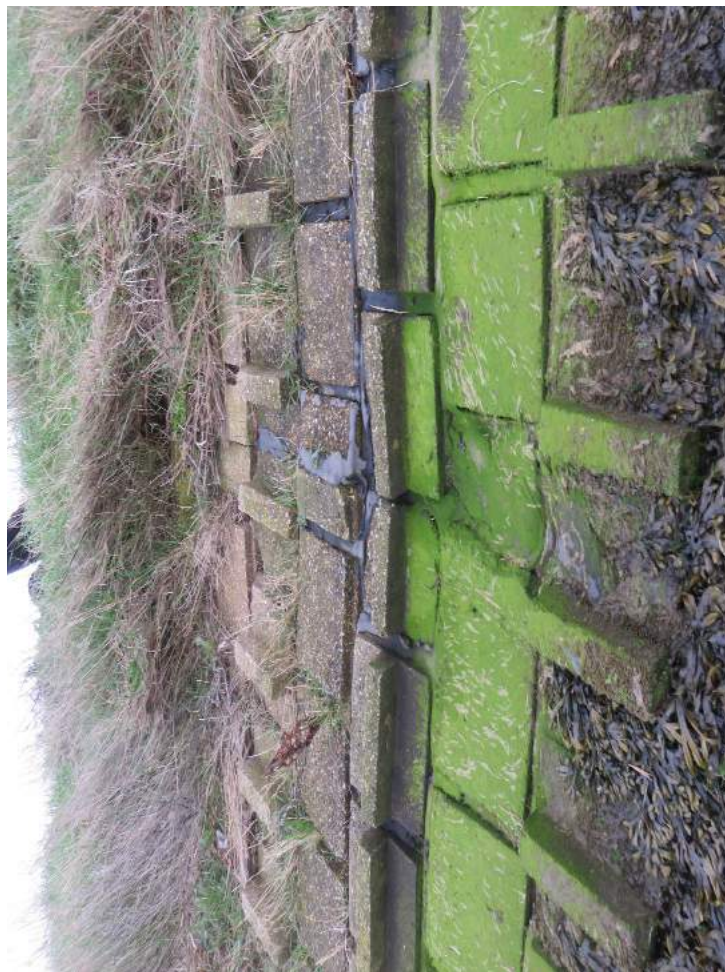
River Wall: Between 448562 and 449565 small infalling collapses of armour work (see photo) about every 10 feet. Not needing repair yet but, on past experience, will deepen each year. This could be tackled when that part of the river wall (which is due to be broadened with a less steep back slope) is dealt with.

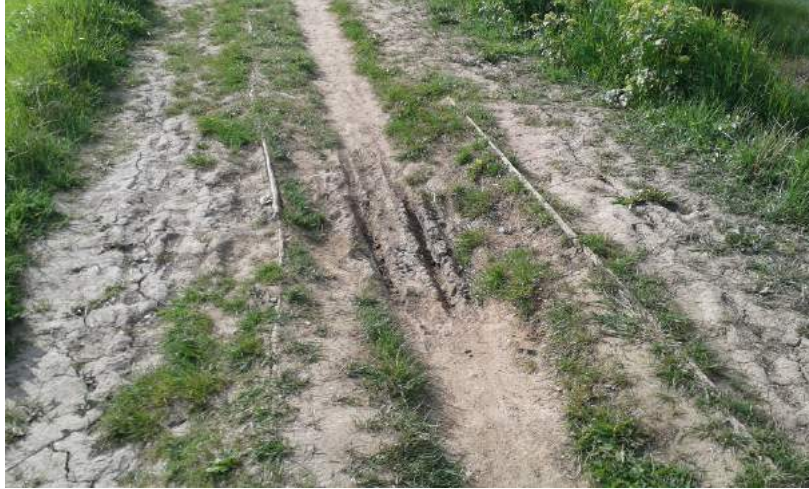
Footpath: 459558 to 464556 badly degraded, made broader by people avoiding the mud in the winter and more soil carried away by feet. The low spot 30 yards from the steps, which was overtopped in 2013, is slightly lower having been worn away even more. Path only really useable in dry weather (Alexanders plant infestation not so bad this year).

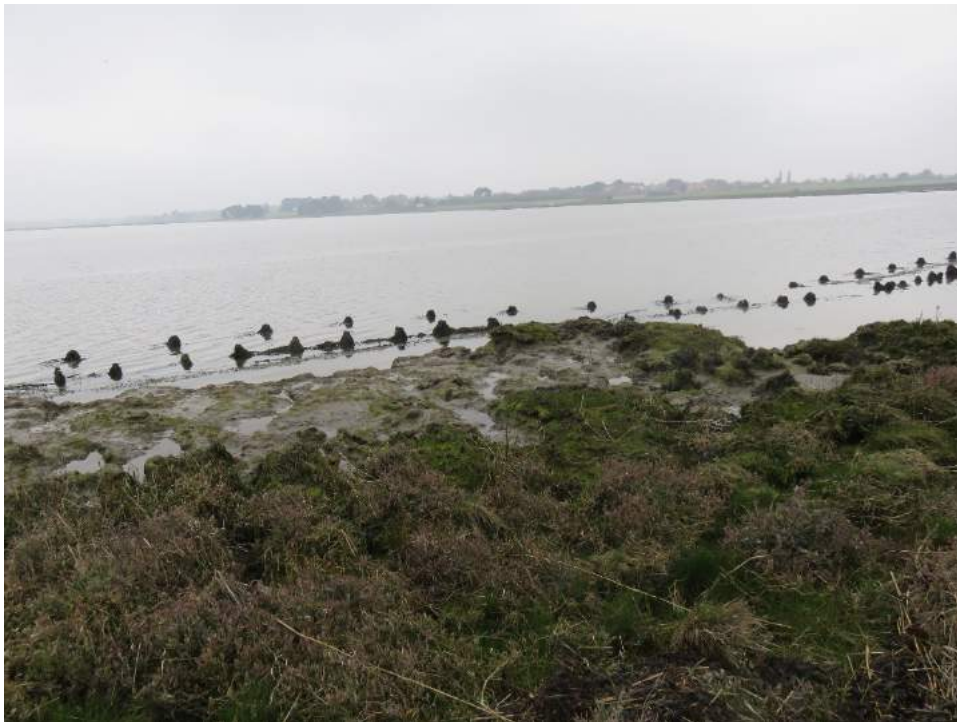
Saltings: Brick Dock 448562 to 449565. Most of the tensor fencing material has come away from the piles, clearly not up to withstanding the strong westerly fetch waves and movement at the bottom prevents accumulation of silt (reported to AOEP saltings group).

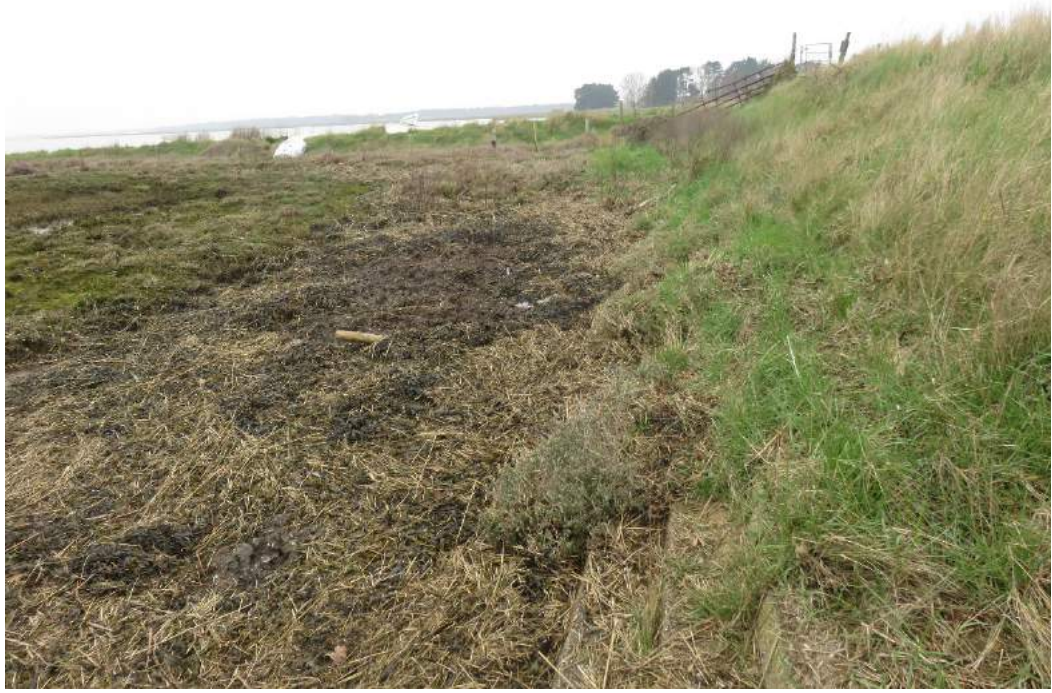
Debris: Mostly at the foot of the river walls, with a biggest accumulation of debris as a result of strong winds at 450565.
