ALDE AND ORE ESTUARY ASSESSORS REPORT

NAMES:	John Grayburn Alison Andrews Nick Robinson Roger Baxter	DATE OF INSPECTION: 24 April 2018
LOCATION:		AREA OF ASSESSMENT:
	Flood Cell 3	Chillesford Marshes

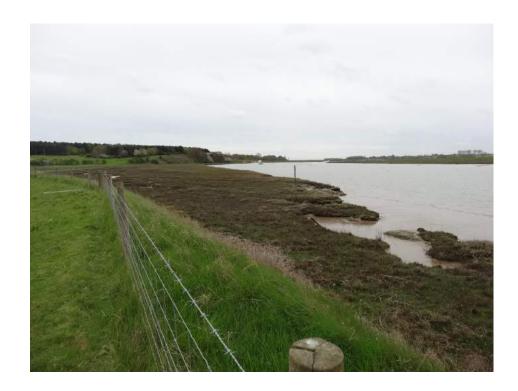
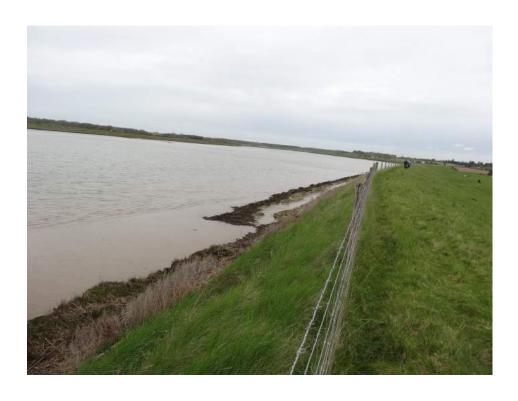
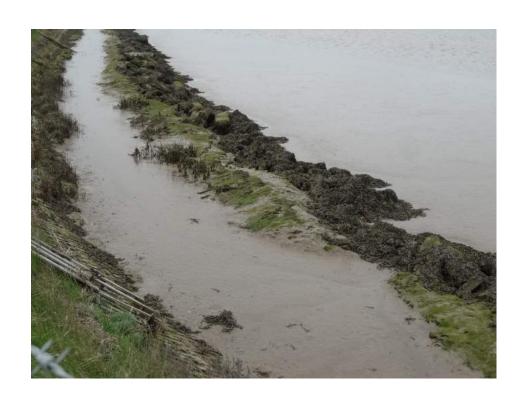
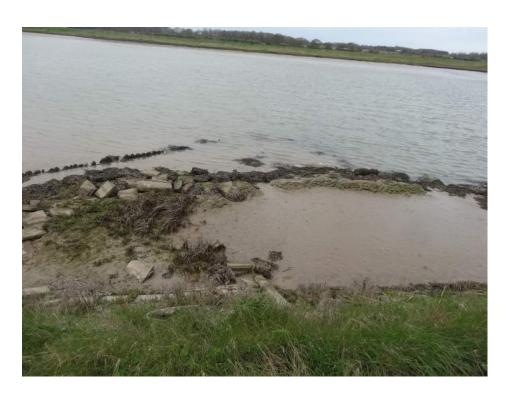
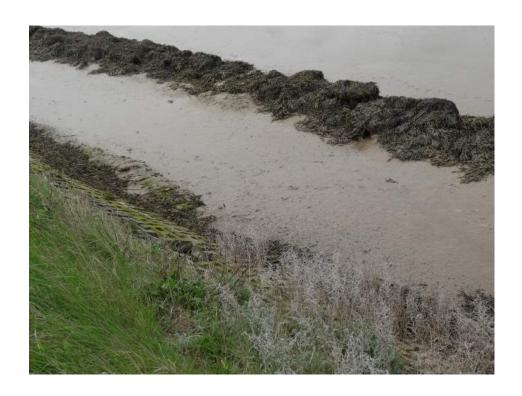
Walls well covered in vegetation with no risk of erosion in the event of over-topping.

A few armour blocks have become loose, but not causing concern.

Where armour has been replaced in the past, the old material has been left to provide additional protection.
