# THE ALDE & ORE ASSOCIATION

## ALDE AND ORE ESTUARY ASSESSORS REPORT

<b>NAME:</b> Andrew McDonald Chris Gill	<b>DATE OF INSPECTION</b> 17 April 2018 [low tide approx 09:30 BST]
<b>LOCATION:</b> Flood Cell 4.1	<b>AREA OF ASSESSMENT:</b> Butley River and Gedgrave Marsh TM 39677 48583 to 41591 48472 OS Explorer 212

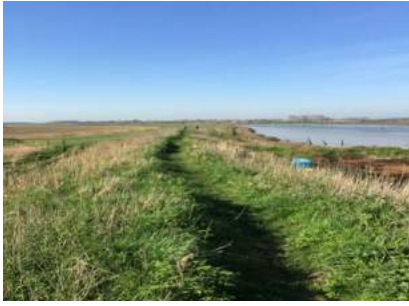
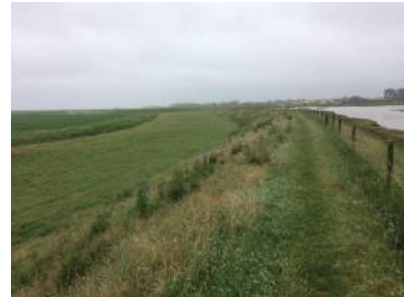
General view of pathway at 397486, start of inspection by Ferry Cottage. All well since 2017 inspection, well grassed and no slippage; landward wall in good order with good grassing, low slope, some cracks evident but all grassed over.

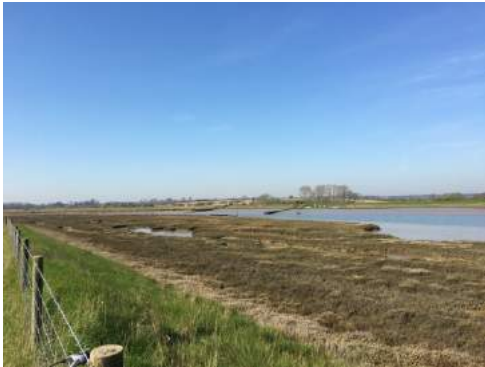
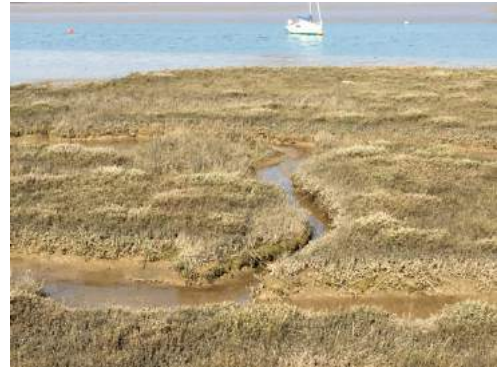
Saltings towards Butley Ferry jetty (395 483), general view and detail. No overall change here, but some evidence of gradual undercutting in the channels.

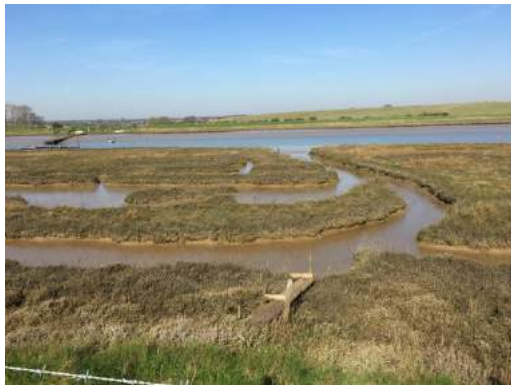
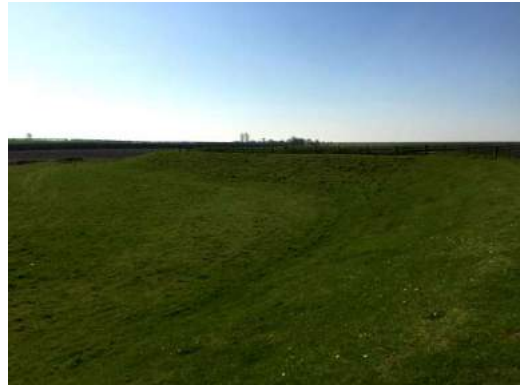
Another view of the saltings (395 483) looking across at the ferry jetty, and of the very good condition of the landward wall a little further along at 394 482.

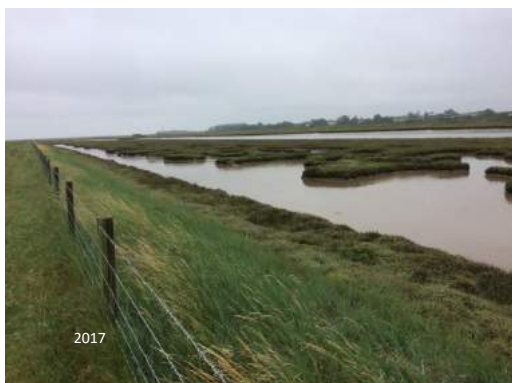
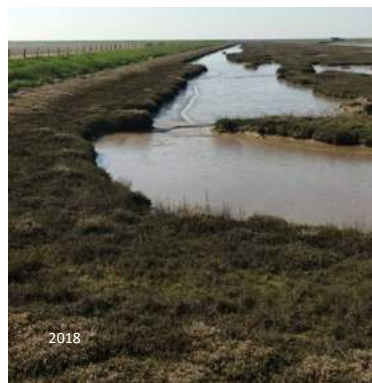
Two shots (*left is 2017, right is 2018*) of the 'inner channel' in the saltings at 394 482– this is gradually widening at the foot of the river wall, and there is further evidence of undercutting on the outer part of the channel, which may be significant.

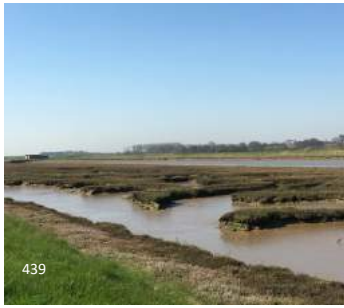
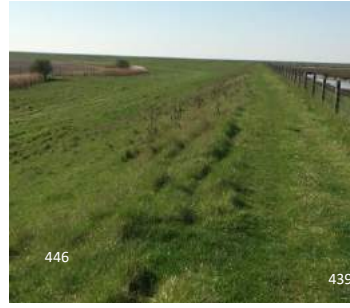
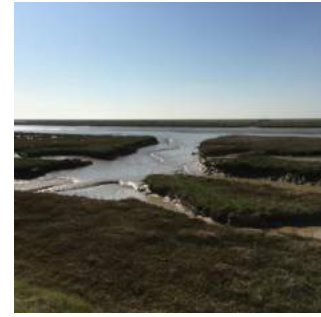
Undercutting in the inner channel (394 479); landward wall grassing over past slippage (394 479); and more undercutting on open channel at 396 474

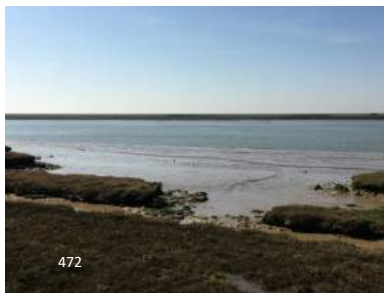
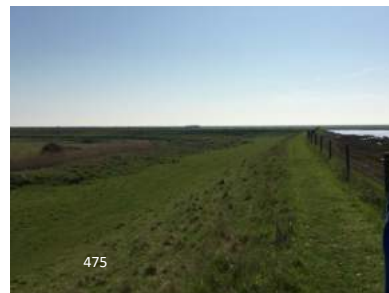
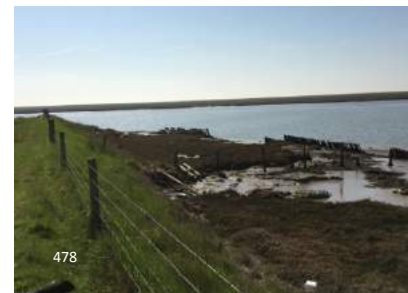
Towards Inset Point, at 405 472 – saltings apparently unchanged, path still worn and damaged but better grassed than 2016/7; and stakes gradually decaying at the bend (406 472)

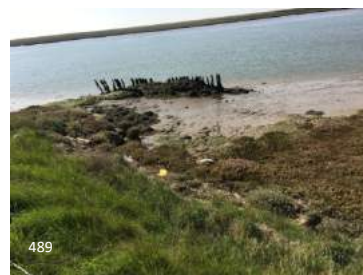
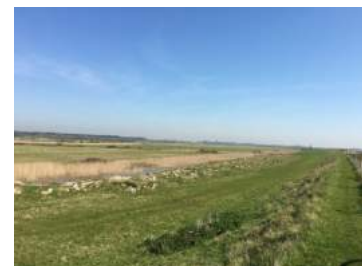
At 407471, Inset Point – path narrow and more worn than elsewhere; piled up stones defending decaying stakes; landward slopes and spoil heaps unchanged from 2017

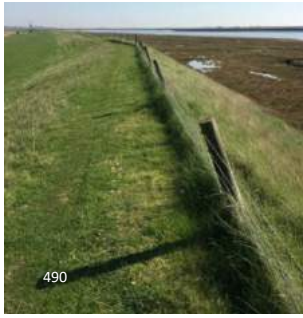
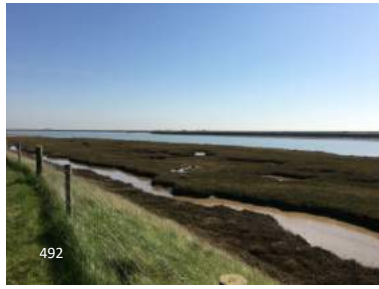
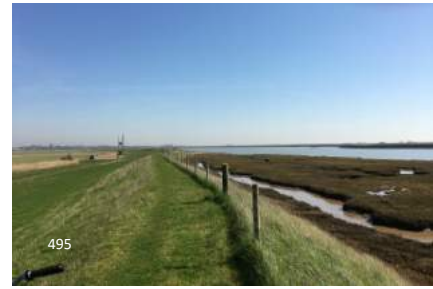
At 408 473, path towards the pumping station – fence posts have started to lean in again after recent repairs; saltings channel and some undercutting visible; general view.

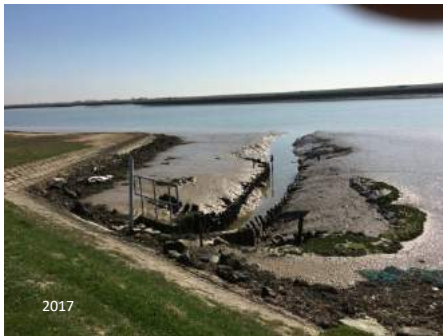
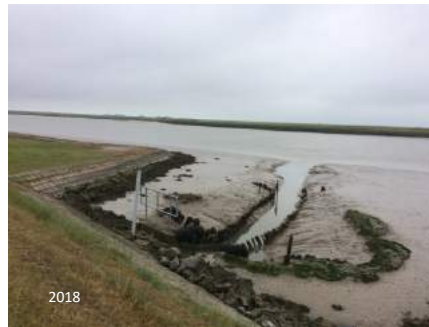
At the pumping station inlet (411 475) – 2017 on the left, this year on the right. No significant changes visible, but a build-up of debris and loose rocks.

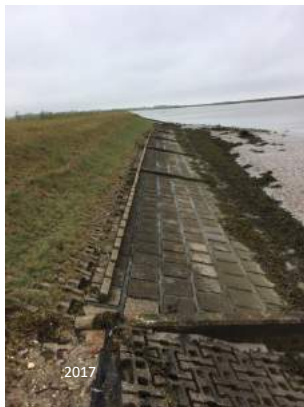
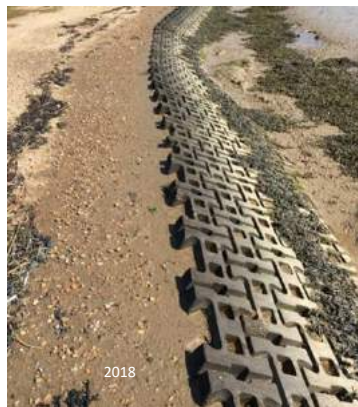
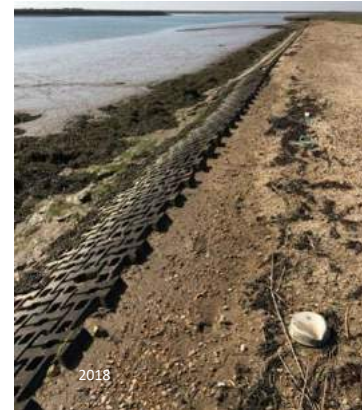
River wall revetment around 411 475, last year and this. At the top of the line of linked defence slabs the mud/shingle is washing away, leaving the top of the revetment exposed.

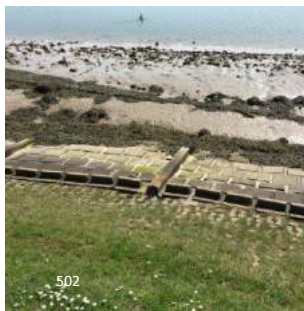
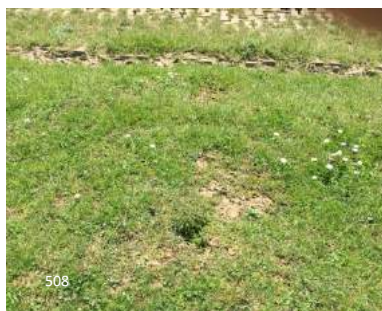
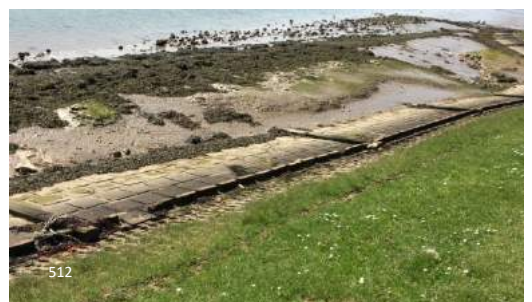
Revetment slabs buckling slightly at 411 476; worn and damaged pathway at this point; generally sound revetments and more evidence that (? sheep) a small track is being created at the outer foot of the wall at around 412 477.

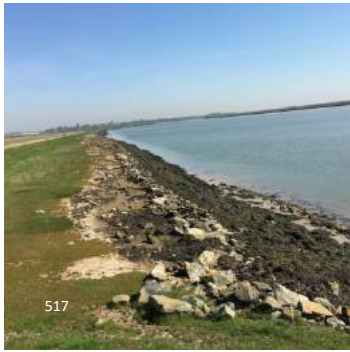
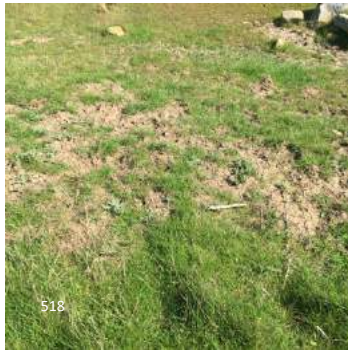
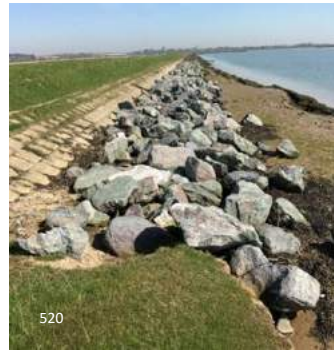
Coming towards Chantry Point – rock defences and bare patches in the pathway and outward wall at 412 477; more recently placed rock defences at 412 478

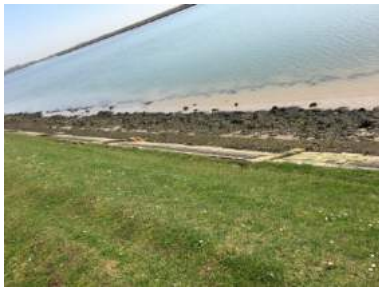
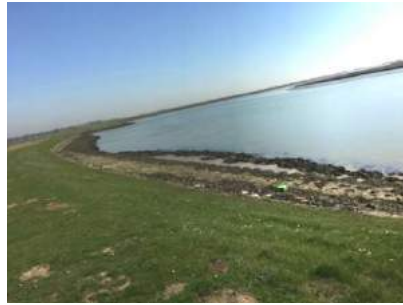
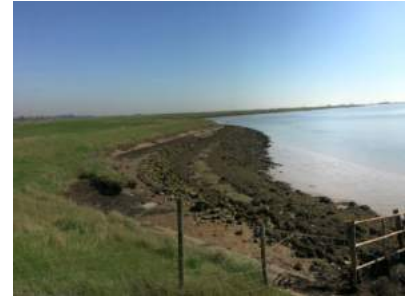
Last stretch towards Chantry Point – pathways in poorer condition than elsewhere in this part of FC4, some mud and seaweed covering up generally sound revetments, no significant changes.

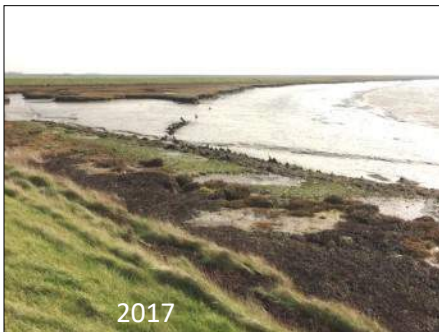
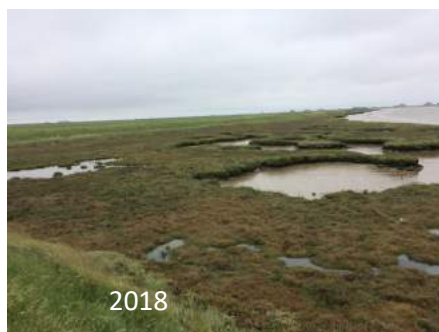
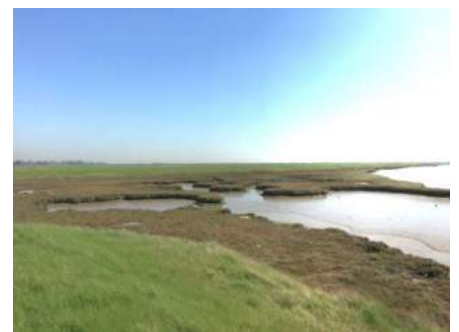
General view of saltings at Chantry Point, 415 484, over the last three years – path is worn but no significant change from last year; saltings and river walls largely unchanged, although some undercutting evident here as elsewhere.
