THE ALDE & ORE ASSOCIATION

ALDE AND ORE ESTUARY ASSESSORS REPORT

NAMES: Frances Barnwell Chris Gill	DATE OF INSPECTION: 17 April 2018
LOCATION: Flood Cell 4.2	AREA OF ASSESSMENT: Chantry Marshes to Orford Quay

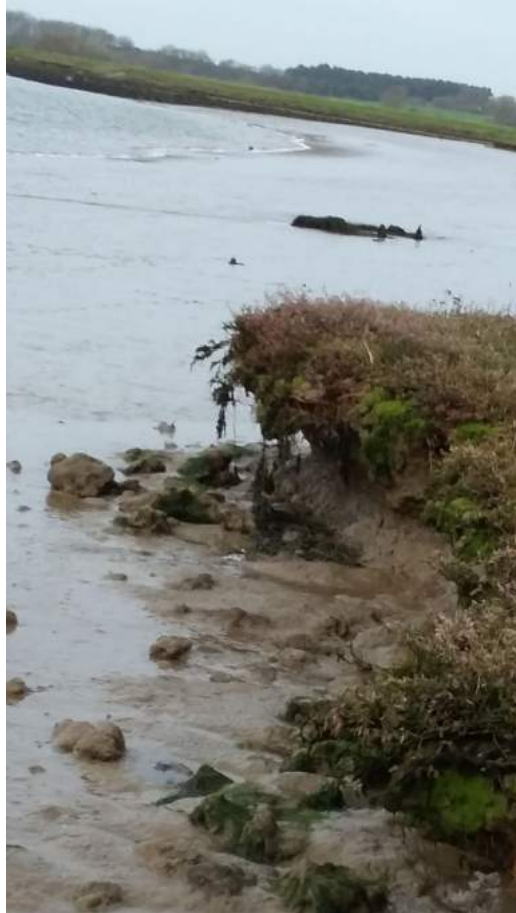
River Wall/Armour	Saltings	High Tide Debris Line
The state of the top is encouraging walkers to establish lower pathways along the river facing sides.	It is hard to assess the extent of changes overall, but it is clear that the saltings on Short Gull are being significantly eroded such as shown in the photo below.	Not clear on the day of our survey.

Photo 1
Erosion of saltings on Short Gull

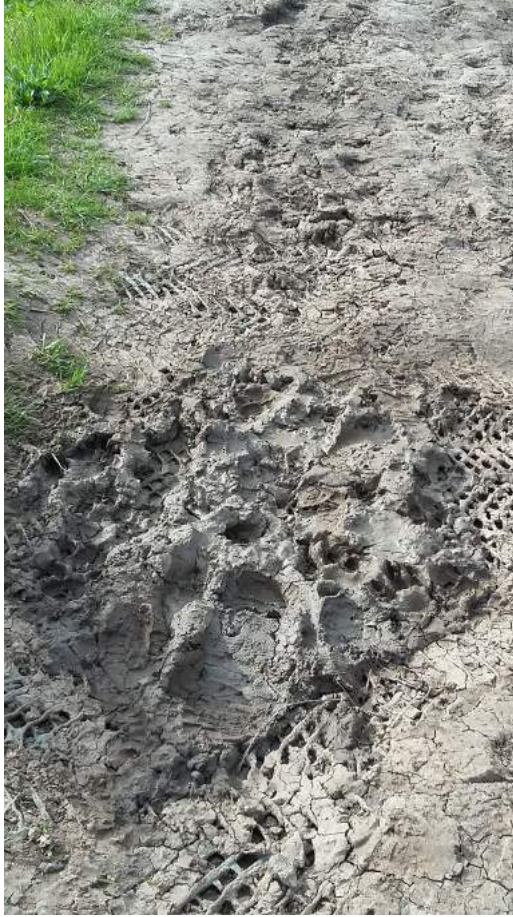
As with earlier reports on this section, the prime concern is the state of the top. With the increasing loss of any grass cover and an ever increasing footfall, the surface, including along the trial section, is turning to mud in wet weather with the obvious associated damage.

Photo 2
Surface turning to mud and exposing netting

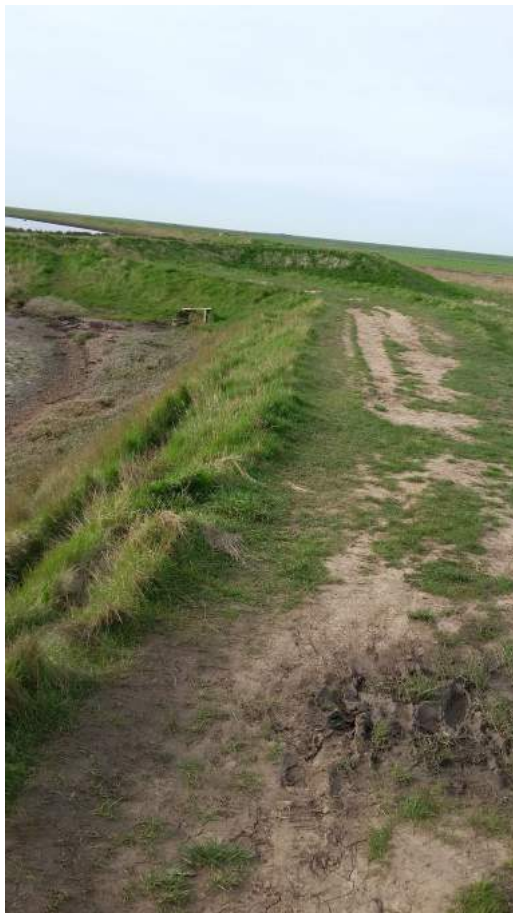
Photo 3
Increasing loss of grass cover

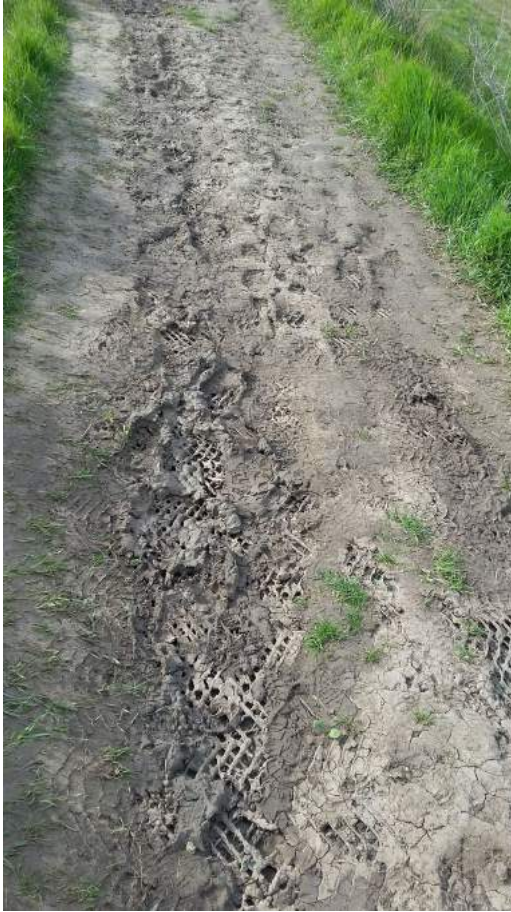
Photo 4
Another photo showing wear
