THE ALDE & ORE ASSOCIATION

ALDE AND ORE ESTUARY ASSESSORS REPORT

NAMES:	Simon Reid Roger Baxter	DATE OF INSPECTION:	May 2018
LOCATION:	Flood Cell 4.4	AREA OF ASSESSMENT:	Pump House to Chapmans Creek

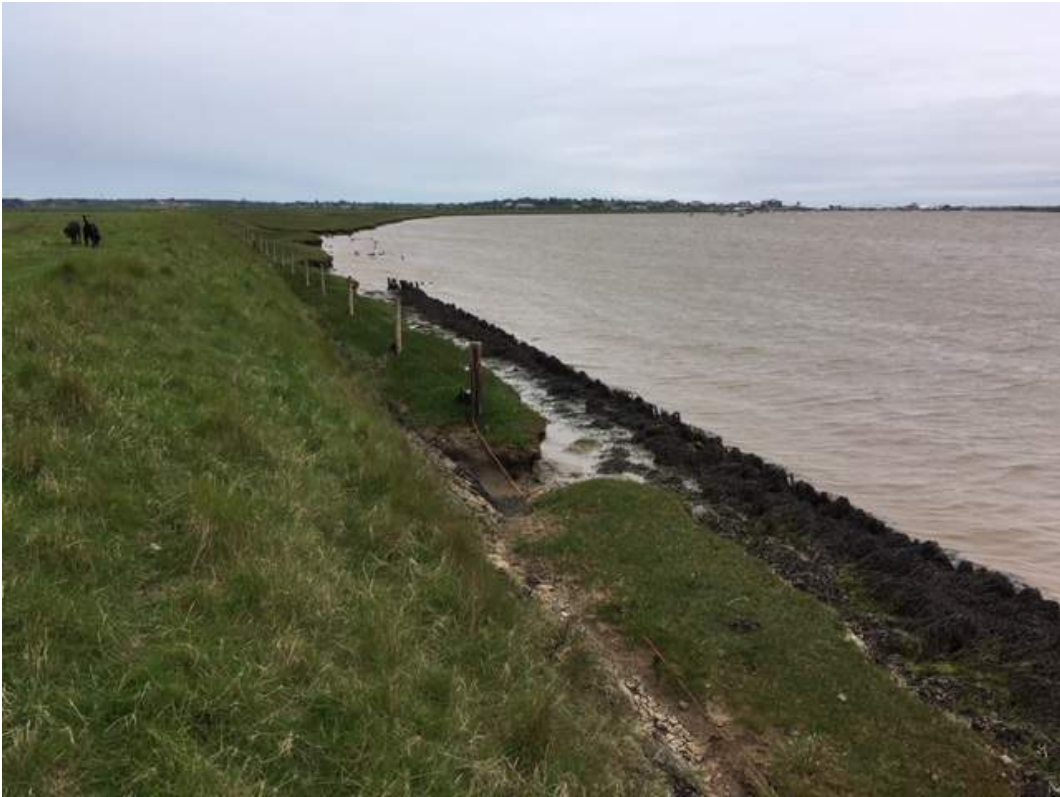
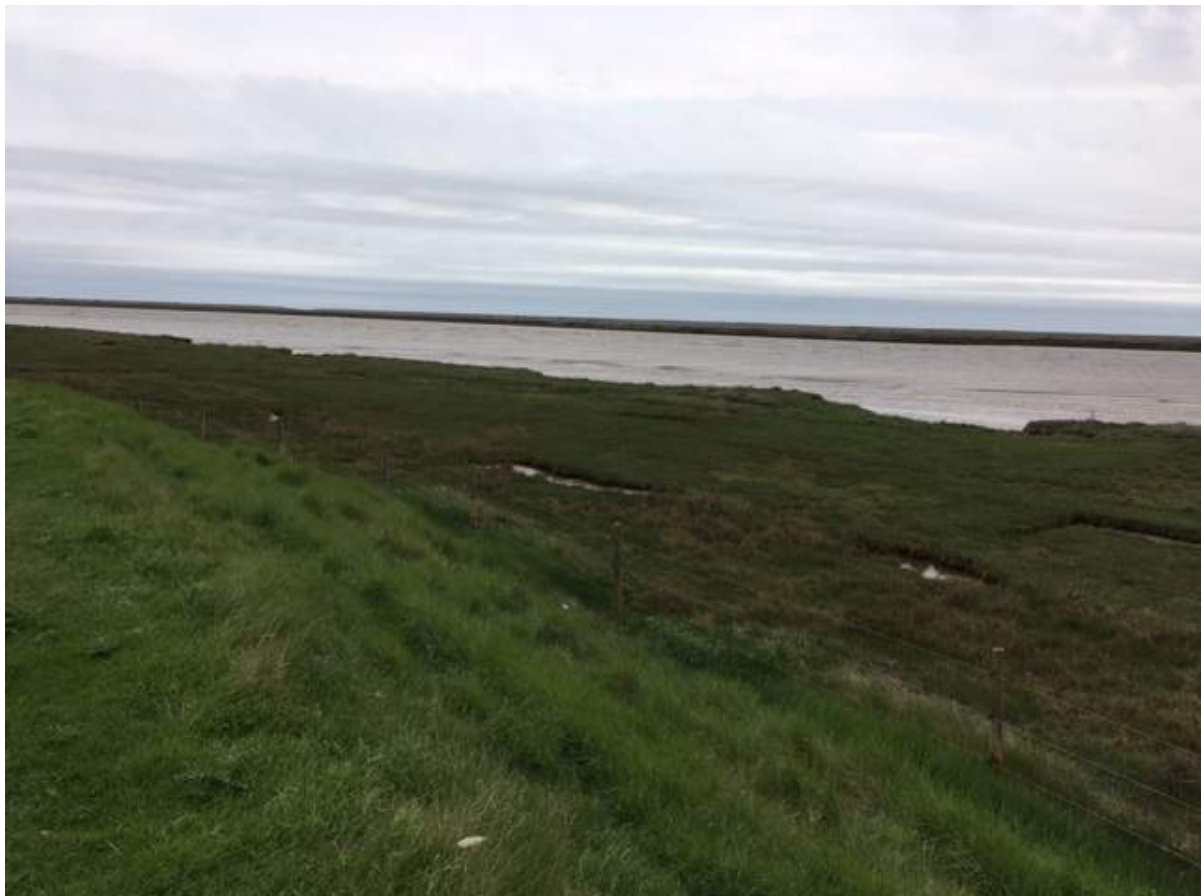
River wall well covered in vegetation, in better condition where sheep have grazed (photo 3)
Back slope shallow, some areas of river slope steep, but not a problem.

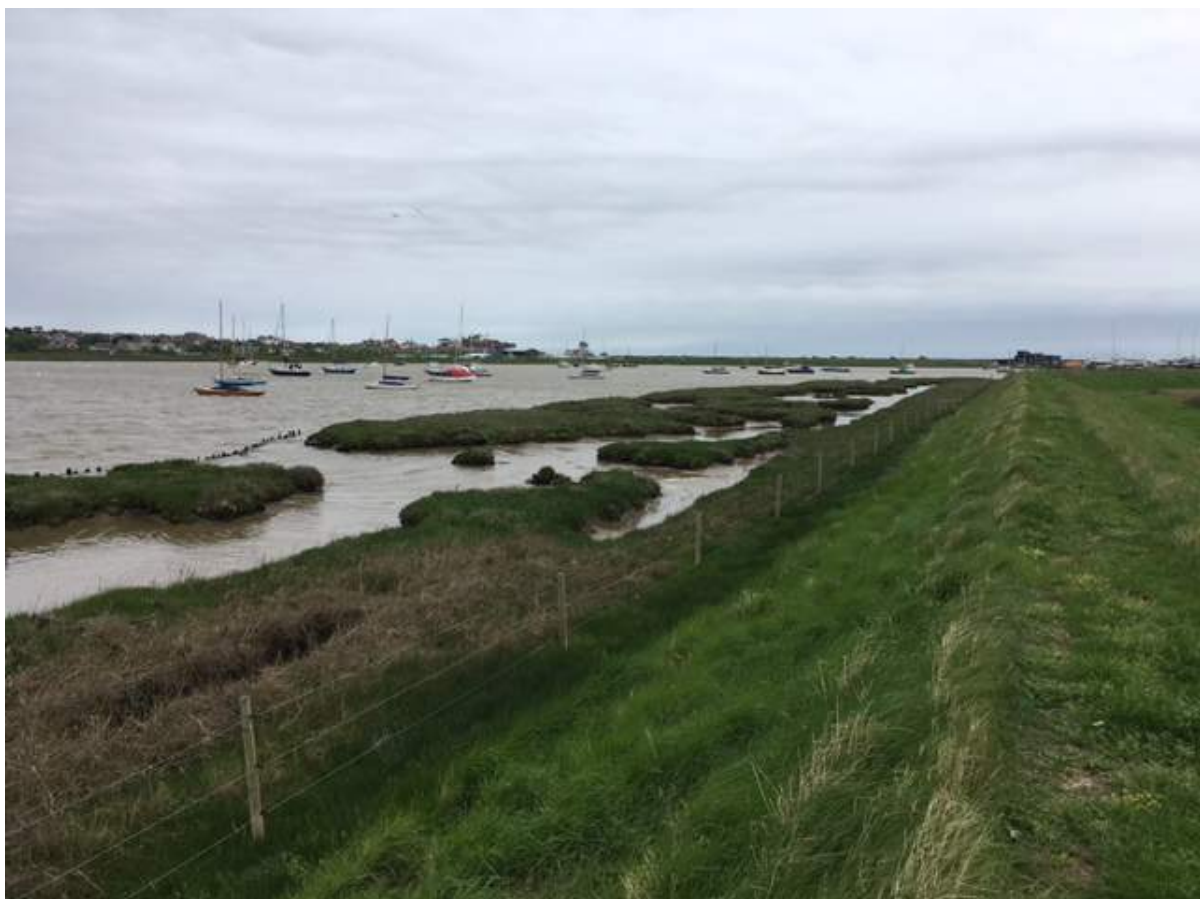
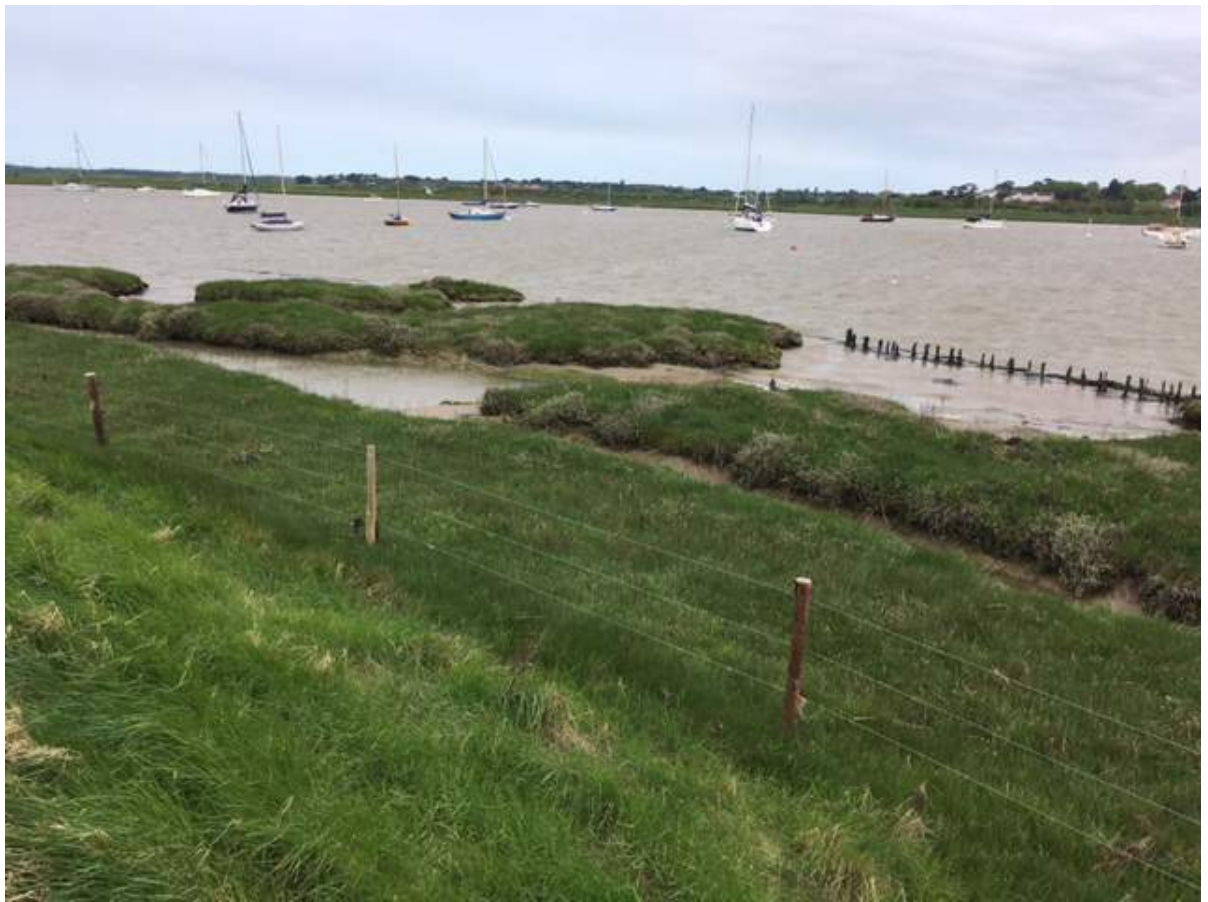
Where saltings are deep there are some lagoons. Saltings on Westrow Reach (where some attenuation system is in place) erosion continues.
