THE ALDE & ORE ASSOCIATION

ALDE AND ORE ESTUARY ASSESSORS REPORT

NAMES: Simon Barrow Keith Martin	DATE OF INSPECTION: 9th April 2018
LOCATION: Flood Cell 5	AREA OF ASSESSMENT: Chapmans Creek to Anchorage, Iken

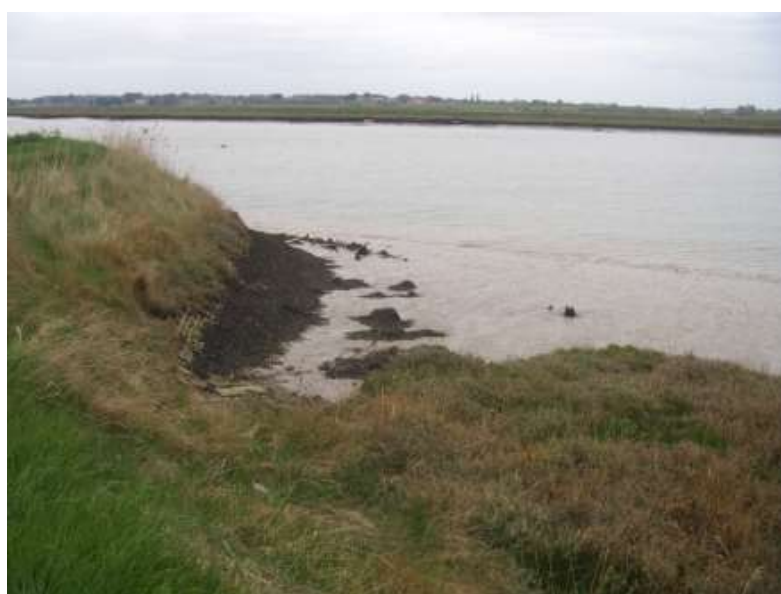
2017

Grid ref	River Wall/Armour	Saltings	High Tide Debris Line
Paul Cook			
552 453	Seems height lower than to the west (1.5m area) Check: LIDAR	Nil in gap. Needs stakes to help build up	20cm below path

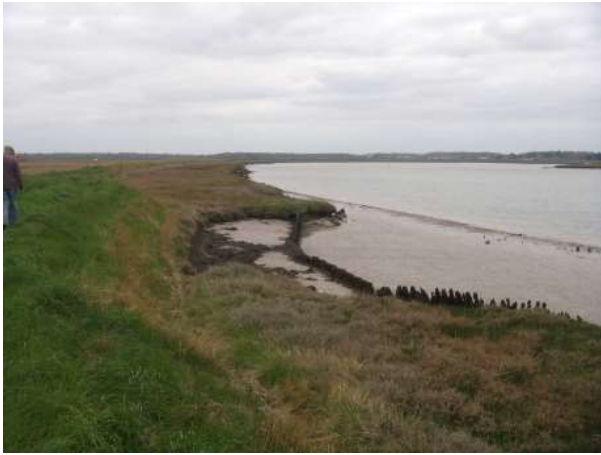
2017

555 444	Ok	Salting 'bay' in place. Mud filling and vegetation growing. Good result of stakes	ok
---------	----	--	----

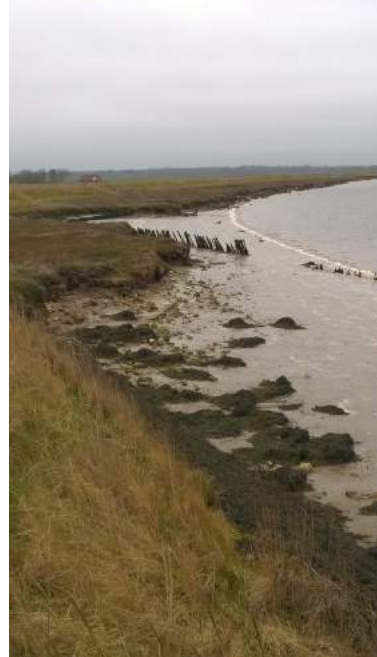
2018

557443 – same as 2017

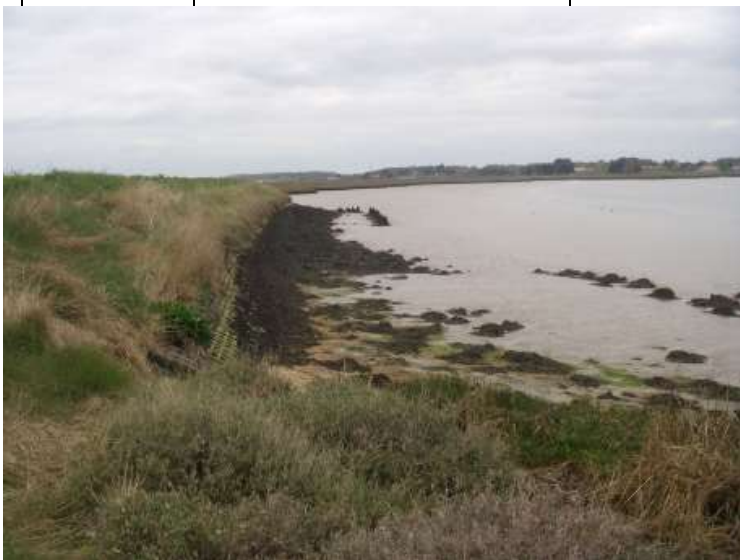
2017

558 442			0.8 metres below
559 442		Needs new stakes. Existing ones hardly visible but have done good – see vegetation

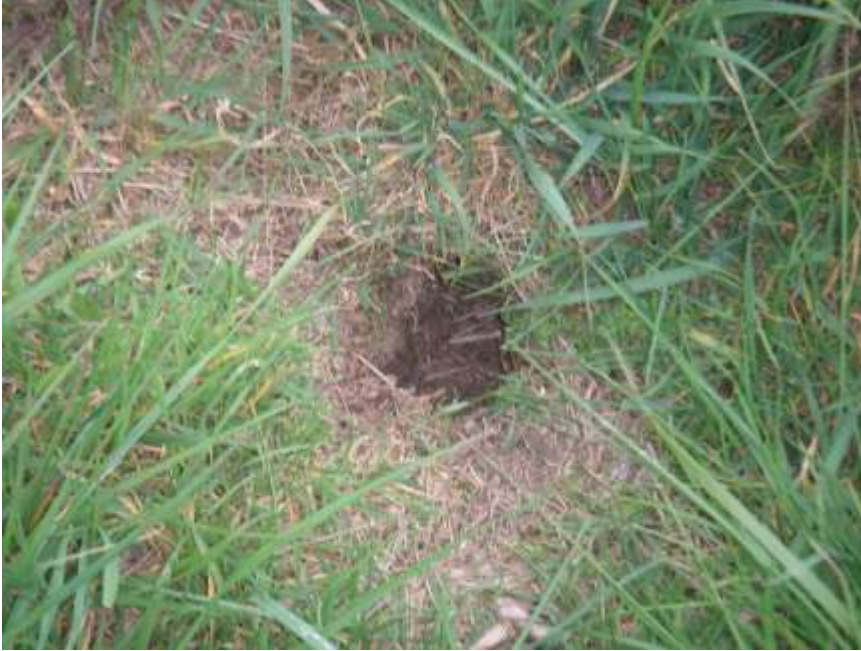
2017

560 442	✓	15 m	0.3 metres below
562 442	✓	Excellent	10cm very close
564 443	Hole on top of river wall – several on this stretch	✓	1.5 metres plus

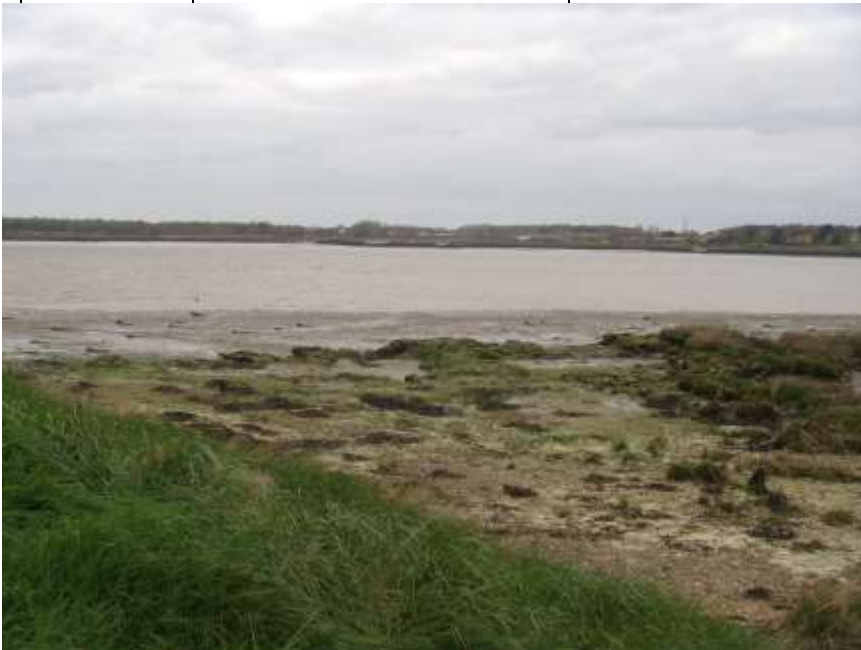
2017

566 441	First notice – mole hill on top	✓	1.5 metres plus
568 441		Opp Hazelwood new stakes needed – big defenceless bay visible	1.0 metres

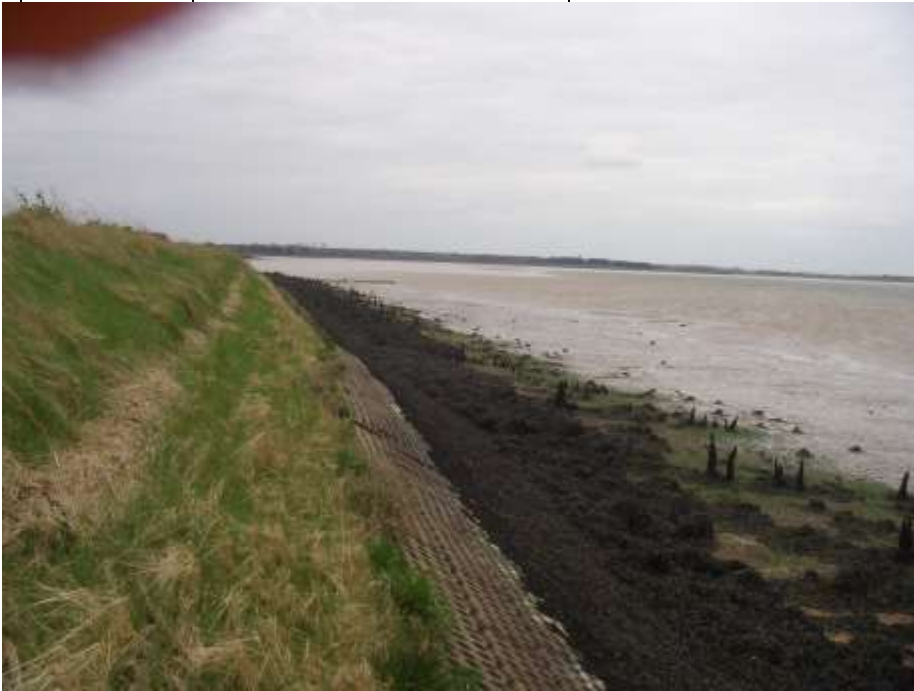
2017

568 440	✓	Old stakes need replacing all along this stretch	1.6 metres
----------------	----------	---	-------------------

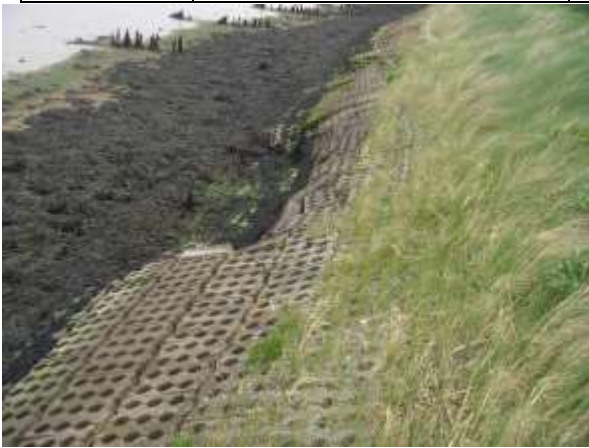
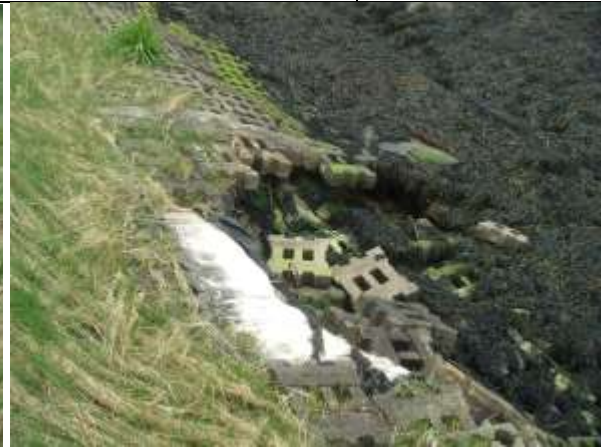
2017

567 438	Serious damage to armour and several to the west of it	Stakes worn	1.0 metres
----------------	---	--------------------	-------------------

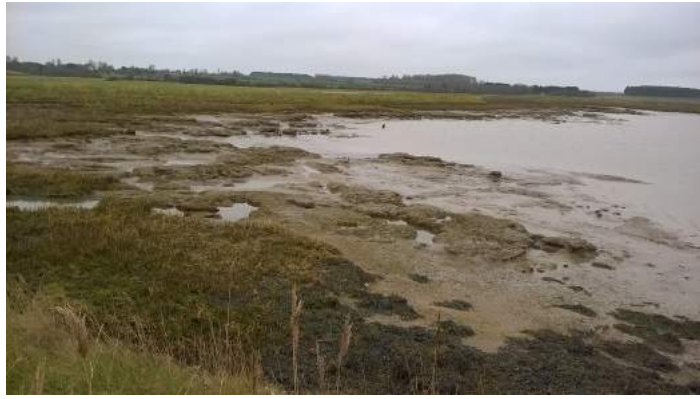
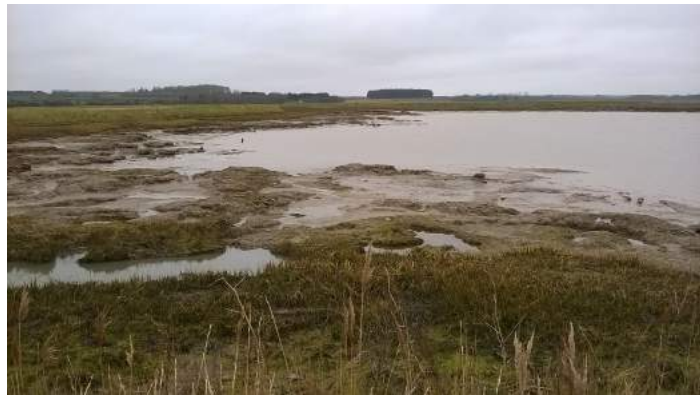
2018 - 567438 – looking west – salting damage

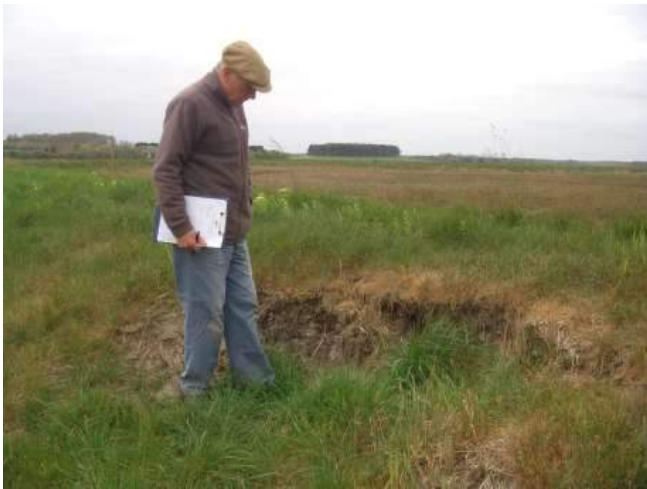
2017

564 437	Big hole on land side	✓	1 metre
----------------	------------------------------	----------	----------------

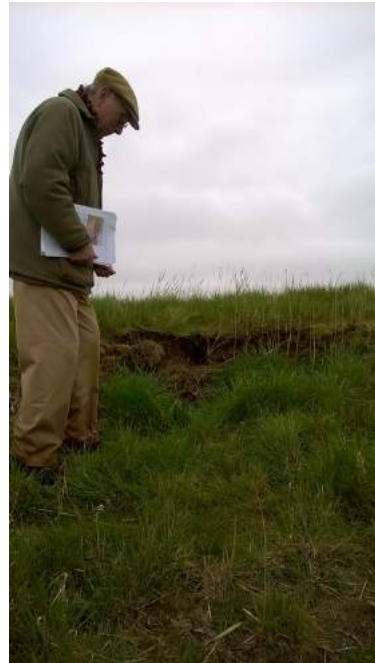
2018

564437 – large hole land side – reported 2017

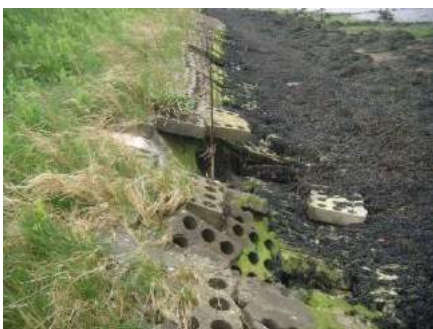
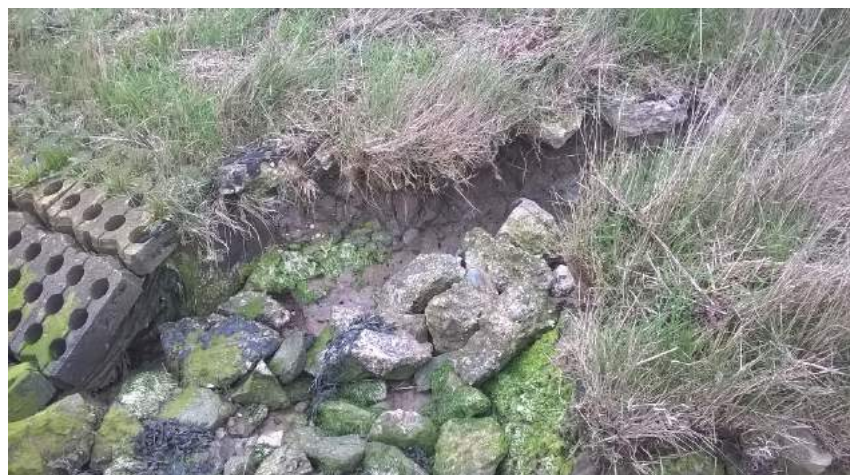
565 433	Serious buckle, much worse than before	Old stakes in diamond shape	0.5 metres
----------------	---	------------------------------------	-------------------

565433 – series of areas of damaged protection – as for 2017

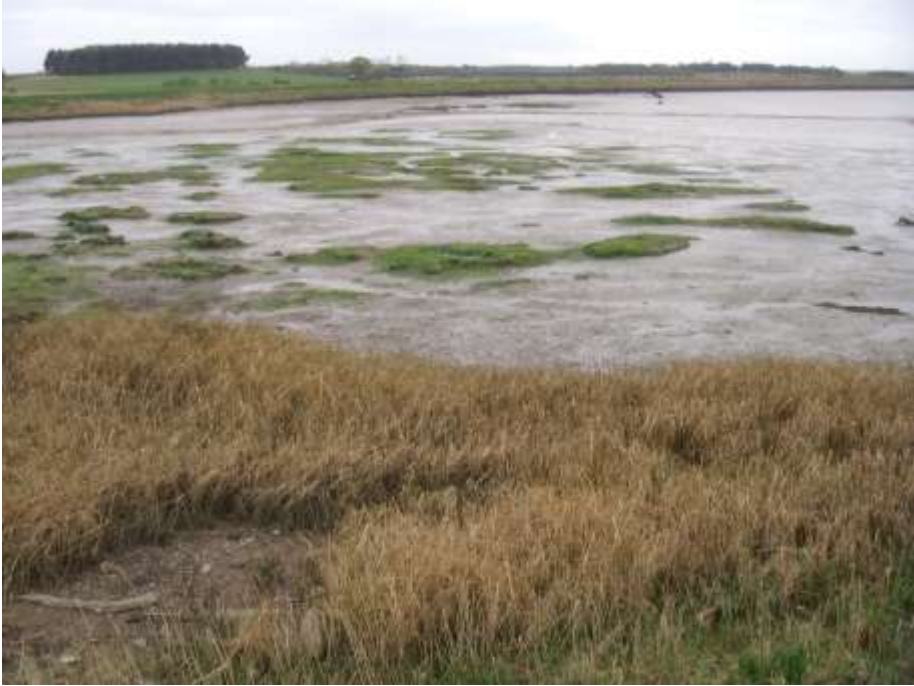
2017

562 433	✓	Why are the saltings so brown? Looking dead	1.5 metres
---------	---	--	-------------------

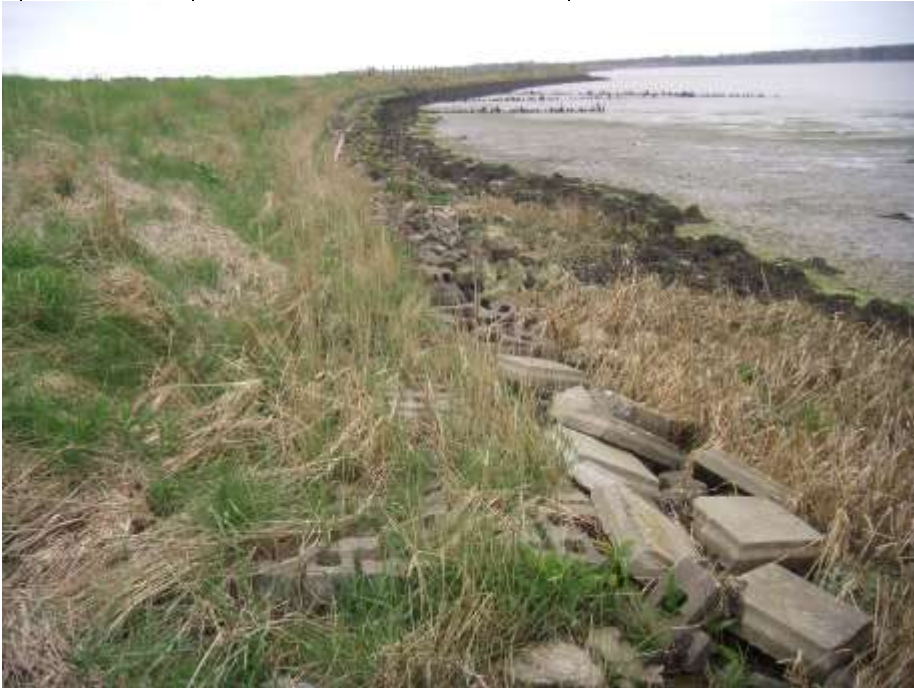
2017

562 431	West of pumphouse Loose armour stones. Dumping of spares or real damage? 20 m further west broken armour (yet quite recently put in place)	Nil – stakes warn and not across the bay	0.5 metres
---------	---	---	-------------------

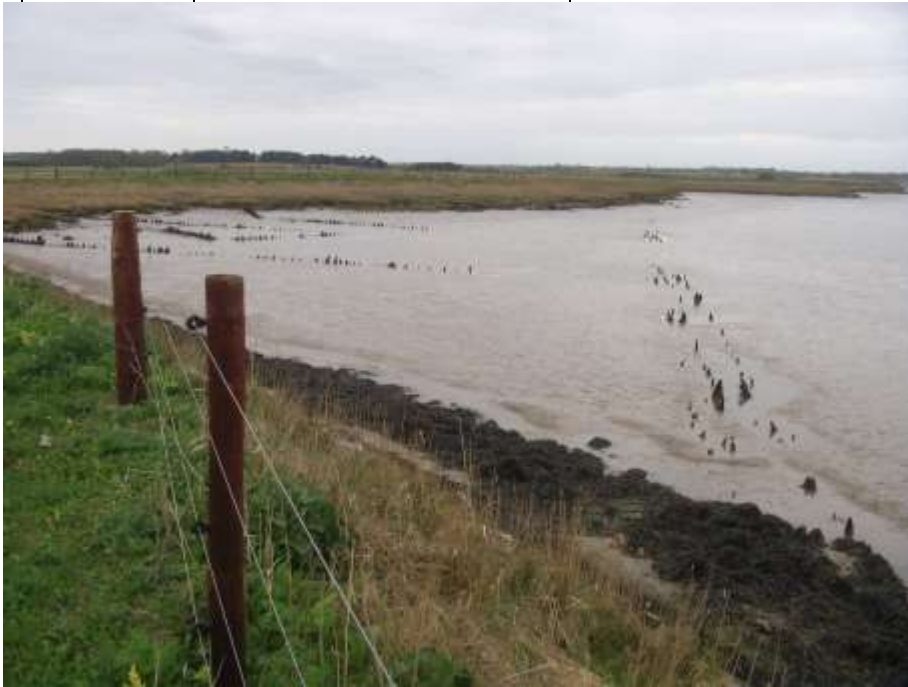
2017

Richard Mann			
563 429	✓	Only a little vegetation	0.3 metres

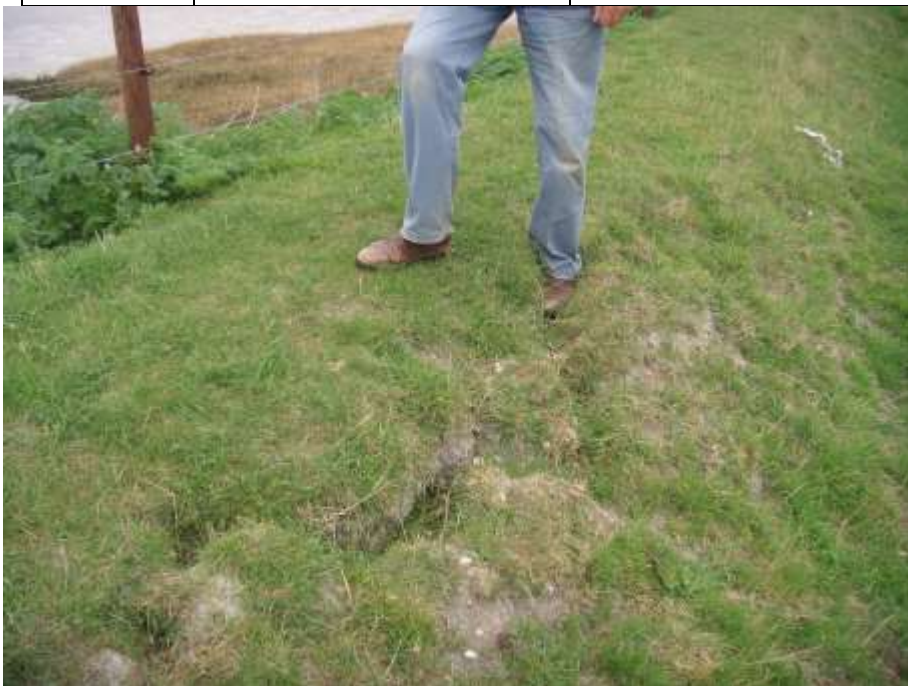
2017

563 428	Mole hills landwards	Bay is protected but very old stakes. Need replacing.	OK
564 424	Cracking on top

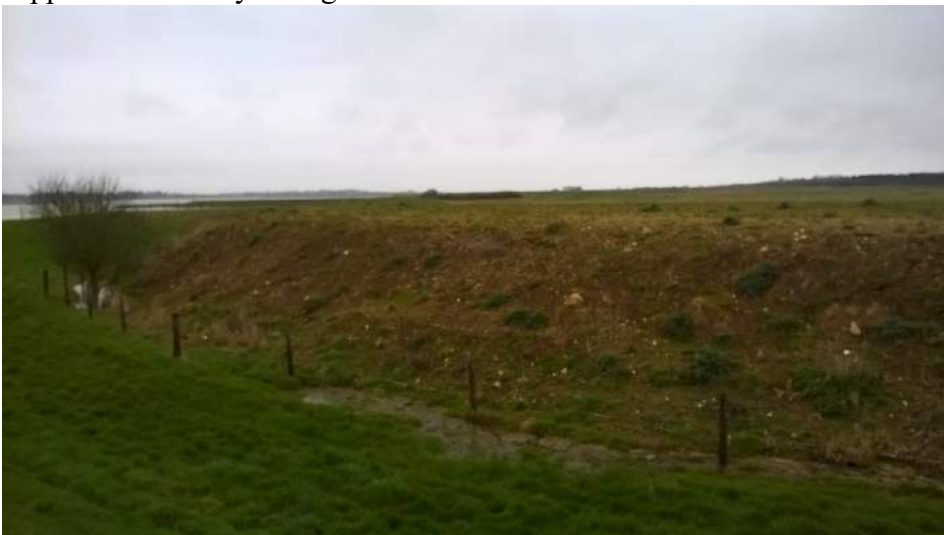
Tippers R us – clay storage??

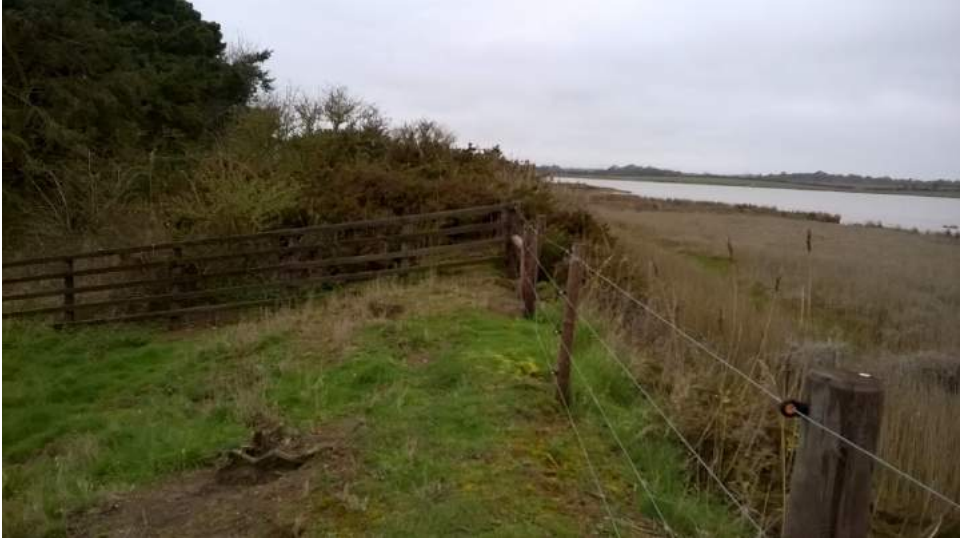
567 426	One gorse bush! Needs removing. West 200m bramble growing		OK
---------	--	--	----

2018 gorse growing on river wall

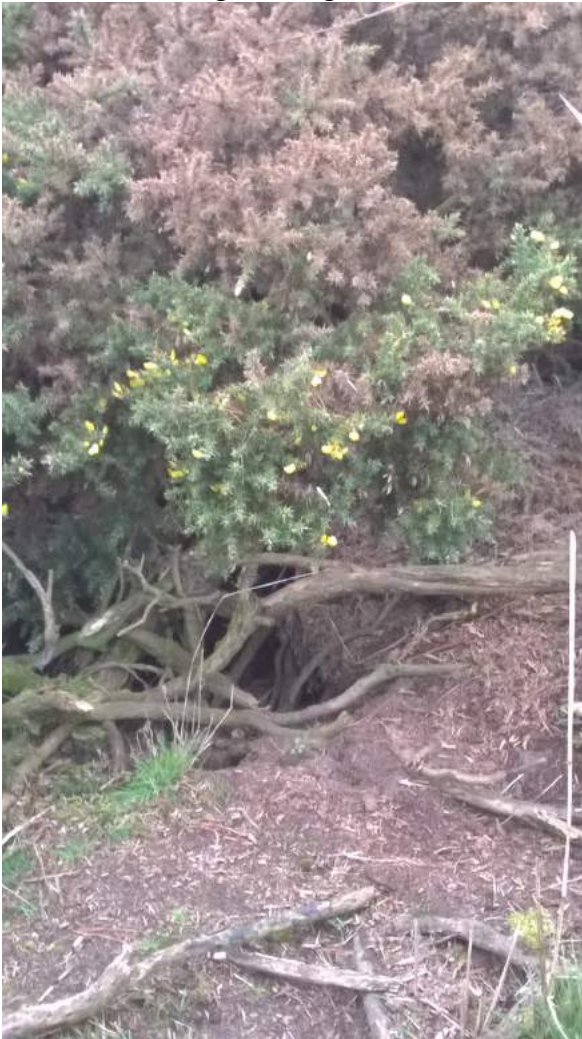
2018 Root damage from gorse

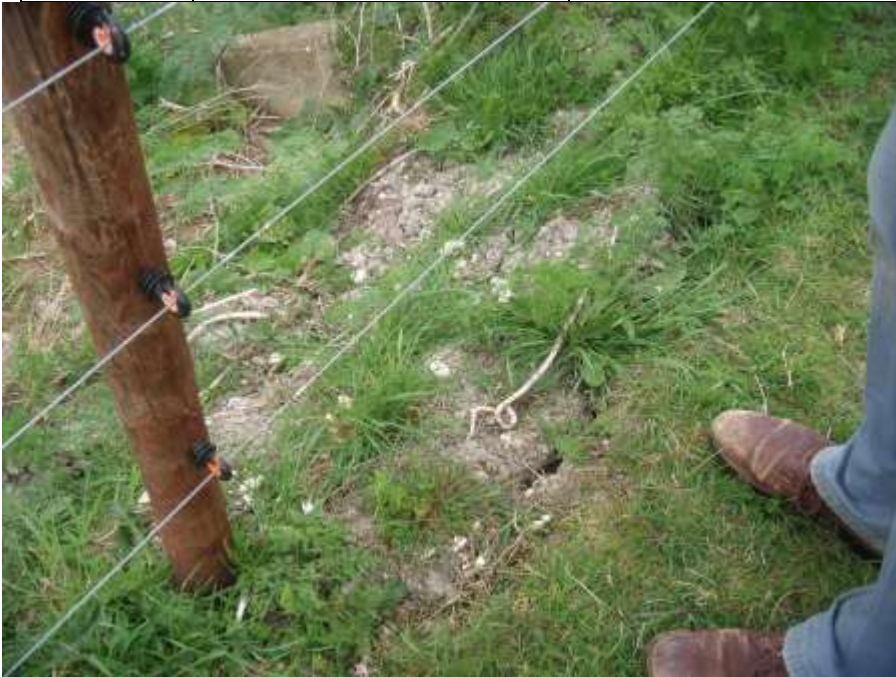
2017

568 422	Multiple serious cracks on landside over 200m Decaying tops on river side and fall on land side too steep	10 metres of salting	OK
---------	--	----------------------	----

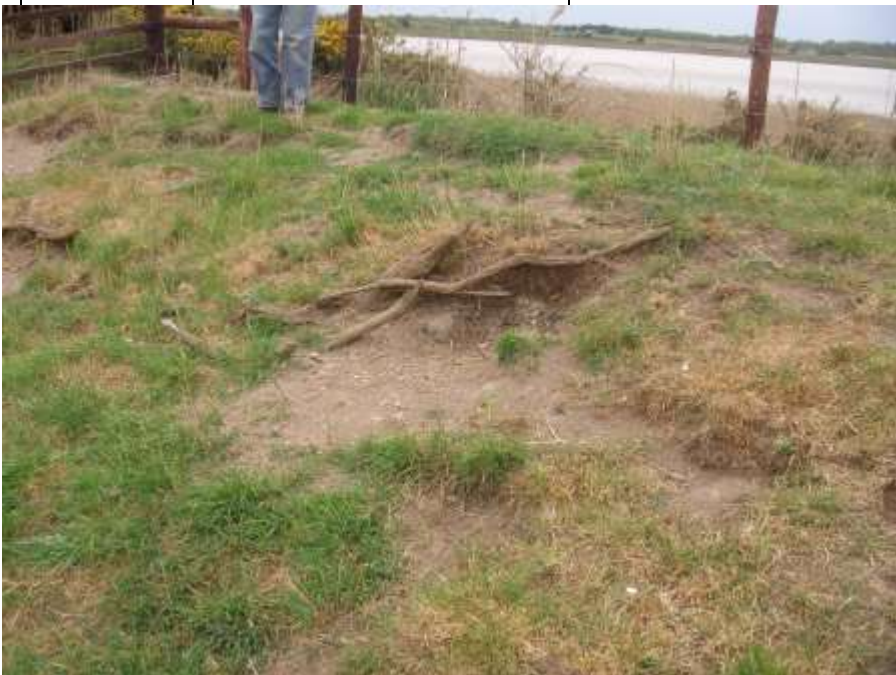
2017

568 421	Dip in top of wall 2.5m width, 0.3m deep	4 metres	0.2 metres
568 415	✓	4 metres	2.5 metres, excellent!
568 413	Old root damage and gorse on riverside	✓	✓

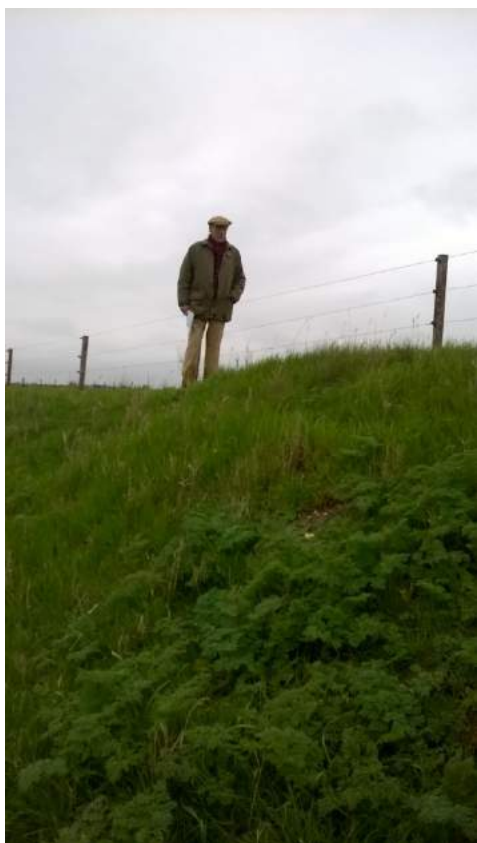
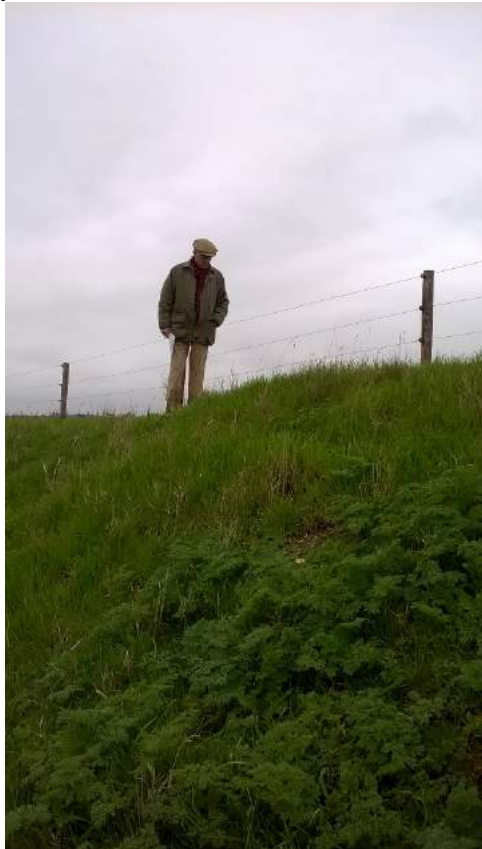
Section of low wall. No grid ref – sorry – I think it's near 564437 in 2017 report
