THE ALDE & ORE ASSOCIATION

ALDE AND ORE ESTUARY ASSESSORS REPORT

NAMES:	Peter Donaldson Rufus Gilday Richard Kihl	DATE OF INSPECTION: 20 April.2018
LOCATION:	Flood Cell 8	AREA OF ASSESSMENT: Ham Creek

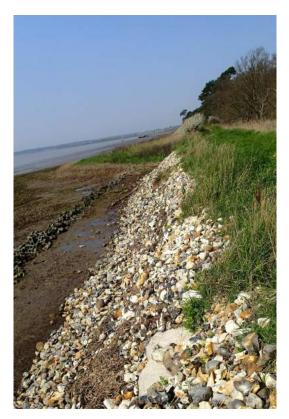
Minor loss of armour, exposing underlying material (see photo 1). Needs to be watched.
