THE ALDE & ORE ASSOCIATION

ALDE AND ORE ESTUARY ASSESSORS REPORT

NAME: Roger Baxter	DATE OF INSPECTION: June 2018
LOCATION: Flood Cell 9	AREA OF ASSESSMENT: Brick Dock

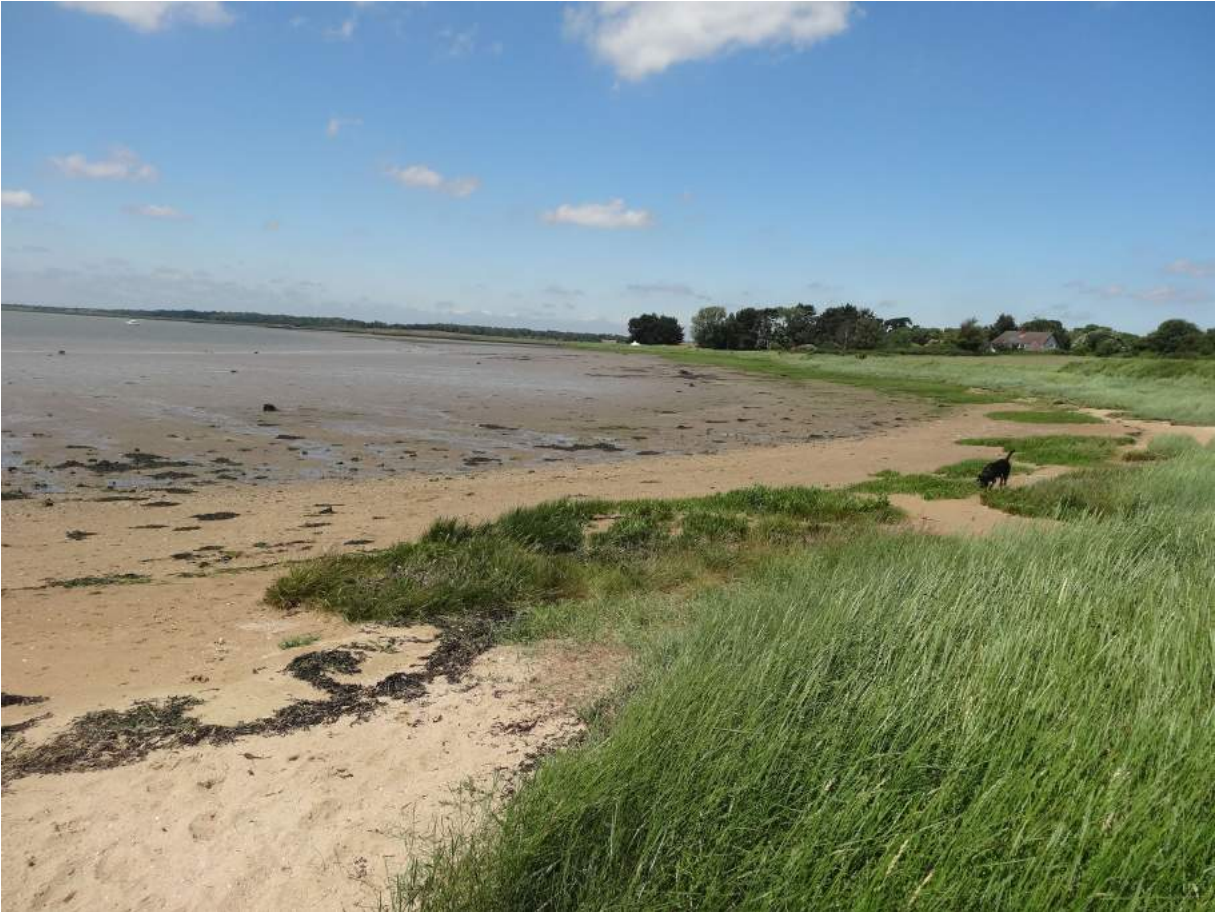
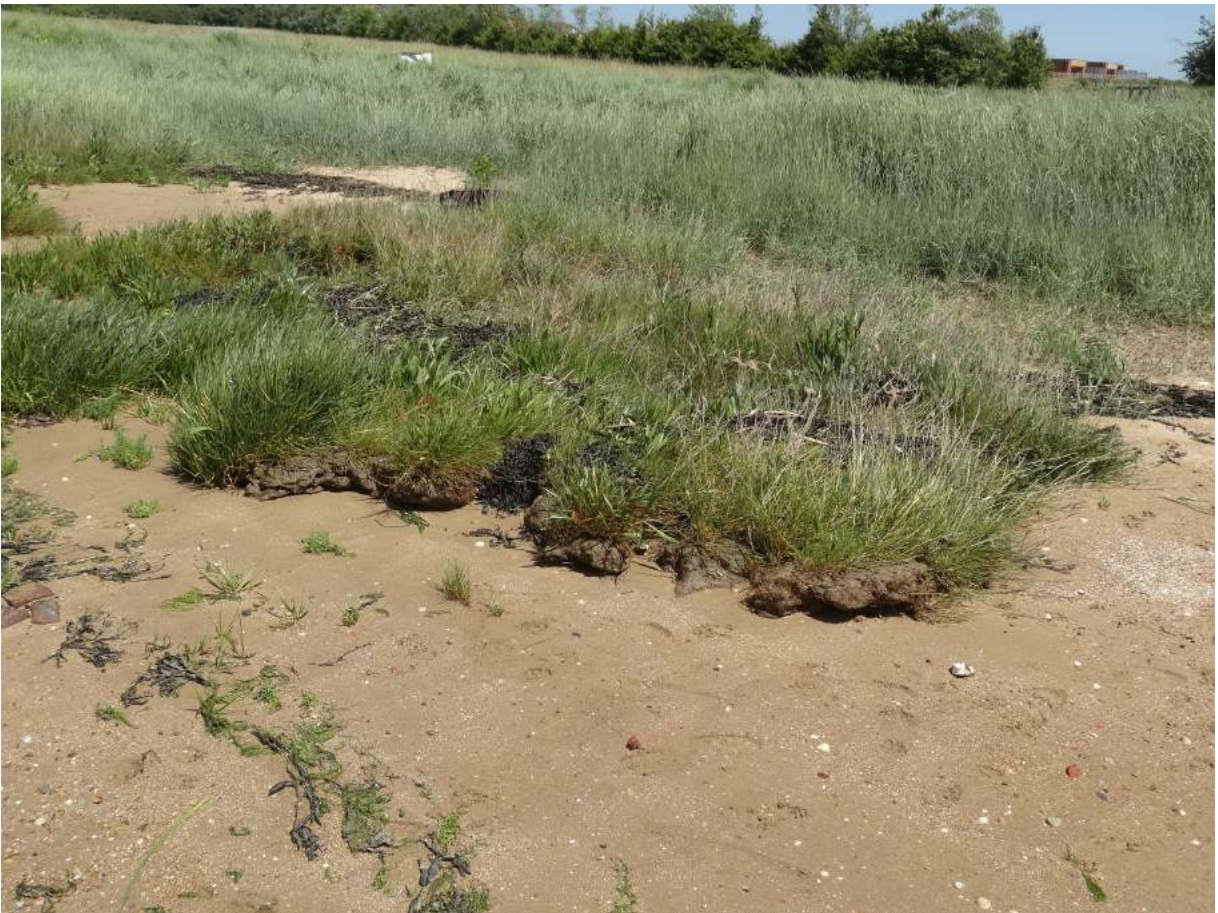
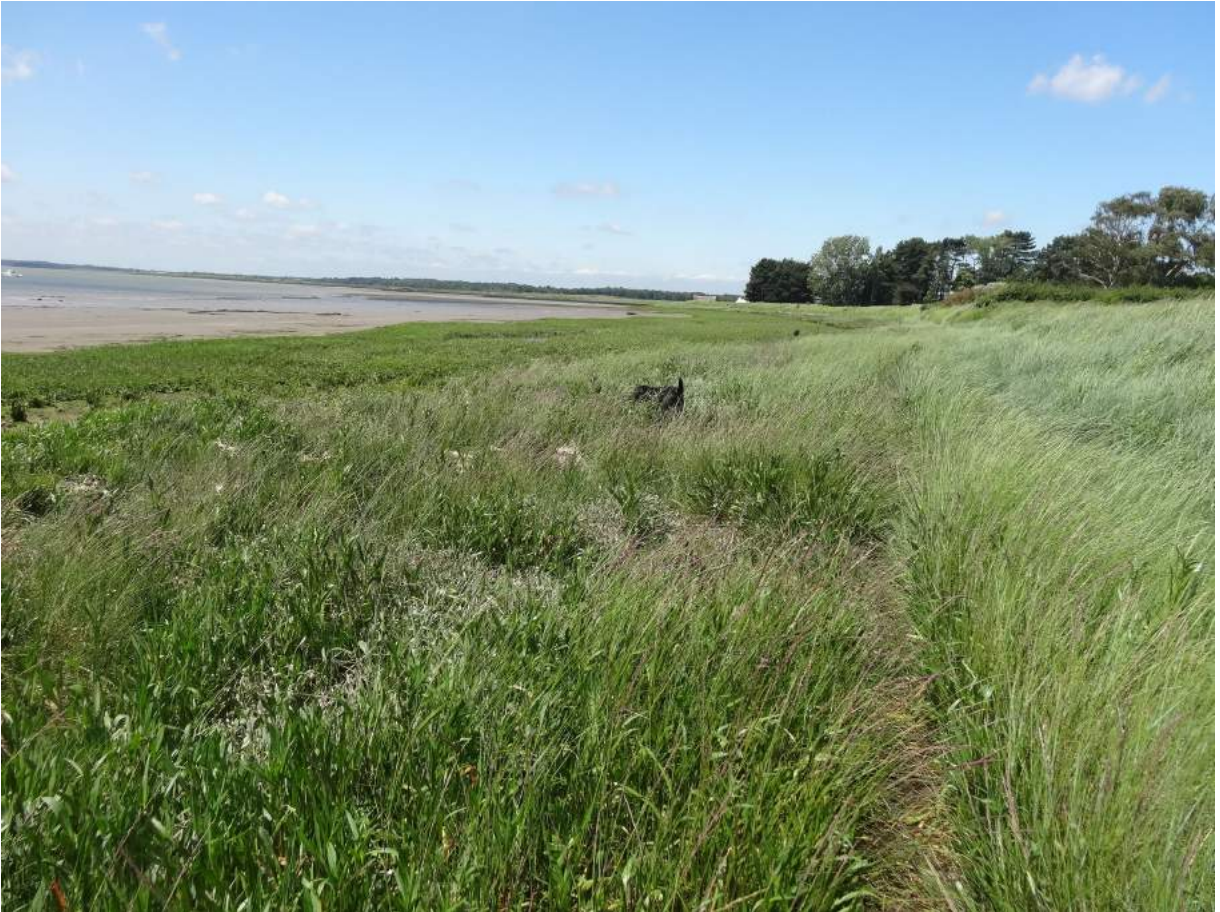
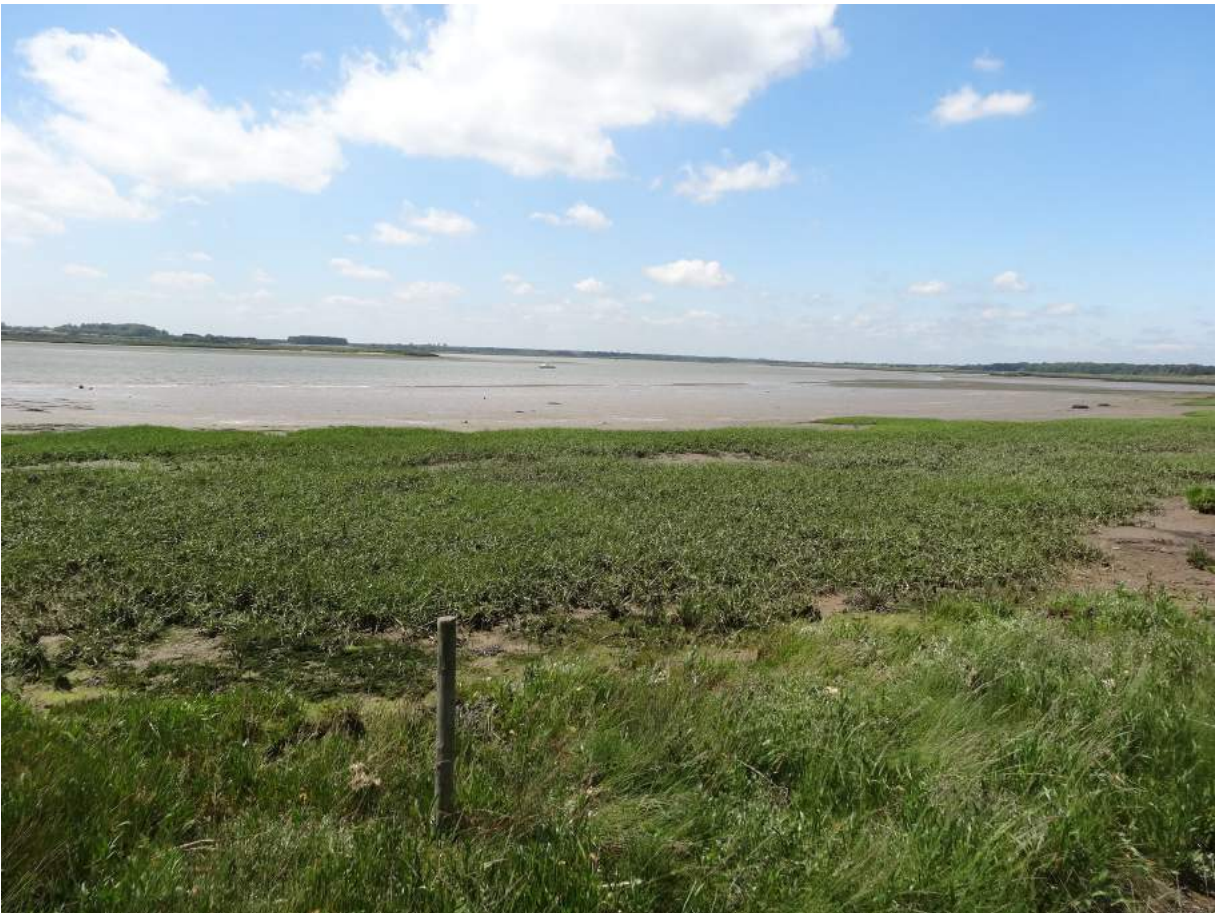
River Wall/Armour	Saltings	High Tide Debris Line
Wall behind the beach is sound with thick vegetation. Armour breaking up at the upstream end of Round House land. Getting worse.	Vegetation in sand suffering from tidal erosion on the beach. Further upstream, saltings are deep but covered during high tide.	Low level
