# THE ALDE & ORE ASSOCIATION

## ALDE AND ORE ESTUARY ASSESSORS REPORT

<b>NAMES:</b> South Section: Susan Bowerman Clare Goodchild.  North Section: Brian Johnson Jonathan Evans Richard Kihl	<b>DATE OF INSPECTION</b> South section 2 May 2019  North Section 24 April 2019
<b>LOCATION:</b> Flood Cell 1	<b>AREA OF ASSESSMENT:</b> Shingle Street to Butley Mills (Hollesey, Boyton & Butley Marshes)

## **FLOOD CELL 1 – SHINGLE STREET TO BUTLEY MILLS - SOUTH**

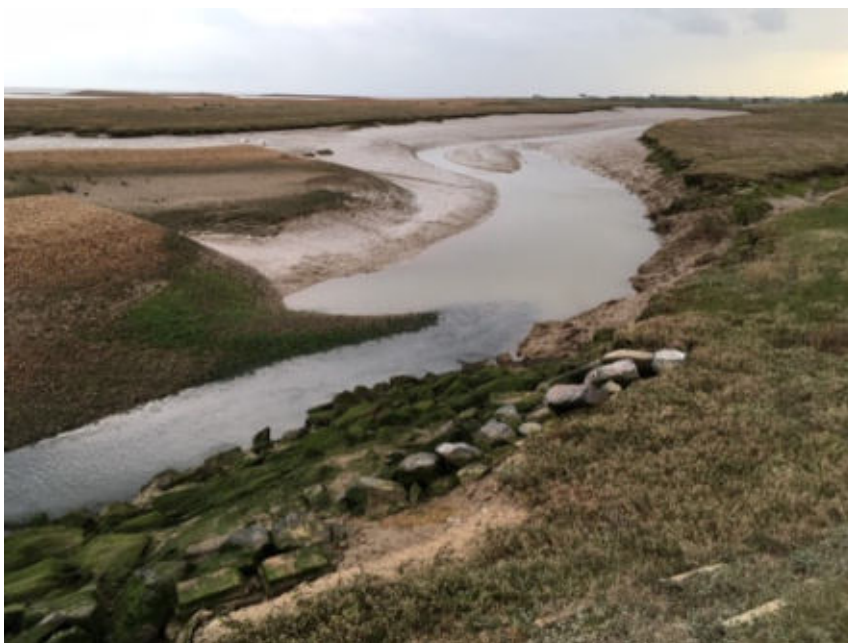
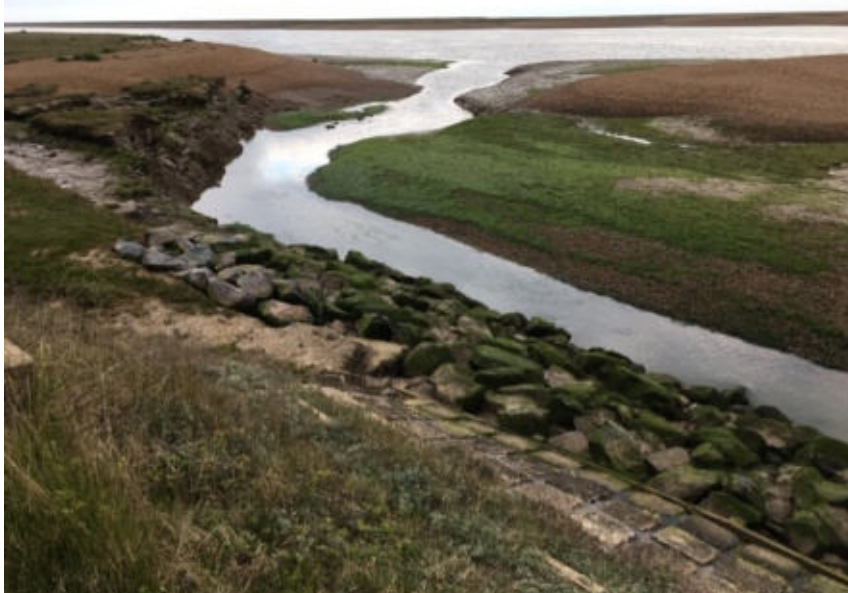
Mouth of Barthorp's Creek: The rock armouring remains intact with no damage to saltings at either side (see Photos 1 and 2).

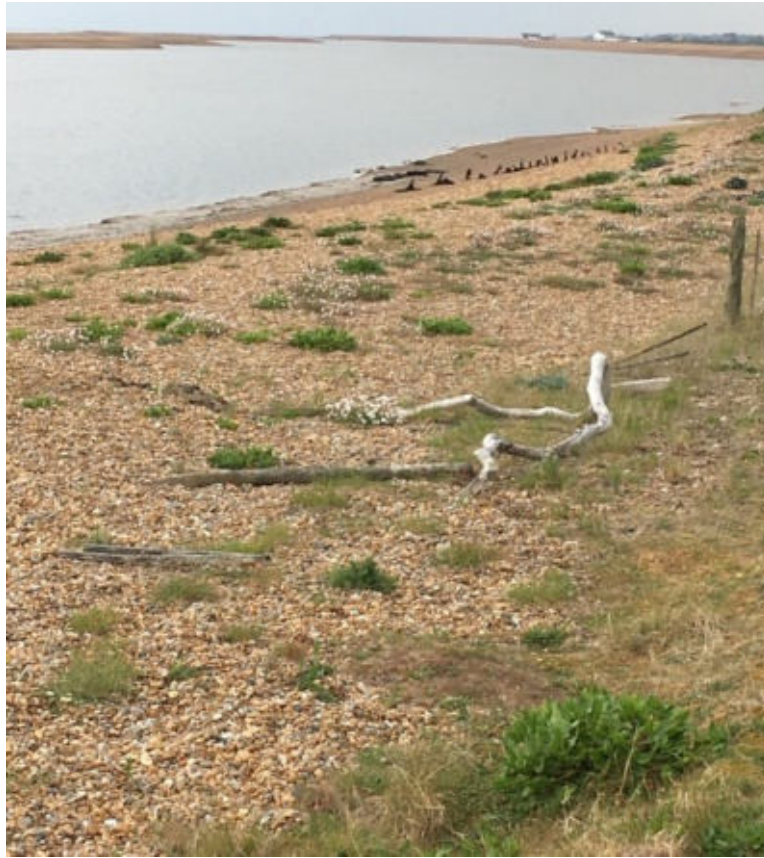
Photo 3

Simpson's Saltings: Fence along levee broken down in many places. Debris line not as high or as extensive as previous year (see Photo 3)

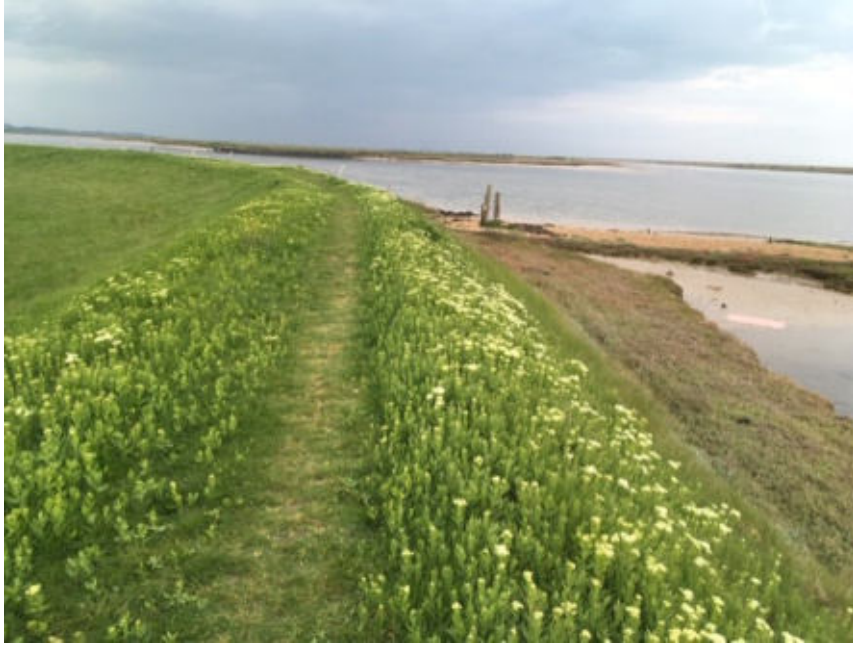
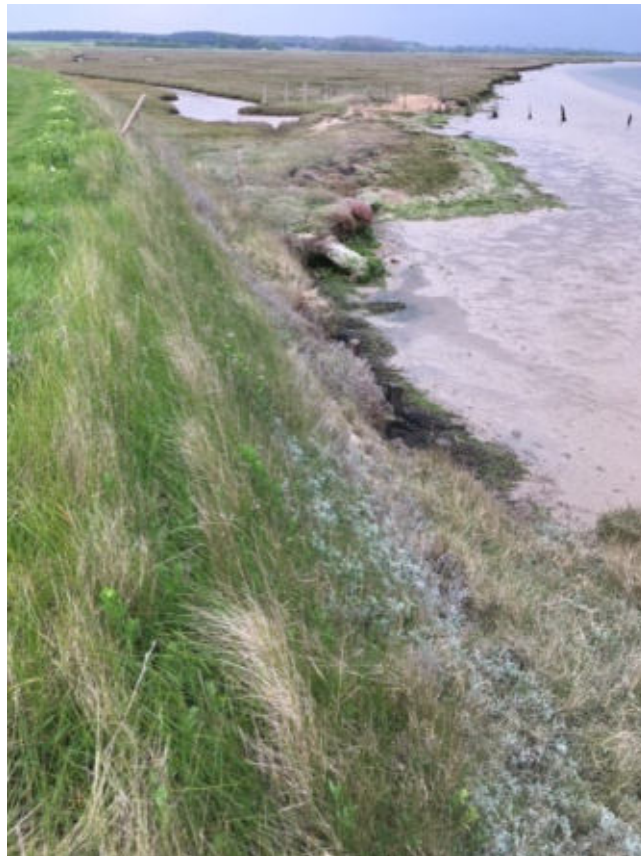
Photos 4 and 5

Flybury Point: Gate at north end of saltings still present, length of levee without saltings at bottom of levee under water every tide. Vulnerable area to watch (Photos 4 and 5), however, no significant rise in debris line.

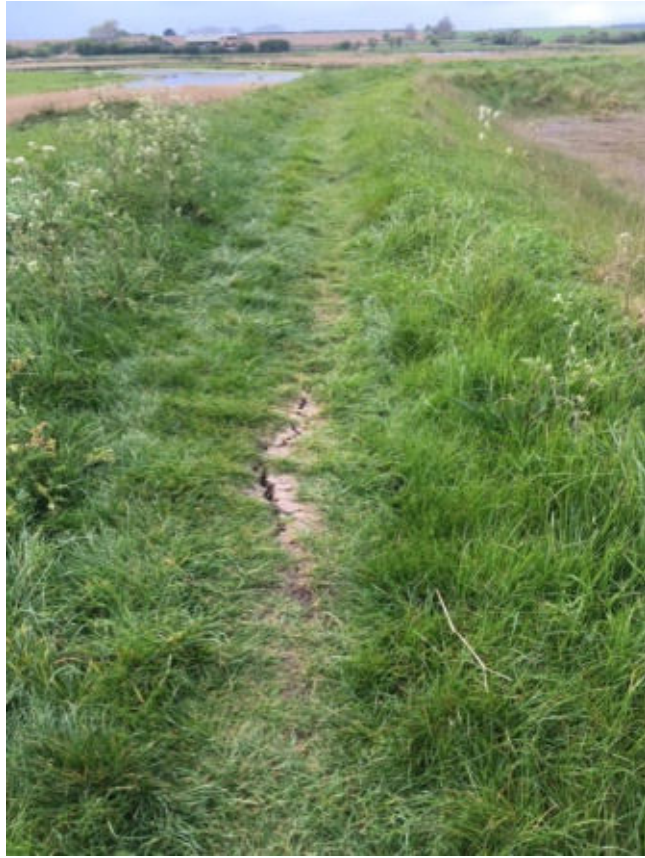
Photo 6

Chainage 4000 to Boyton Dock: Top of wall uneven with some cracking, and increased undergrowth due to lack of grazing (Photo 6)

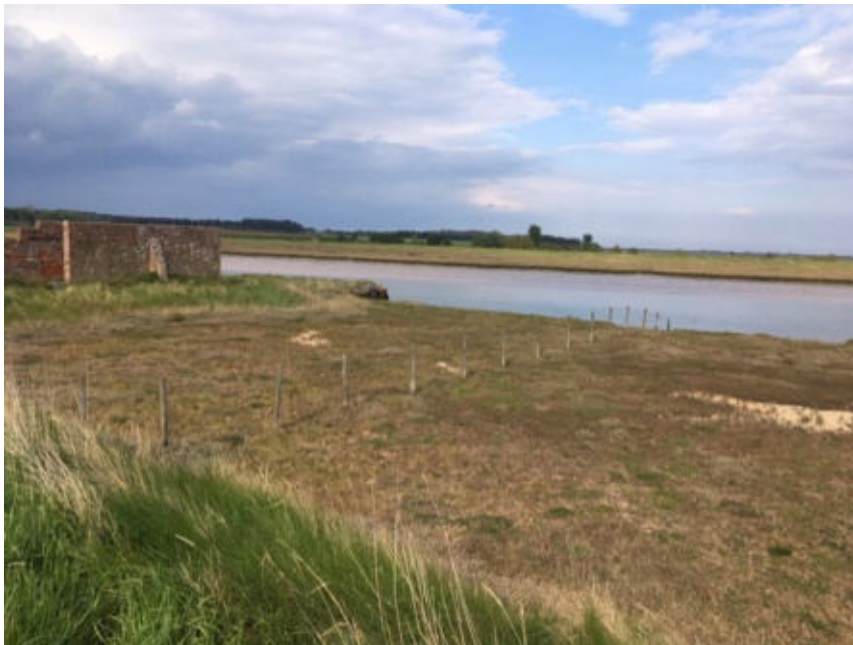
Photo 7

Boyton Dock: New fence, purpose unclear (Photo 7)

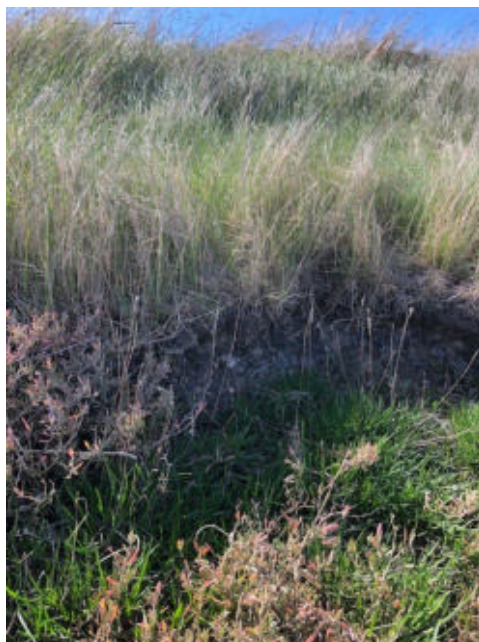
At 395497 no saltings and bottom of bank is undercut: this has been mentioned in previous reports and has led to some slumping on river side of levee (see photo).

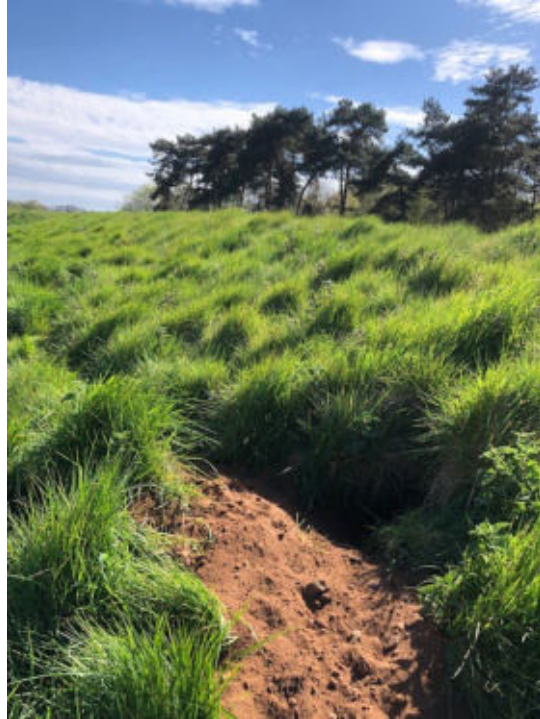
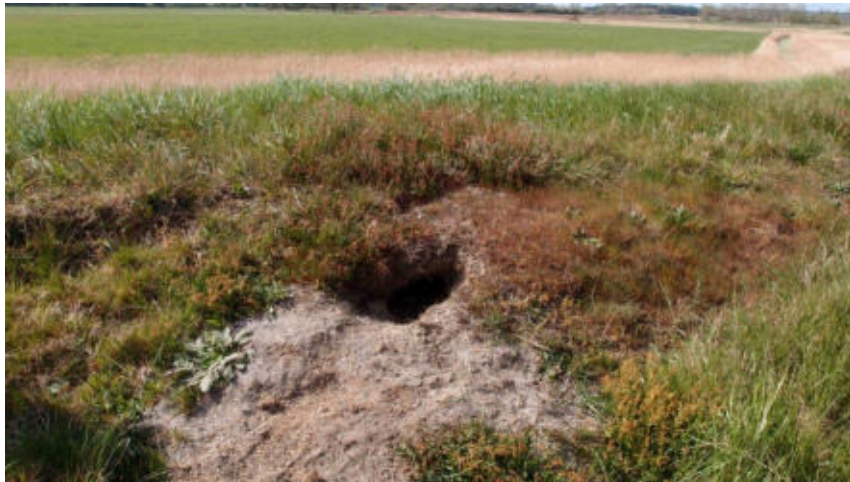
Badger hole 2

At chainage 9300 opposite Sparrow Hill Covert (see OS map) large badger sett towards top of east bank in current use (see photos).
