# THE ALDE & ORE ASSOCIATION

## ALDE AND ORE ESTUARY ASSESSORS REPORT

<b>NAMES:</b> Alison Andrews Roger Baxter Victoria Cozens Caron Hill	<b>DATE OF INSPECTION:</b>  16 April 2019
<b>LOCATION:</b>  Flood Cell 10 s	<b>AREA OF ASSESSMENT:</b>  Brick Dock to Martello Tower

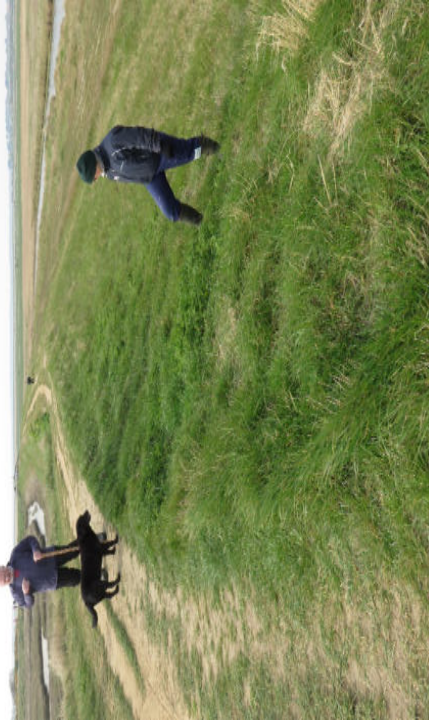
Possible arc of slippage in back of wall around TM460 557

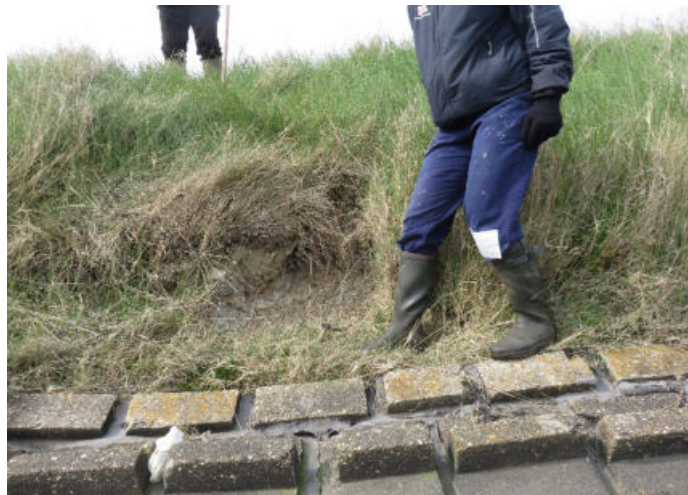
- i. Upper line of concrete 'bricks' (approx 8x15" each) appear to be slipping down with two bare patches (approx 2ft across) above, above tide but not storm wave line?

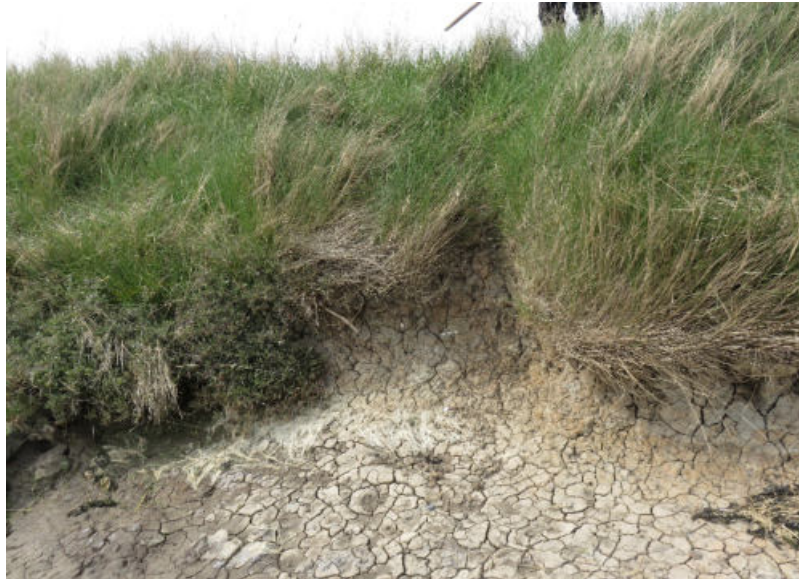
- ii. New erosion of clay bank 6-8ft to east of armorlok protection TM 459557

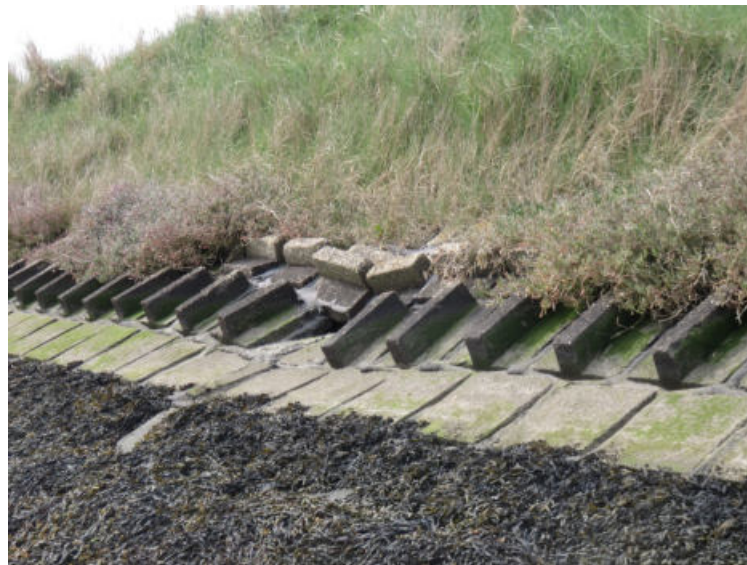
- iii. West of sluice outlet, two patches of concrete blocks caving in with erosion of clay from behind (photo) one with hollow behind TM 458557

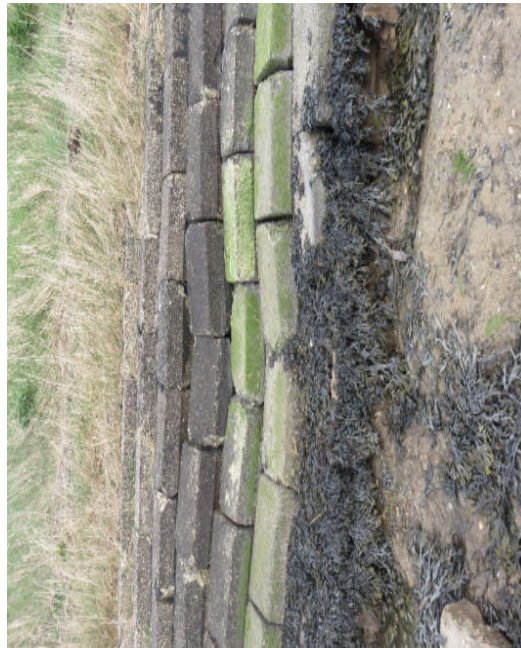
- vii. Brick Dock Steps to Jetty TM 450565 to 449568 over 50 year stretch now every 10 yards or so slippage of odd concrete blocks in the protective wall.

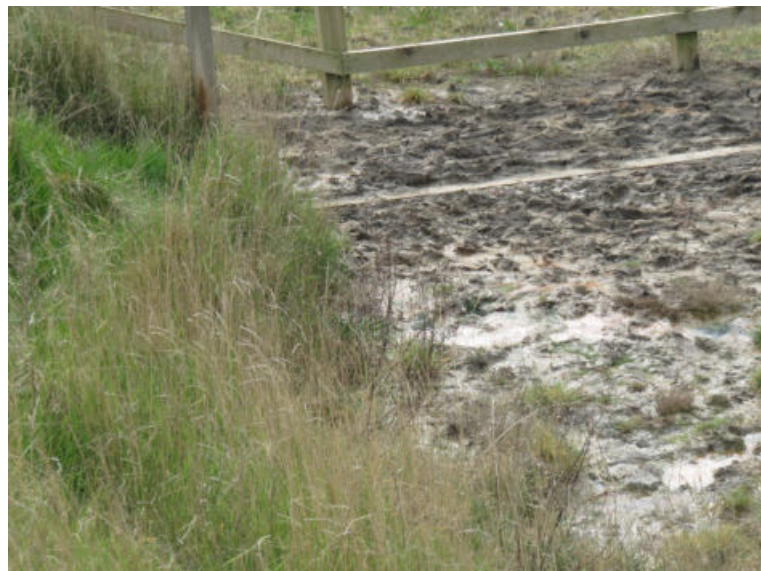
- i. Slaughden Road to steps (TM464556-459558) becoming ever more worn, very muddy and slippery in winter months. Between road and steps 12 2ft long 6” deep pits in path, including at the lowest point around TM460557 which is already a foot or more lower than the rest of the wall has been worn down a little more (the water came over here in 2013 surge).  
(Gate missing lock catch - to tell SCC ROW Dept)
- ii. Steps down from TM 456556 to path below, just at start of newly repaired river wall - very mushy/muddy despite no rain for several weeks - seepage?

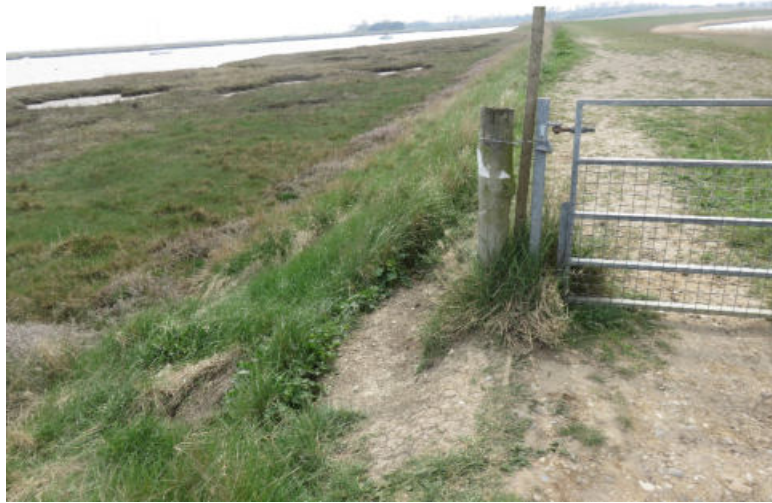
- iii. Fence by gate to new river wall does not stop people passing on the river side and making wall edge front bare.

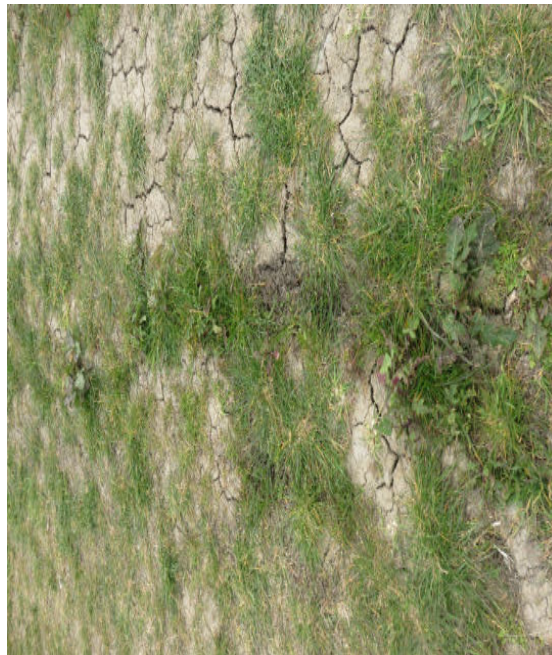
- iv. Newly repaired wall stretch - grass has not been able to establish except patchily, also very dry.
- v. At various points bare front edge to newly repaired wall, just the odd foot in patches.
- vi. On new wall, 20 yards of track with central line gap, with narrow crack 8" deep in places, slippage?

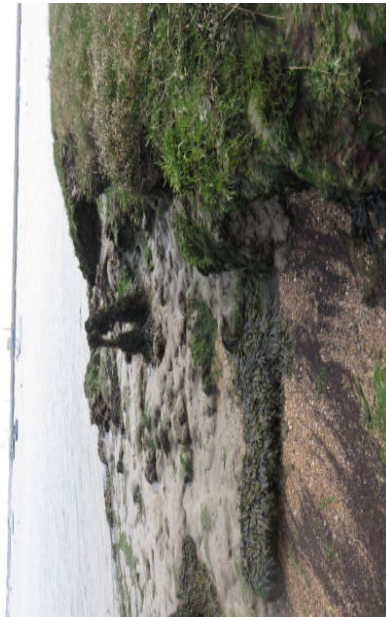
- ii. Salt marsh cliff edge just west of Aldeburgh Sluice - more broken off this year. TM 458557.

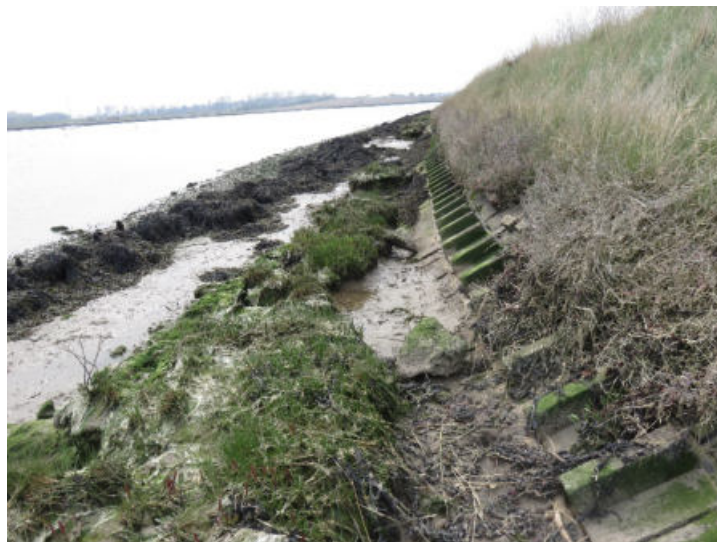
- iii. Inlet near Sailing West Row Buoy TM457556, more erosion of salting bank with mud at cliff edge not vegetation and some collapse of a chunk of salting
- iv. Salting degradation along front of new river wall at RM454554 - what there was (only a foot wide or so) has mostly lost its vegetation but wall is protected by concrete armour at base behind the saltings.

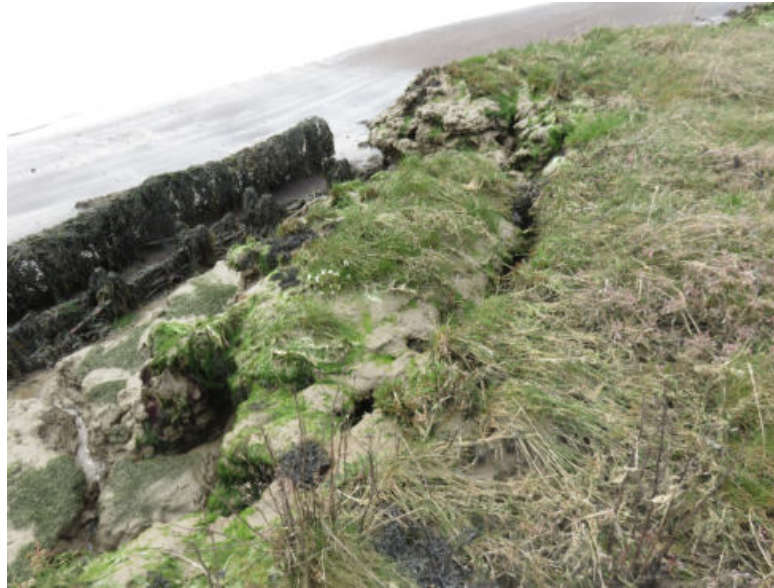
- v. Saltings pilot project - in most cases (5 sites) the hazel bundles behind the tensor fencing plastic has disappeared. Not clear how much protection the tensor offers - needs monitoring by AOEP.

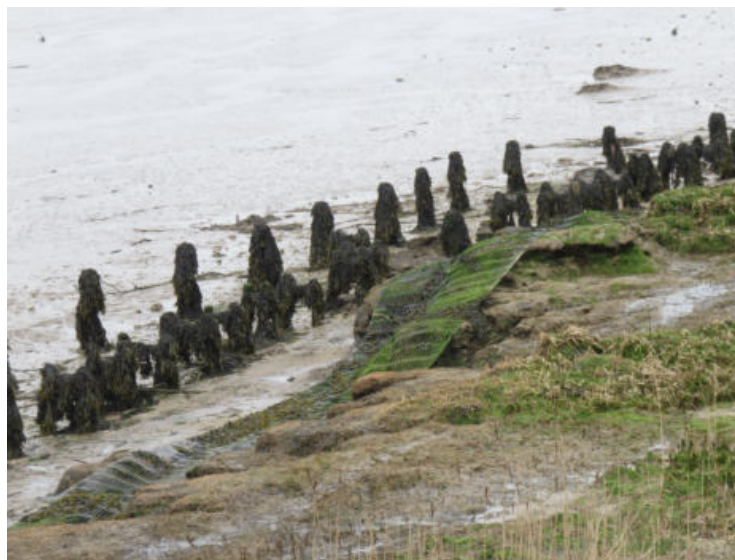
- vi. Saltings fronting much of the whole stretch - showing signs of loss of vegetation at edge, instead bare, slippery hard mud and some partly covered by algae. This appears to be worse than last year. Advice on monitoring needed.
- vii. Pilot within Brick Dock Curve, TM447564 to TM 449565, some tensor stretches have been washed away and plastic removed. On what is left a 76 yard and 30 yard stretch could be reattached at either end (AOEP to deal).

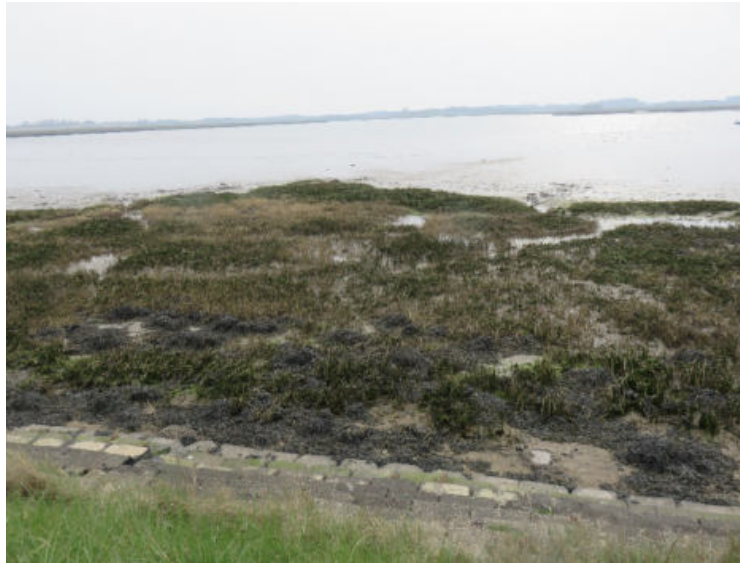
viii. Near Brick Dock jetty, TM 458569, reeds covered in algae, not looking very healthy!
