ALDE AND ORE ESTUARY ASSESSORS REPORT

NAME: Roger Baxter Michael Hazeldene Jane Salter	DATE OF INSPECTION: 27 May 2019
LOCATION: Flood Cell 2	AREA OF ASSESSMENT: Butley Mills

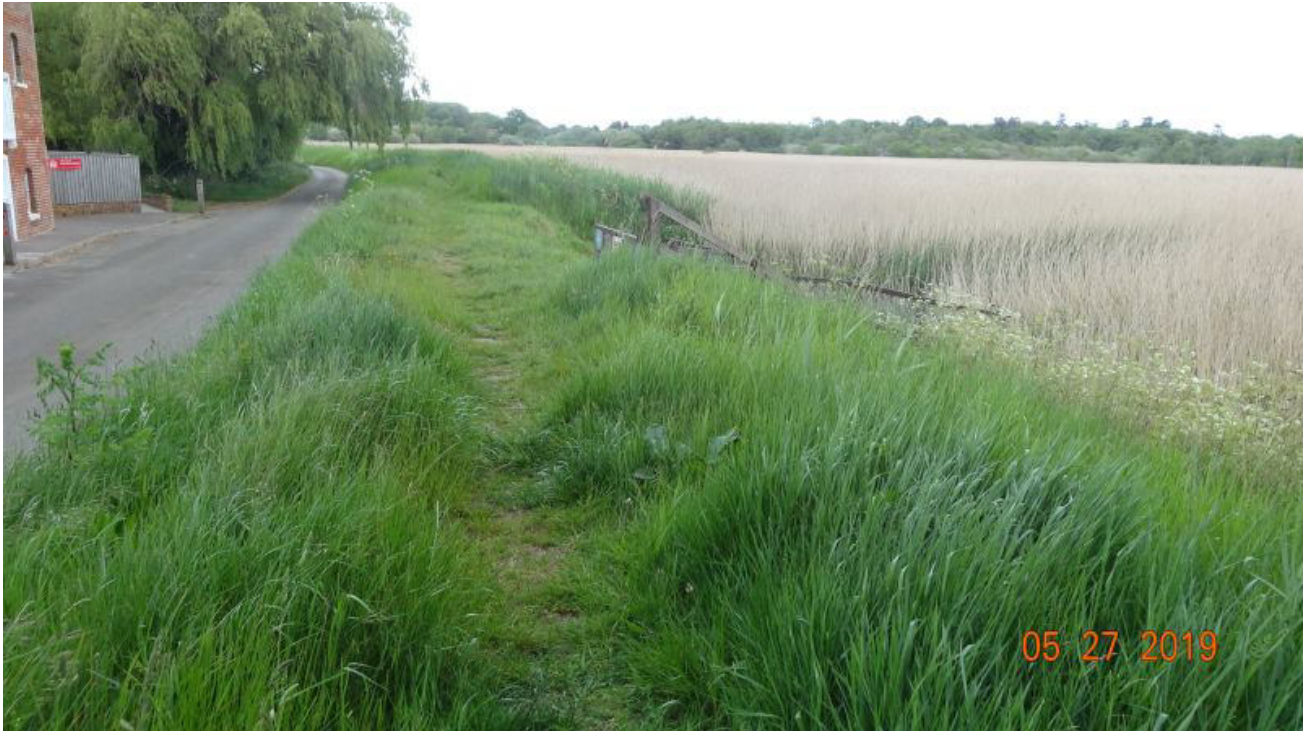
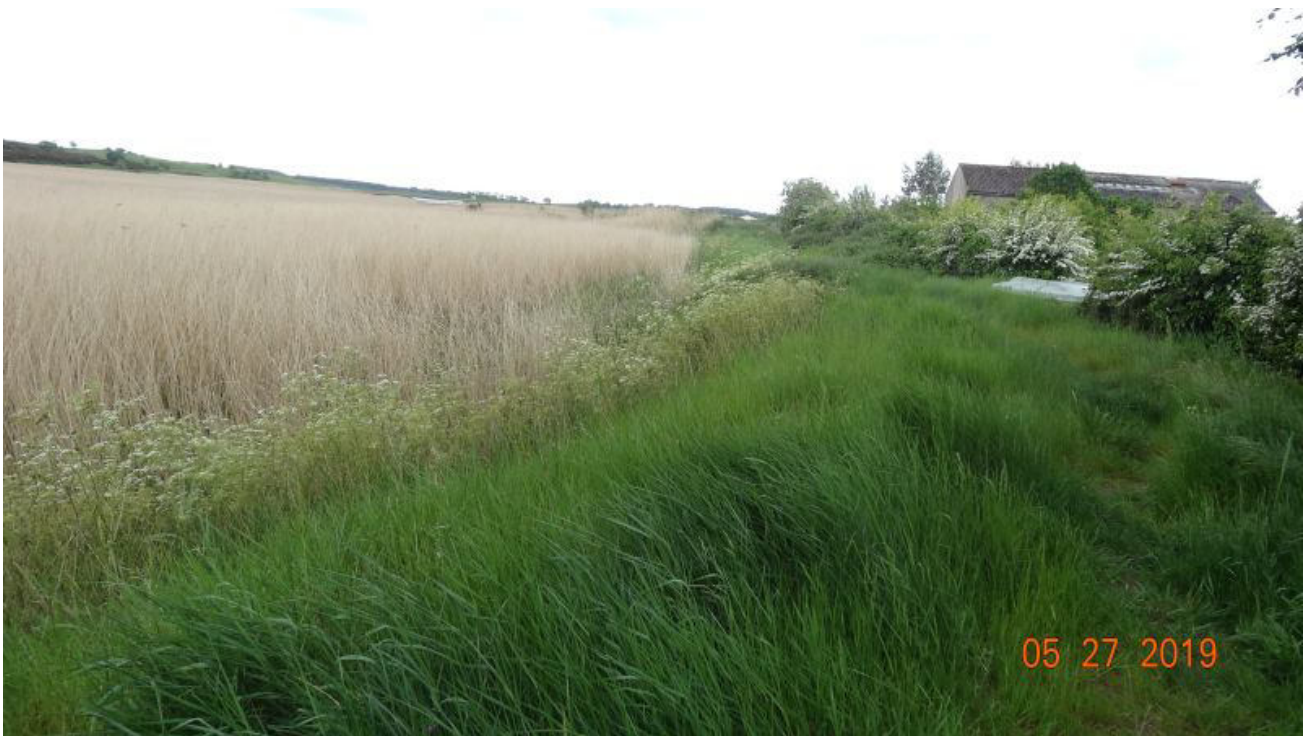
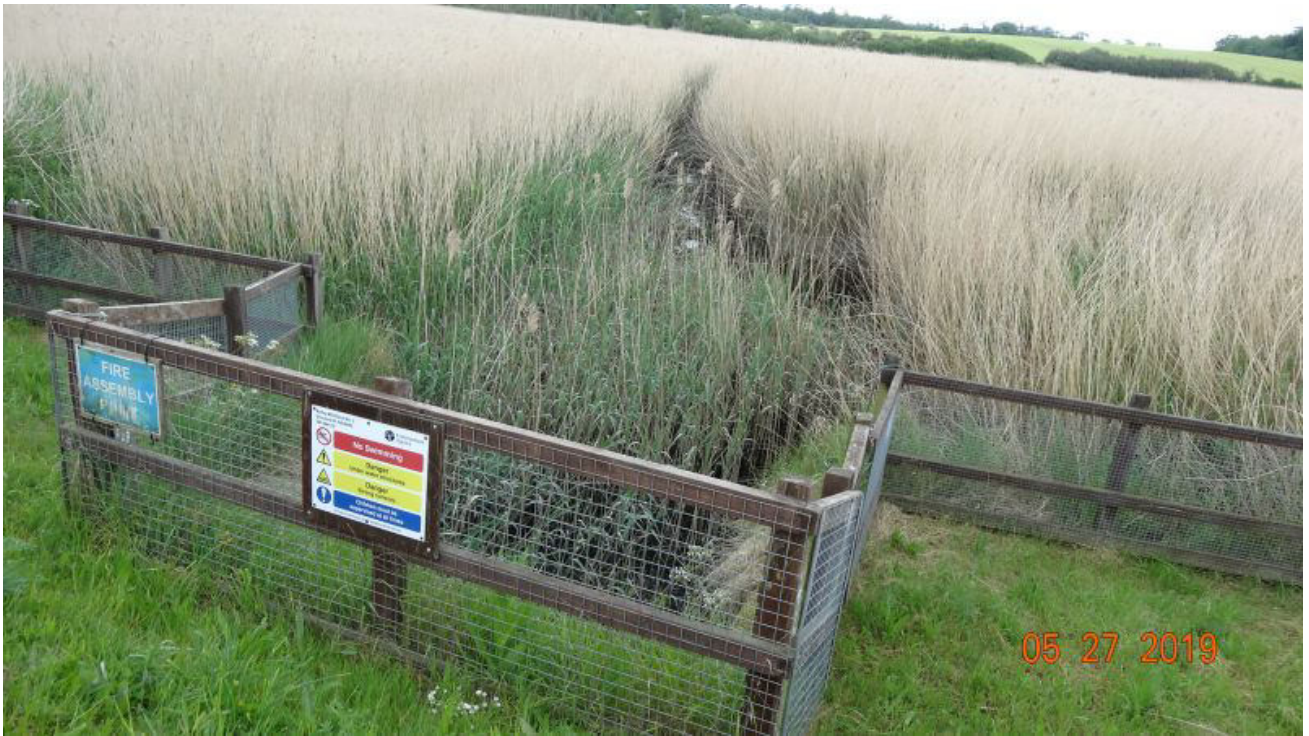
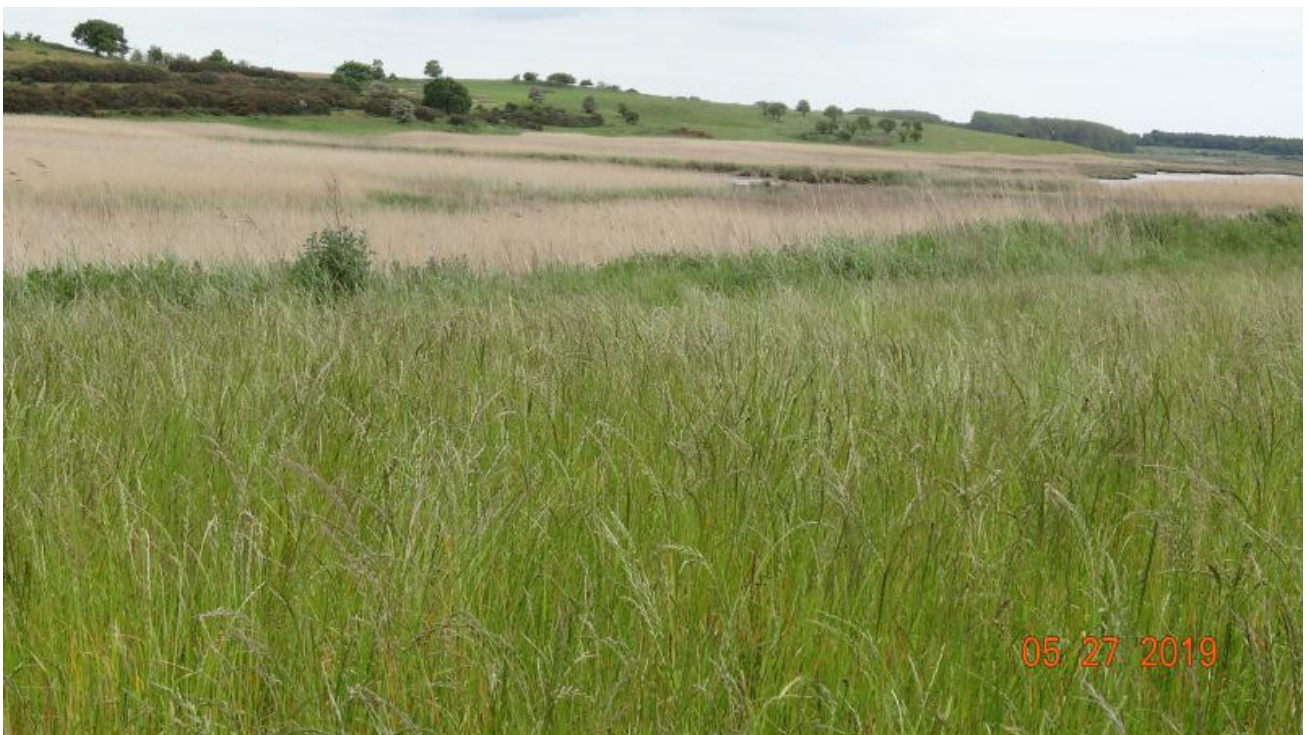
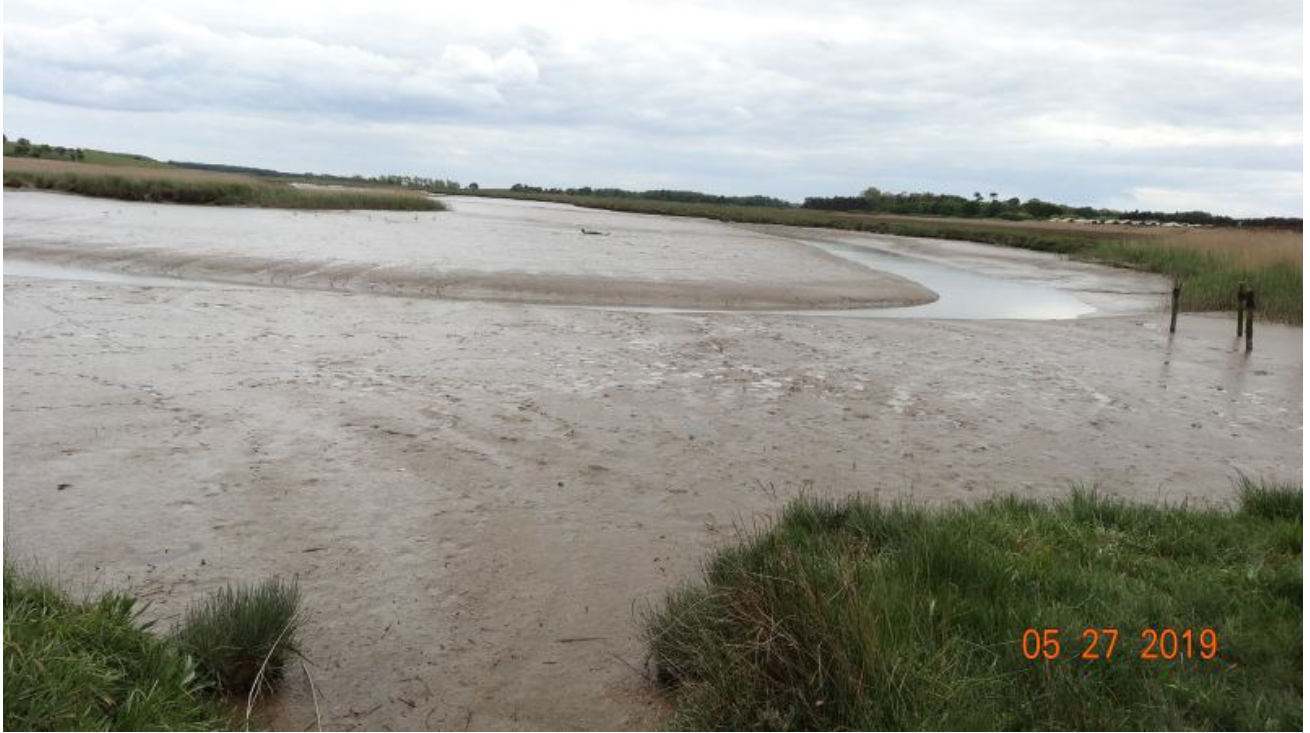
A solid wall separates the road from the saltings. A mill stream on one side flows underneath and drains through two controllable sluices into the marsh and onto the river.

The wall is in good condition with good vegetation and thick grass. This is cut annually in September.

The saltings/marsh is deep and flat down to the Butley River channel.
