ALDE AND ORE ESTUARY ASSESSORS REPORT

NAMES: Frances Barnwell Susie Bridges	DATE OF INSPECTION: 6 May 2019
LOCATION: Flood Cell 4.2	AREA OF ASSESSMENT: Chantry Marshes to Orford Quay

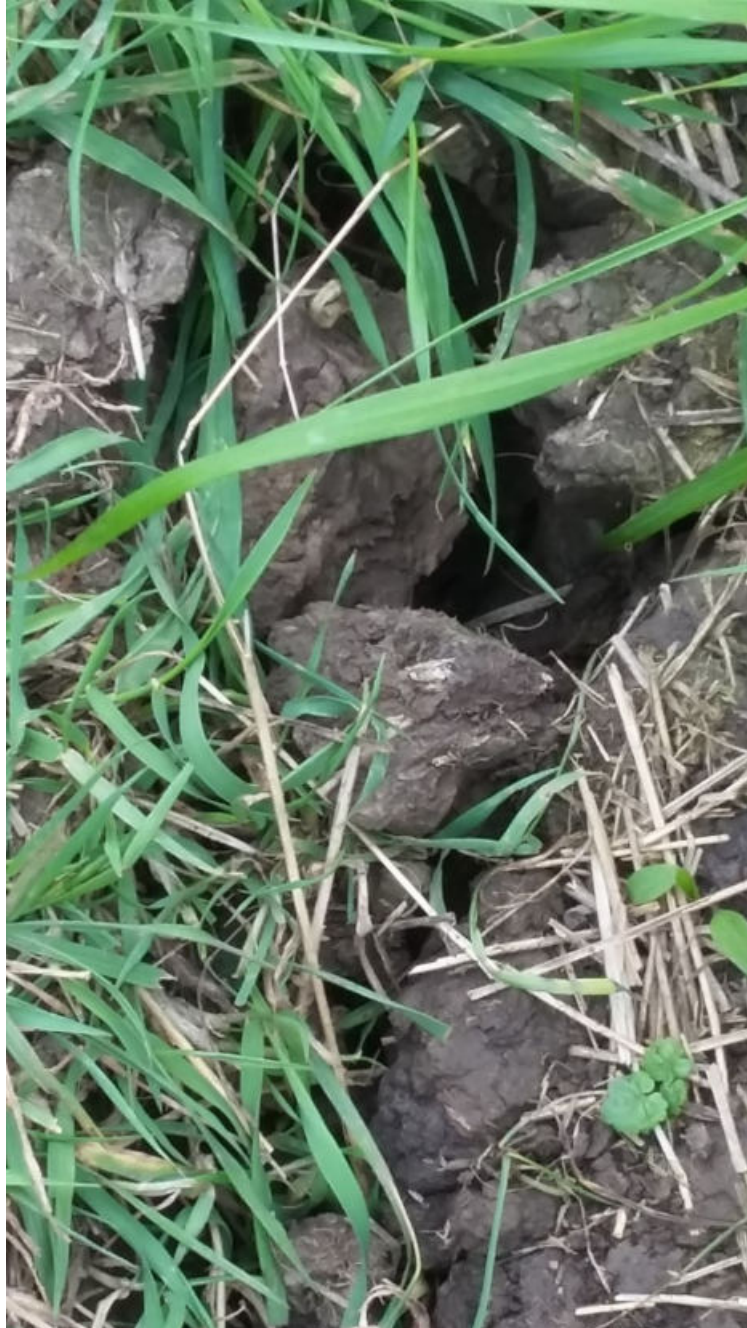
As with all FC4.2 reports, the key concern is the continuing deterioration of the top surface. In the dry weather preceding the survey, cracks had opened up in the exposed areas of mud as shown in the photographs below.

Photo 1 – Cracking in side of wall by sewage outlet

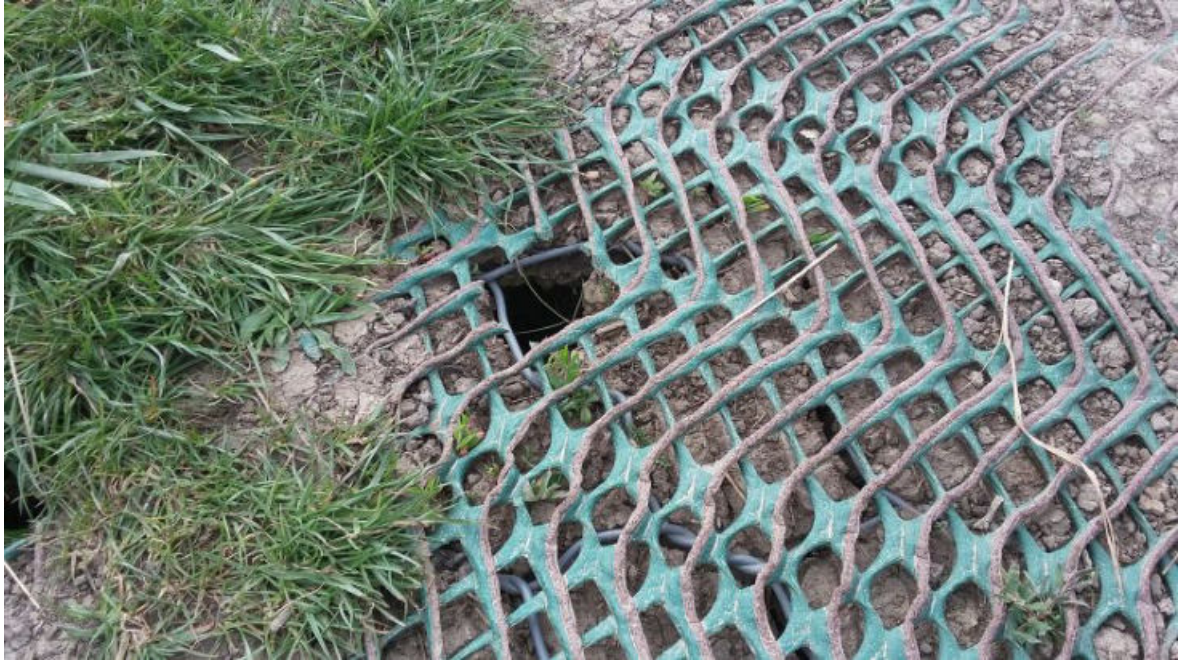
Photo 2 – Erosion under netting

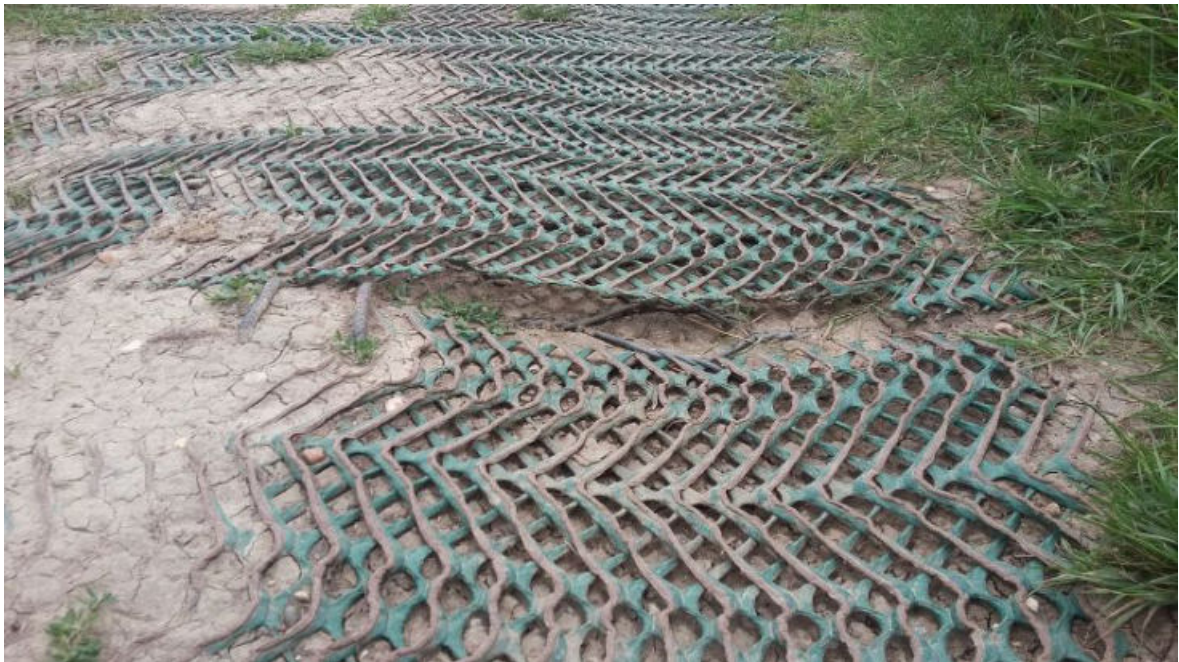
The netting has lifted creating a significant trip risk as shown on the photograph. It is not clear who is responsible for repair of this section (between the sewage outlet and stile).

Photo 3 – Tripping Hazard

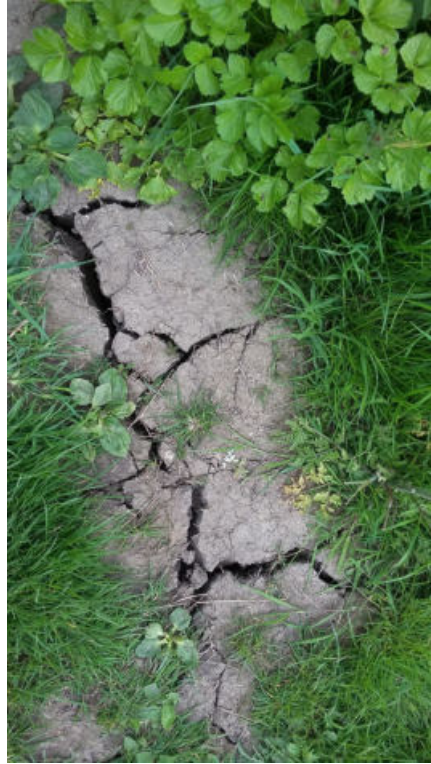
Photo 4 – Cracking on path
[a feature through the length of the survey]

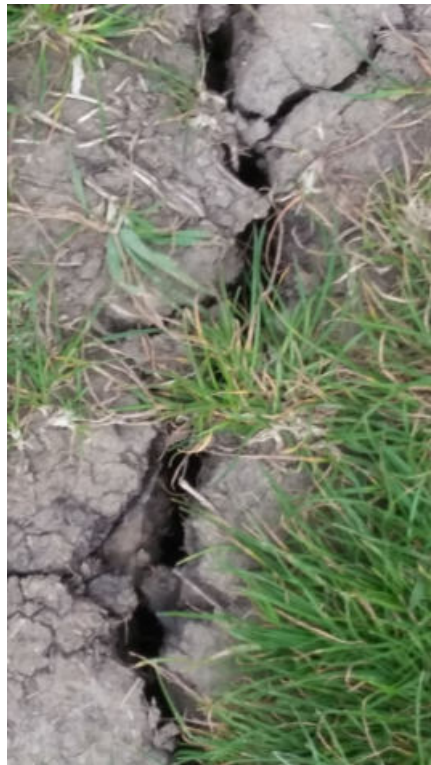
Photo 5 – Cracking on path
