THE ALDE & ORE ASSOCIATION

ALDE AND ORE ESTUARY ASSESSORS REPORT

NAME: Simon Reid Sue Ingham	DATE OF INSPECTION: 5 May 2019
LOCATION: Flood Cell 4.3	AREA OF ASSESSMENT: Pump House to Orford Quay

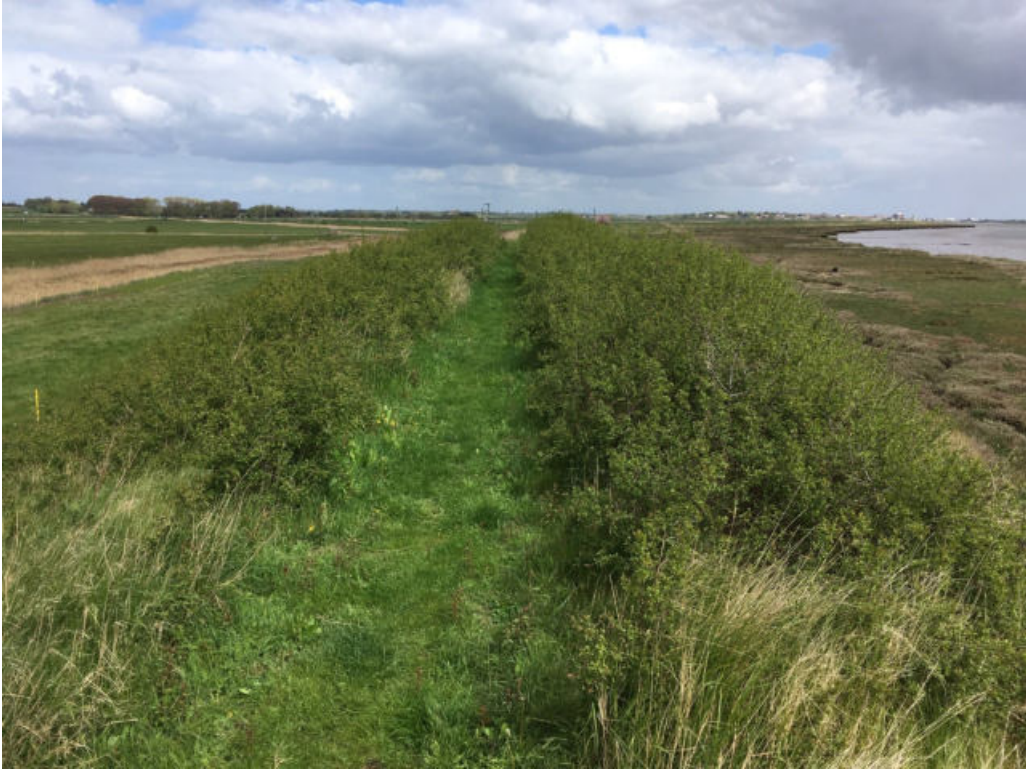
Hedges still growing [435 535]

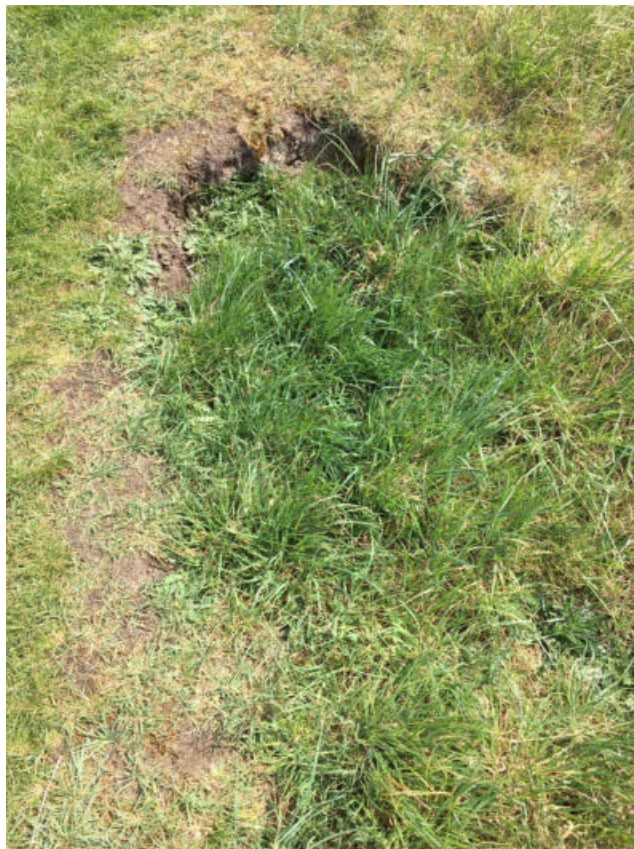
Vertical hole less noticeable [450 525]

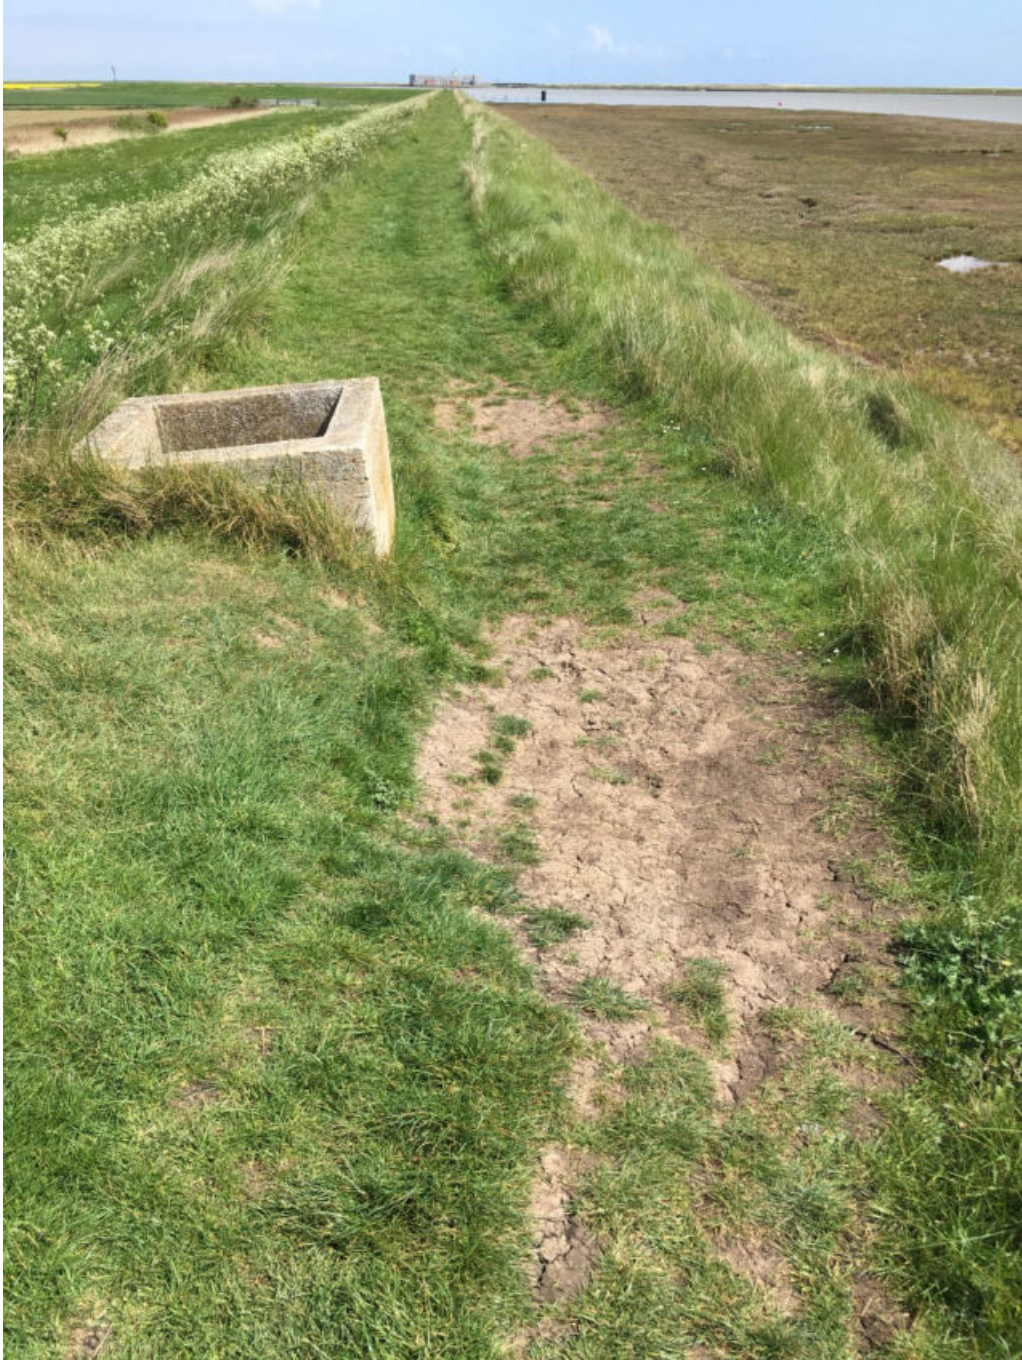
Dip in wall getting bigger [437 500]
