THE ALDE & ORE ASSOCIATION

ALDE AND ORE ESTUARY ASSESSORS REPORT

NAMES: Victoria Cozens Caron Hill	DATE OF INSPECTION: May 2019
LOCATION: Flood Cell 6 & 7	AREA OF ASSESSMENT: FC6 South bank from tidal sluice to end of Maltings defences at TM393573 FC7 North bank from tidal sluice to rising ground at TM401576

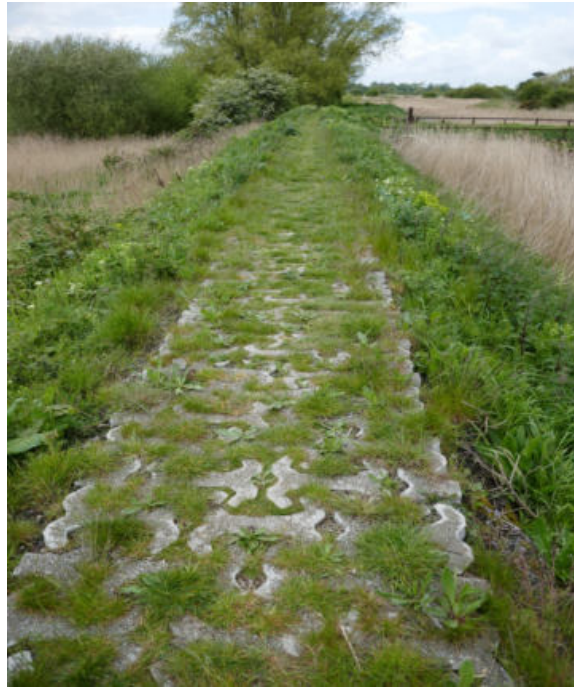
Photo 1

1. No apparent problems with the path/reed beds south west of the Maltings.
2. South bank of Snape Bridge – evidence of subsidence of the concrete capping with little vegetation growth for approx 5yds (TM391395/TM391675).

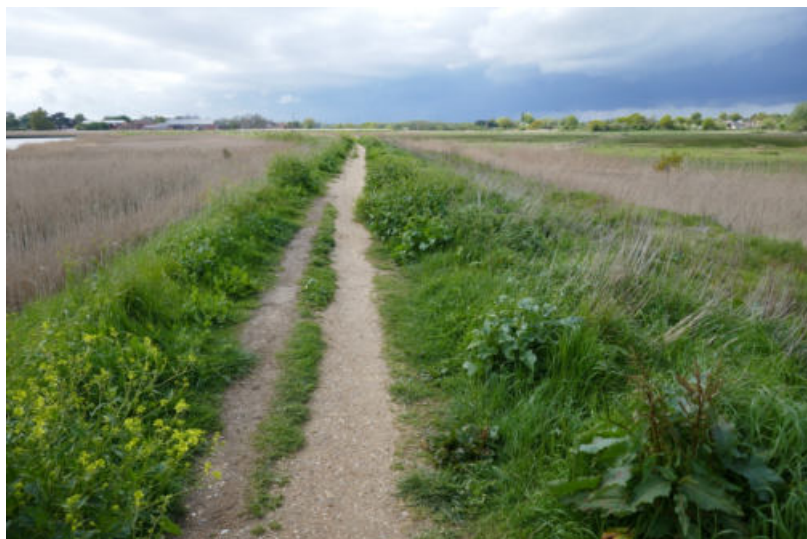
Photo 2

1. There is no change to the area of slippage between Snape Bridge and Blackheath sluice.
2. The bank north of the river is not very steep (TM396615).
3. The path slopes north towards the drain, with a shallow bank (TM396725).

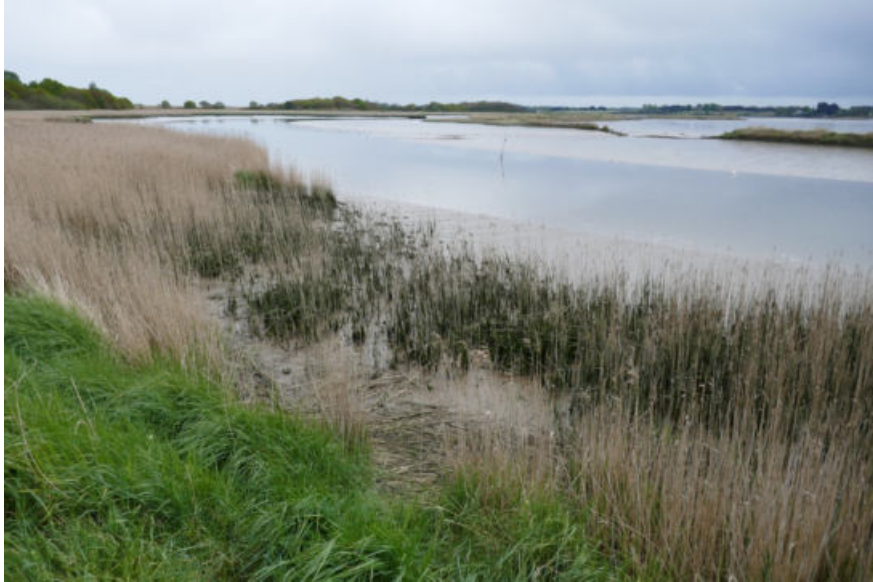
Photo 3

4. Erosion of reed beds for approx 18yds (TM397205).

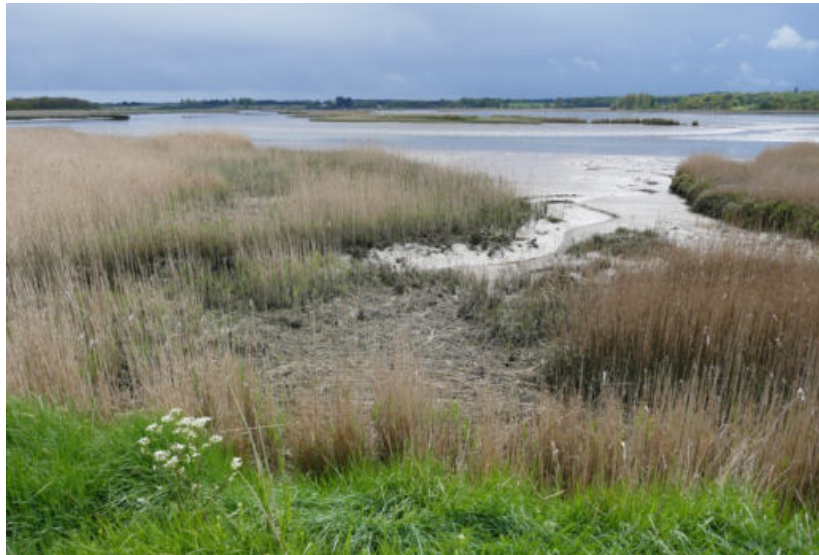
Photo 4

5. Area of reed bed gone, approx 12yds (TM400255)

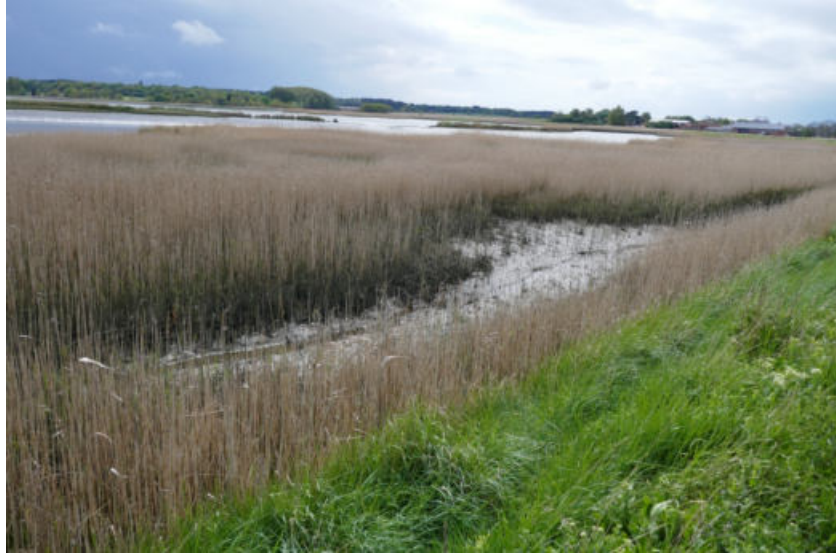
Photo 5

6. At this point (TM400255) and towards The Warren, the reed beds are reduced, with a 'channel' of no reeds behind the path and reed bed, for approx 100yds. (photo taken east to west).
