ALDE AND ORE ESTUARY ASSESSORS REPORT

NAMES:	Roger Baxter Jonathan Evans Richard Kihl Jeremy Nice	DATE OF INSPECTION:	14 May 2019
LOCATION:	Flood Cell 8	AREA OF ASSESSMENT:	Ham Creek

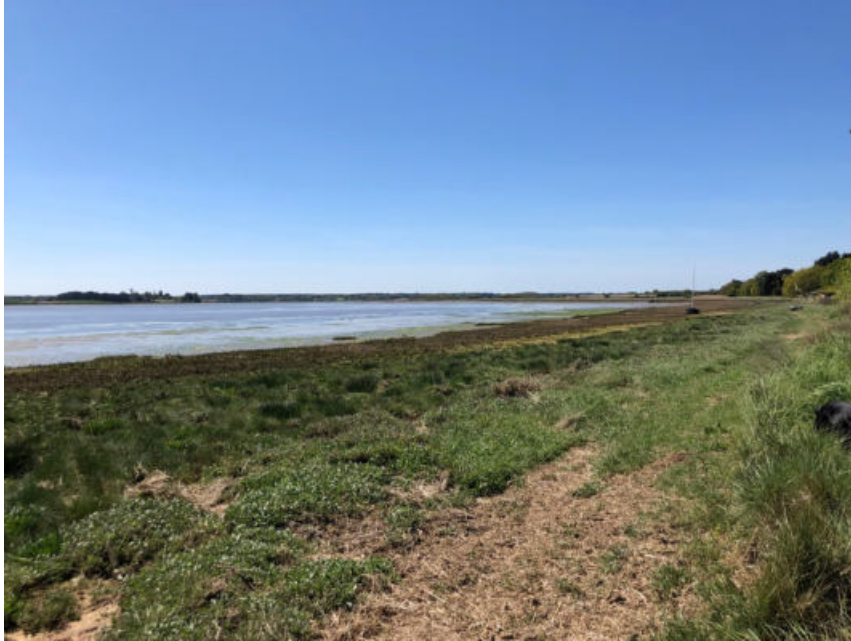
Upstream stretch has wide saltings with a beach and sand cliff behind. Debris here is at a low level with no risk of flooding.

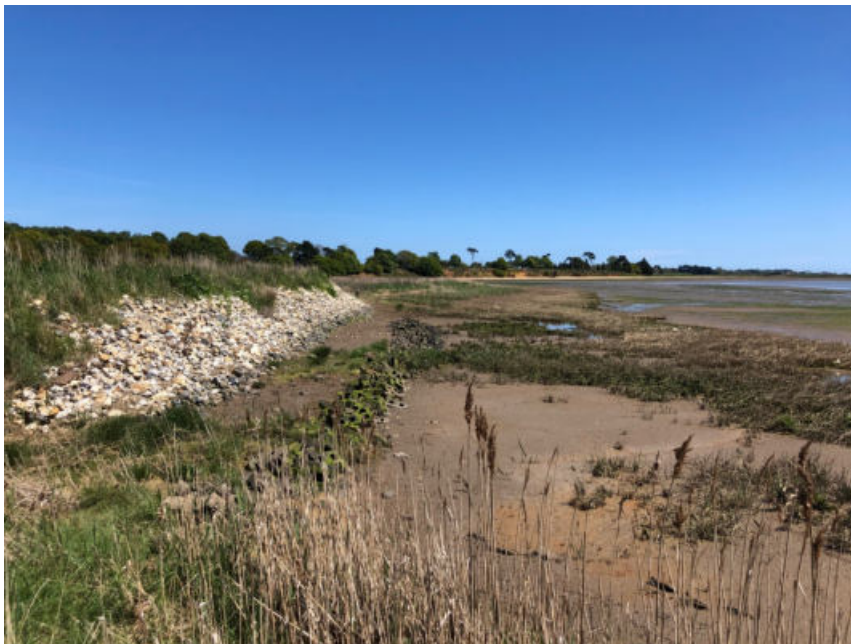
At Ham Creek the wall down to the sluice has been repaired with flint stone which is holding well.

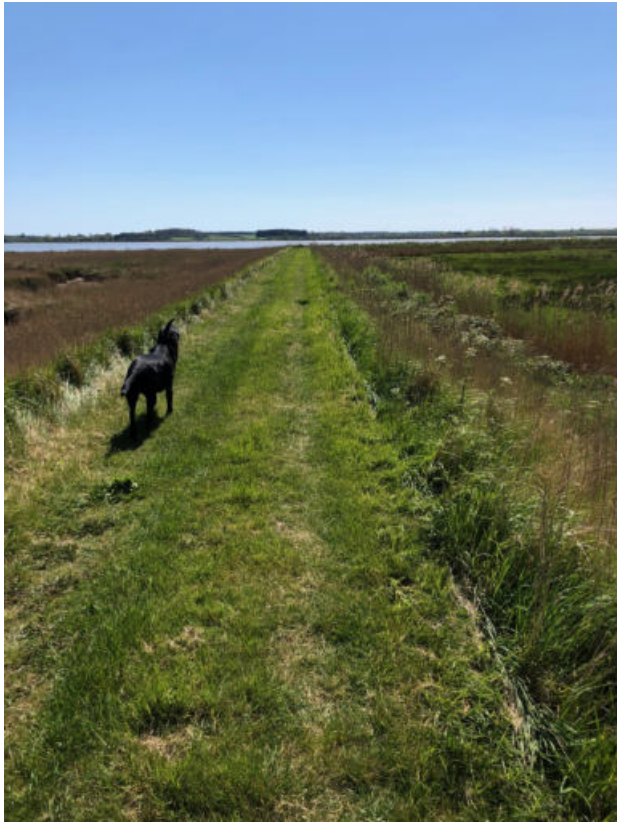
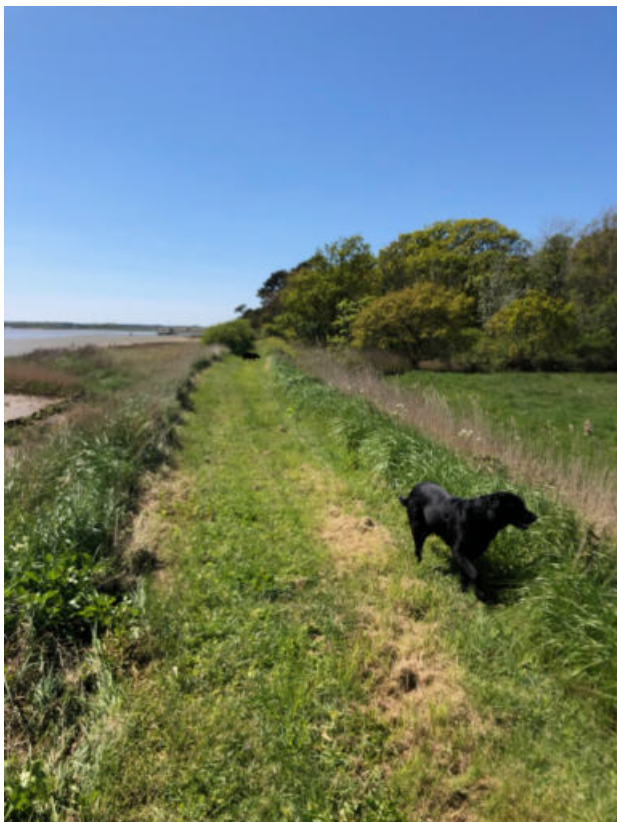
There are plans to raise the wall to 3.5m. However, the wall is in good shape, apart from the top slopes to the back. There is good vegetation and the wall profile is fine.
