# THE ALDE & ORE ASSOCIATION

## ALDE AND ORE ESTUARY ASSESSORS REPORT

<b>NAME:</b> Roger Baxter	<b>DATE OF INSPECTION:</b> April 2019
<b>LOCATION:</b> Flood Cell 9	<b>AREA OF ASSESSMENT:</b> Brick Dock

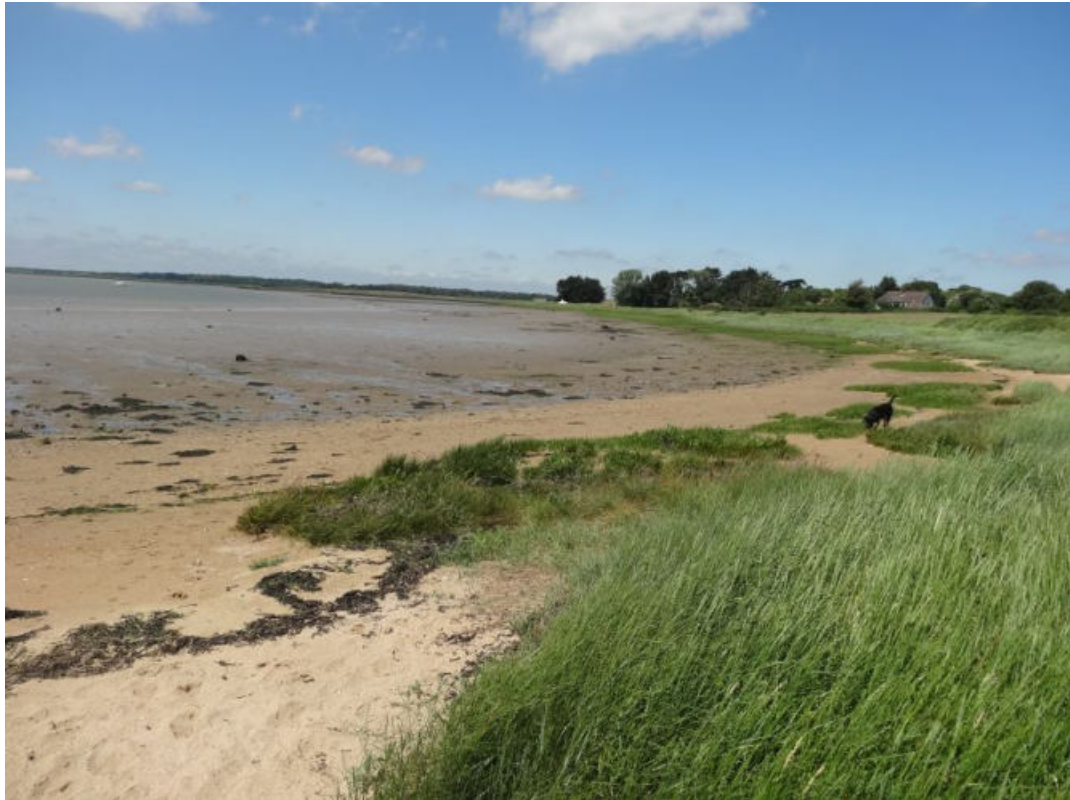
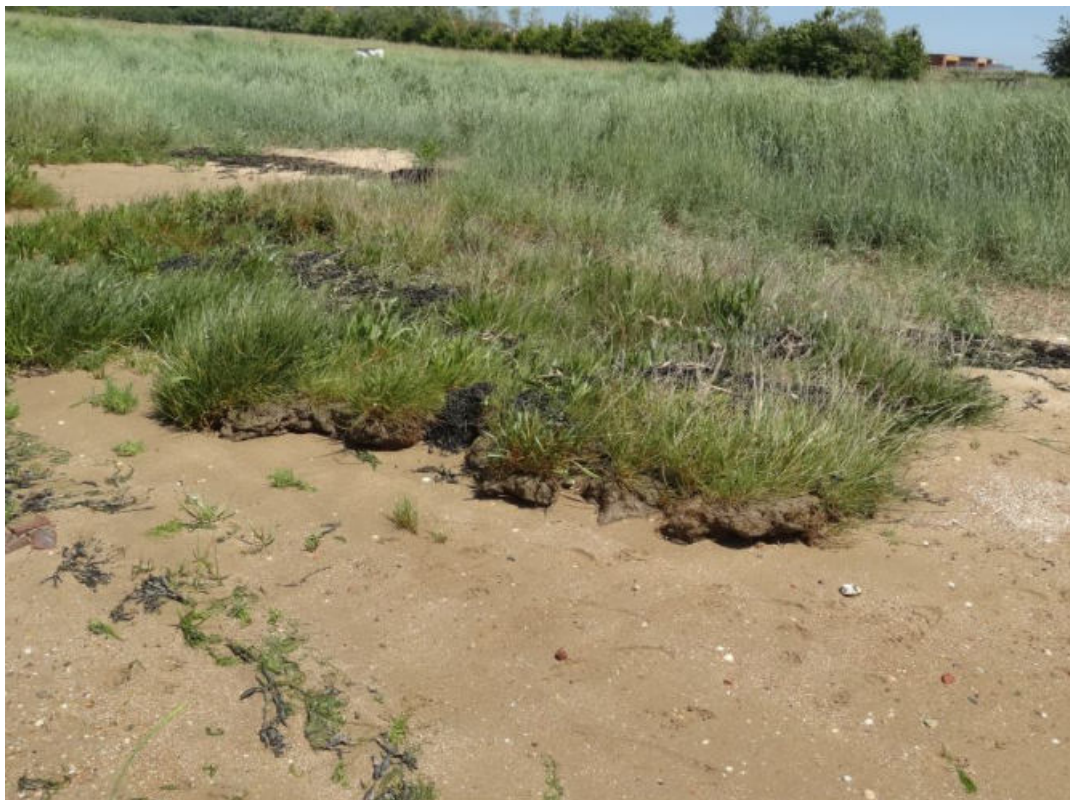
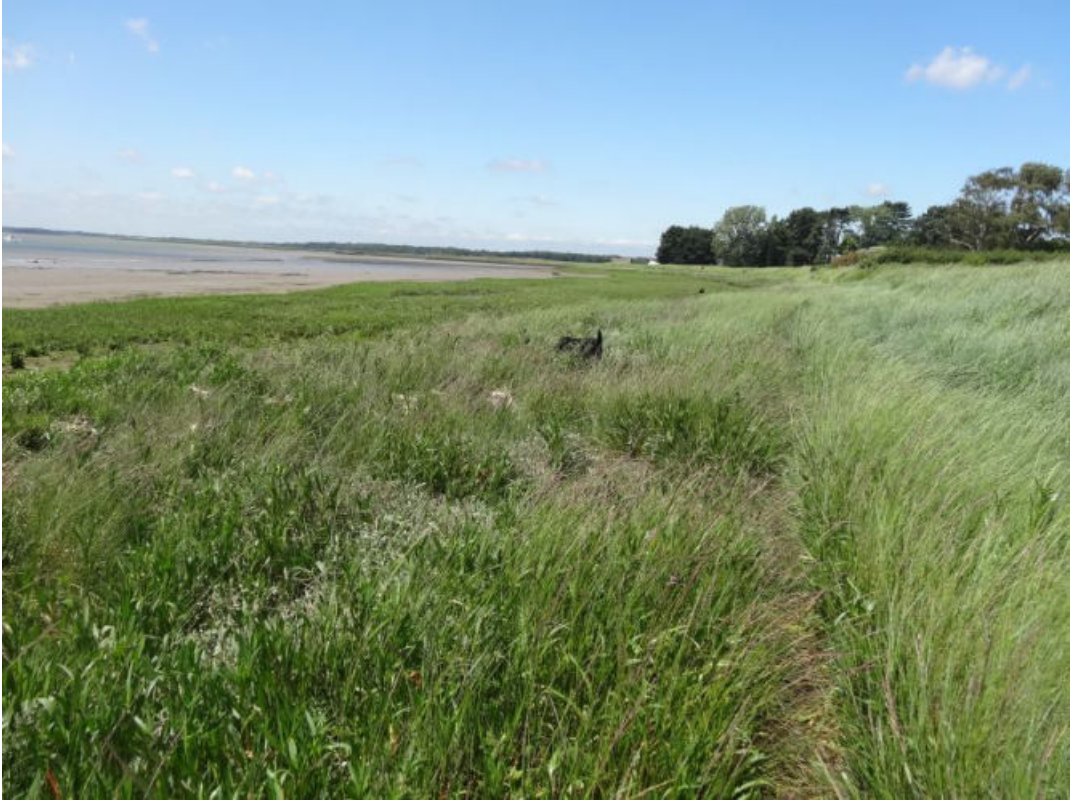
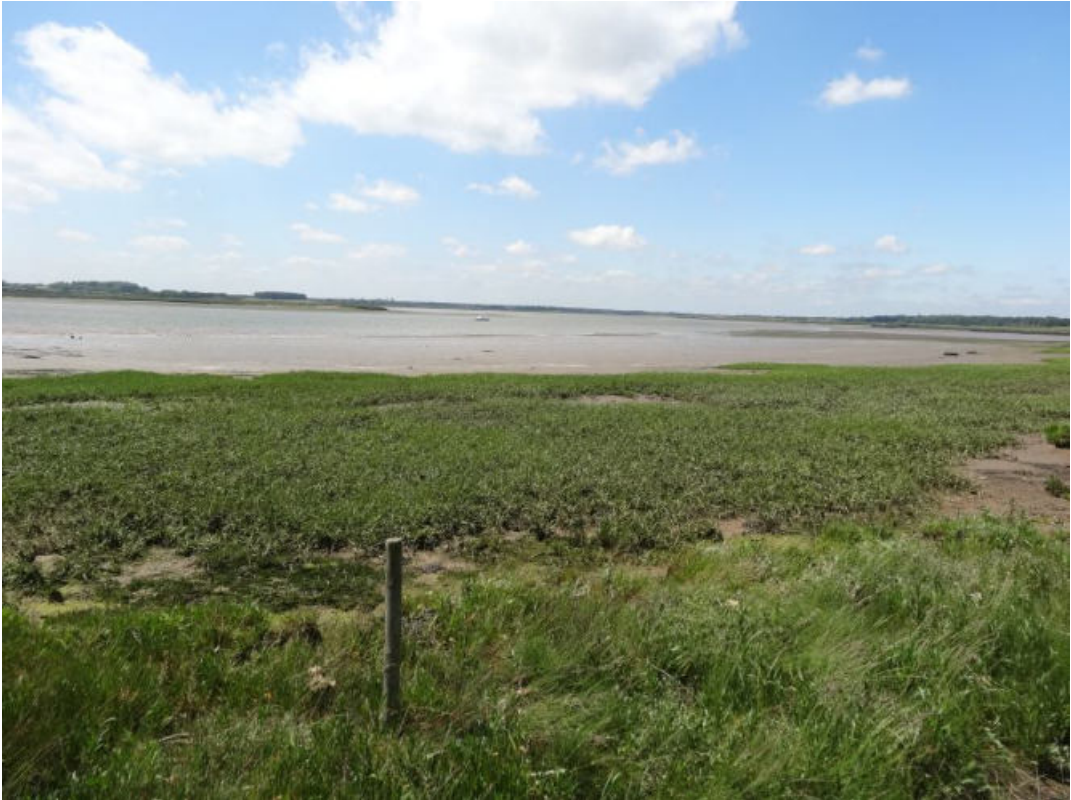
There was little change this year over 2018. The beach rises into a well vegetated wall, behind which is a meadow with no risk of flooding.

The saltings are wide and are submerged at high tide. The river wall is robust with rising ground behind.

(Library photos below illustrate conditions).
