THE ALDE & ORE ASSOCIATION

ALDE AND ORE ESTUARY ASSESSORS REPORT

NAMES: B and J Johnson	DATES OF INSPECTION: 1. 22 May 2020 2. 12 th June 2020
FLOOD CELL: FC1	AREA OF ASSESSMENT: 1. Shingle Street pump house north to chainage 2500 2. Boyton Dock south to chainage 2500

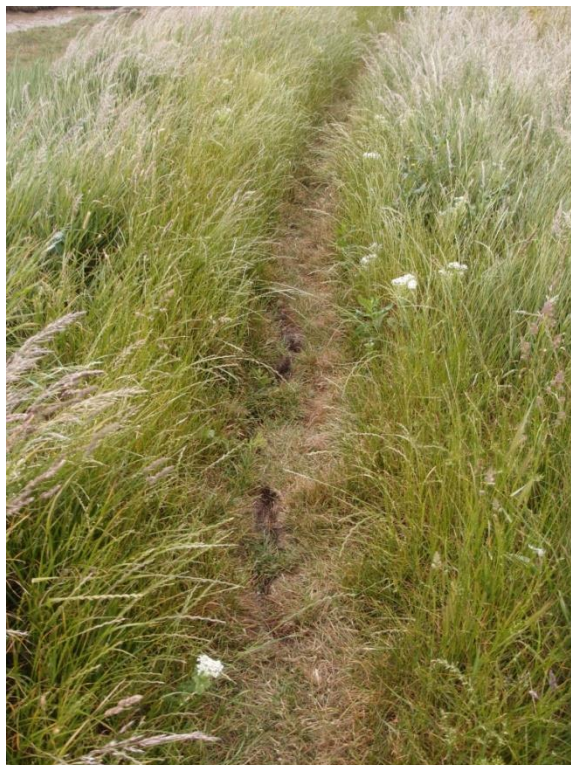
Photo1

Timber surround and dock walls at Boyton Dock in reasonable condition. Serious cracking for 500 metres south of Boyton Dock (Photo 1). This cracking will presumably infill following autumn rains?

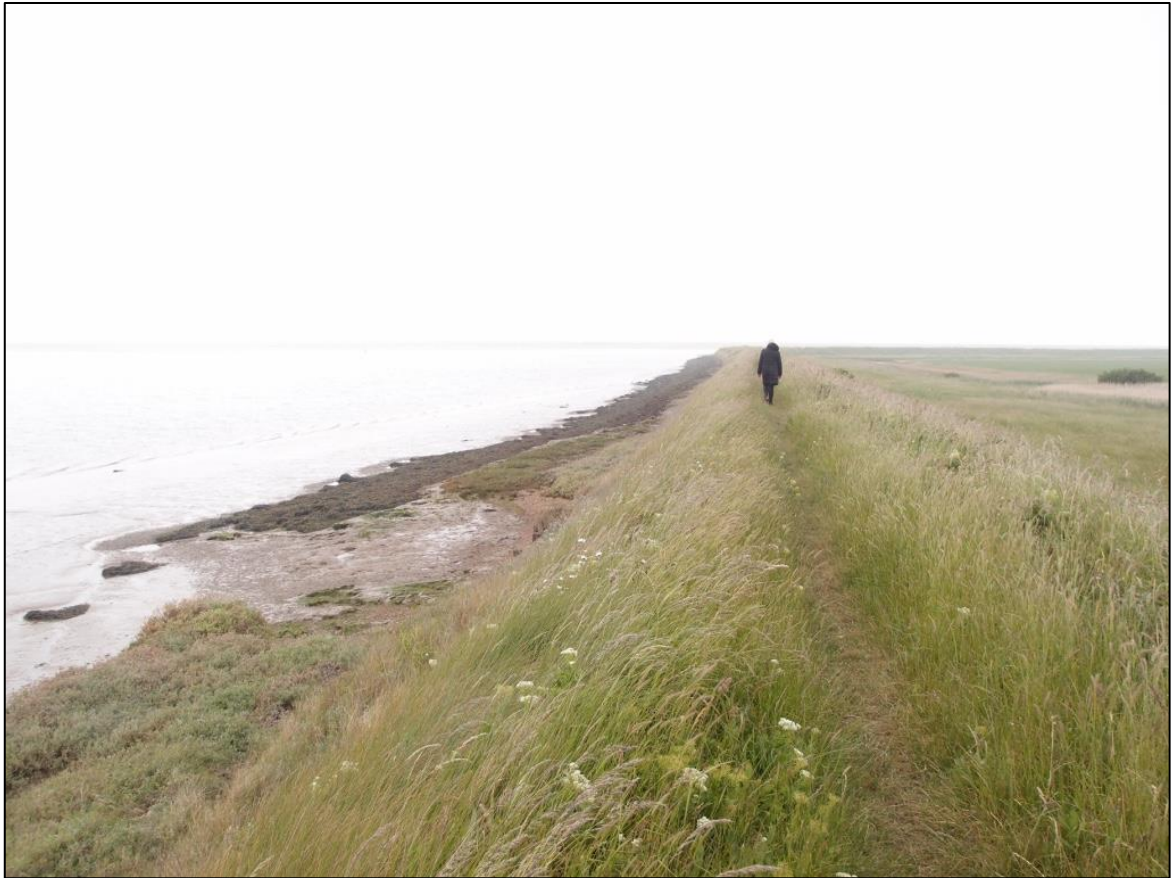
Photo 2

The wall at Flybury Point is not protected by saltings, the river reaches foot of wall at all high tides (See Photos 2 & 3). See comments in 2019 report and previously. This still remains vulnerable location.

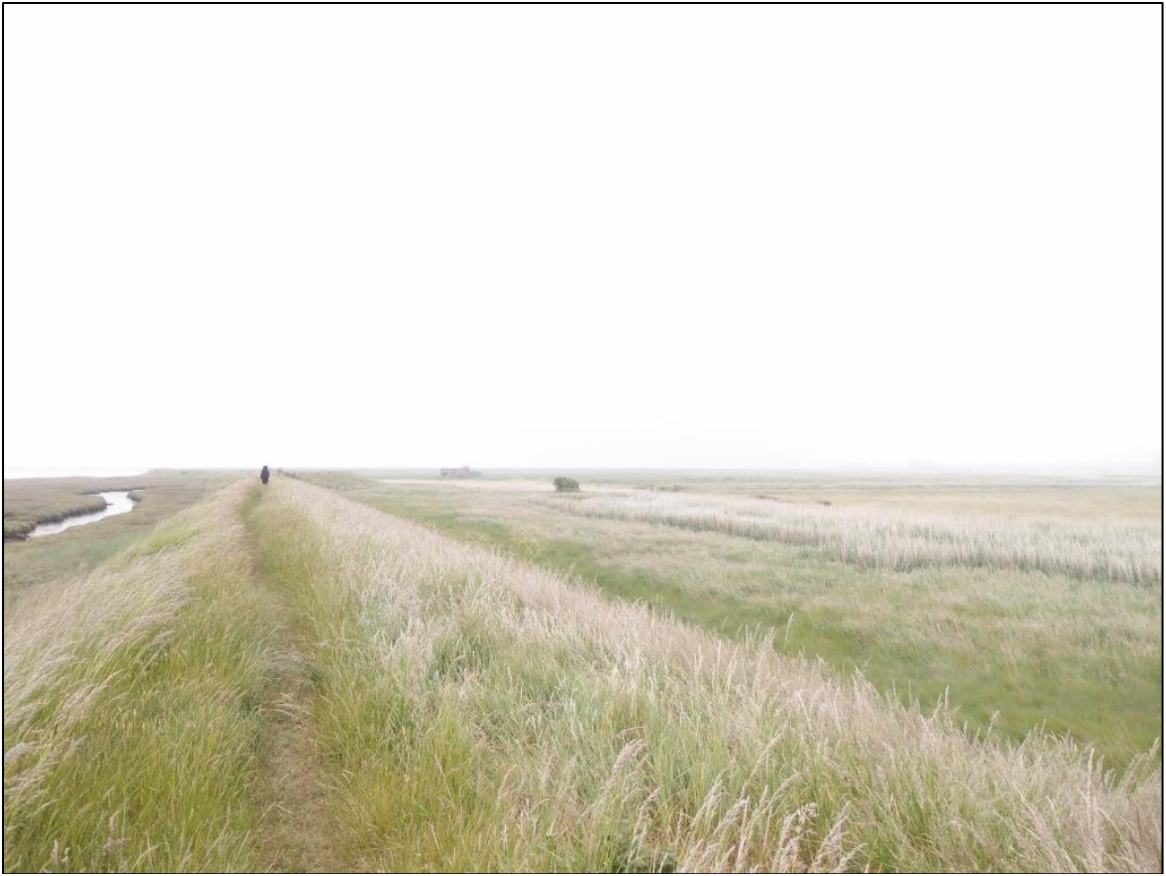
Photo 4

RSPB submitted a planning application for Boyton Marshes for the formation of a large scrape to improve the habitat for various birds. This will be inland of borrow dyke behind the river wall from Approx chainage 4000 to 5500. The report claims that the river defence system will not be affected. Note the substantial distance between river wall and borrow dyke (see Photo 4) which may be useful for Estuary Plan upgrading.
