# THE ALDE & ORE ASSOCIATION

## ALDE AND ORE ESTUARY ASSESSORS REPORT

<b>NAME[S]:</b> A Andrews +	<b>DATE OF INSPECTION:</b>  31 March 2020 and mid April
<b>FLOOD CELL:</b>  FC10	<b>AREA OF ASSESSMENT:</b>  Slaughden Quay to Brick Dock Jetty

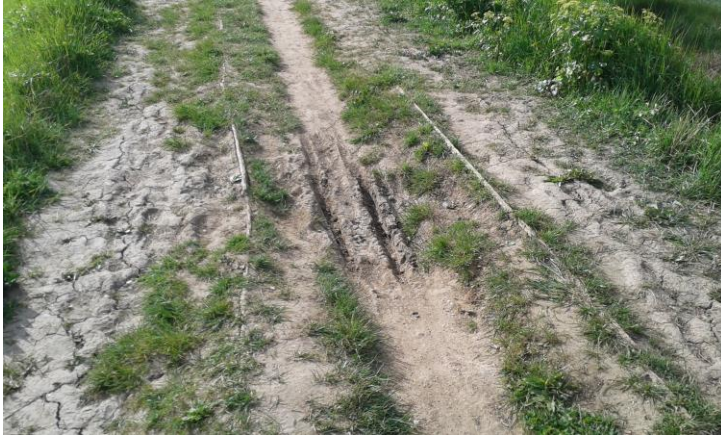
**TM464555 to 459557** i. No obvious slippage but in many places the path now covers the entire width of the wall instead of only the centre, so the walls are being broadened and flattened by footsteps especially when the surface is extremely muddy and slippery in the winter months. Worst broadening/lowering on the stretch between Slaughden Road and the steps up from the Aldeburgh Dump road point, especially where the wall is lowest anyway.

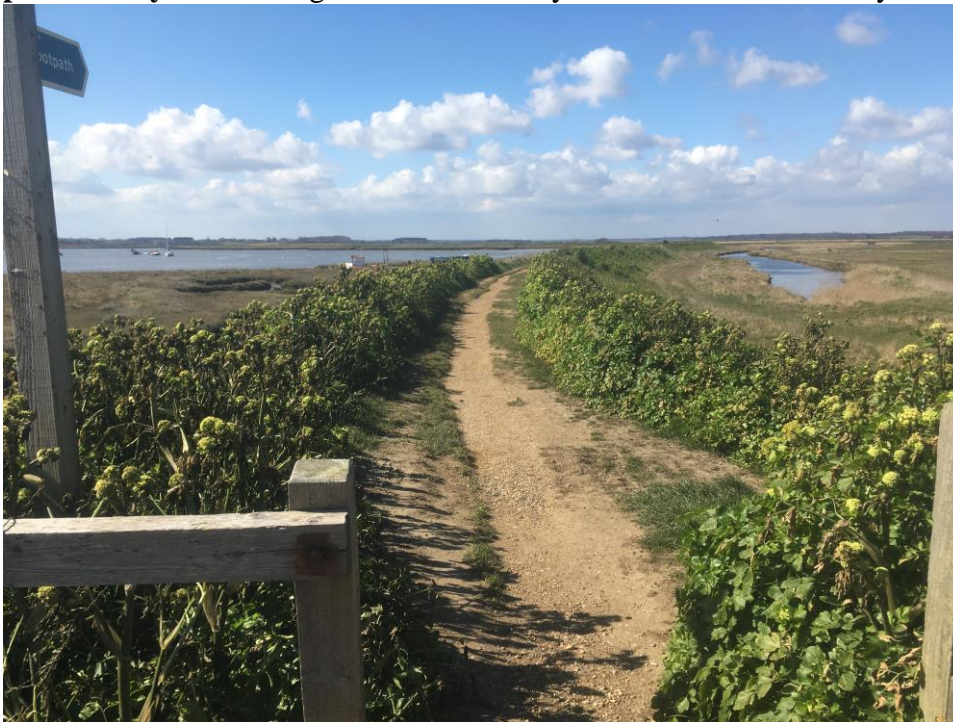
ii. Wall could be damaged by long stretches of alexanders infestation **particularly** at the Slaughden end for 100 yards or and intermittently after that.

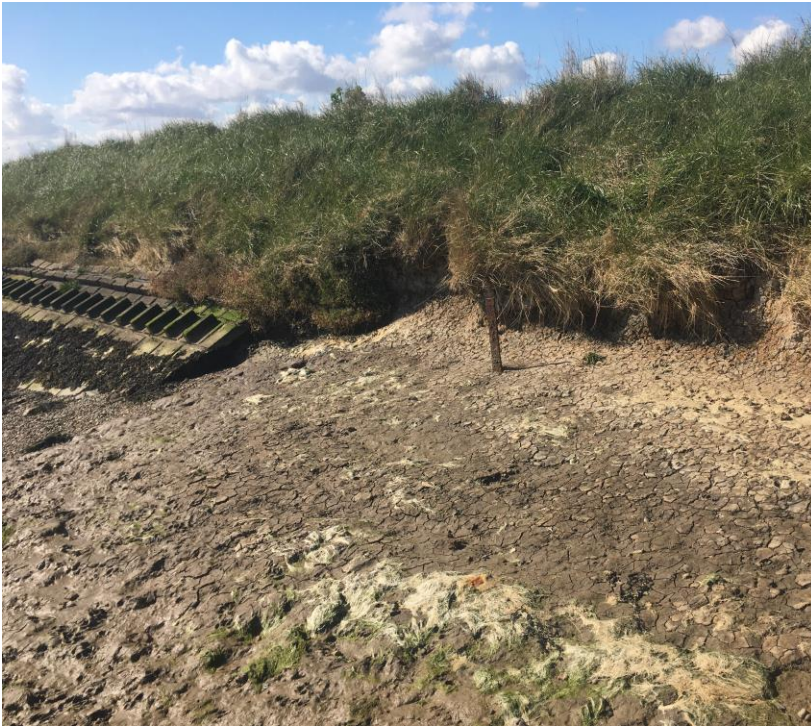
**TM 458558** defences to east of Aldeburgh Sluice- i. the bank is being worn away at the edge of the concrete armour protection beginning to be undermined and the beach muddy slope being extended upwards.

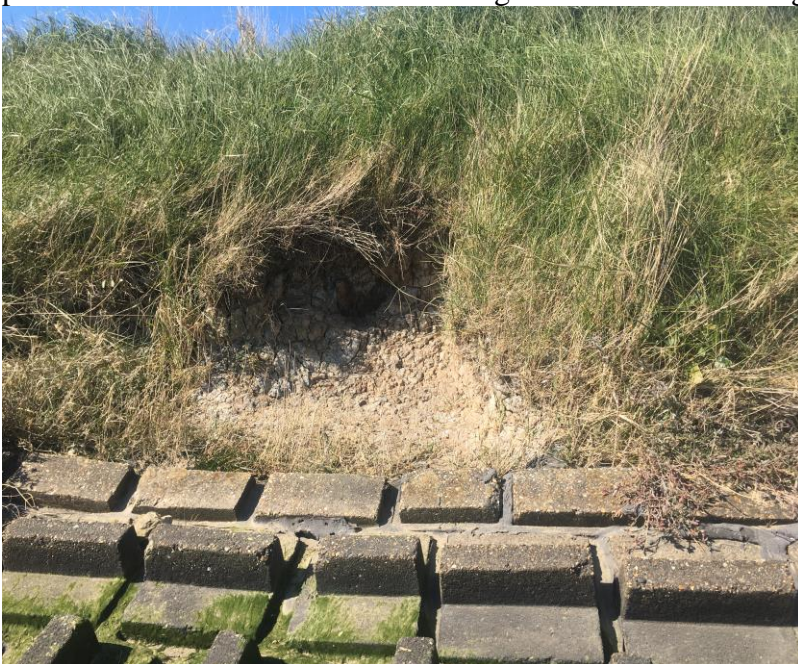
ii. large 'cave' (2 ft. high) in bank above the concrete protection has increased further making wall vulnerable to large waves.

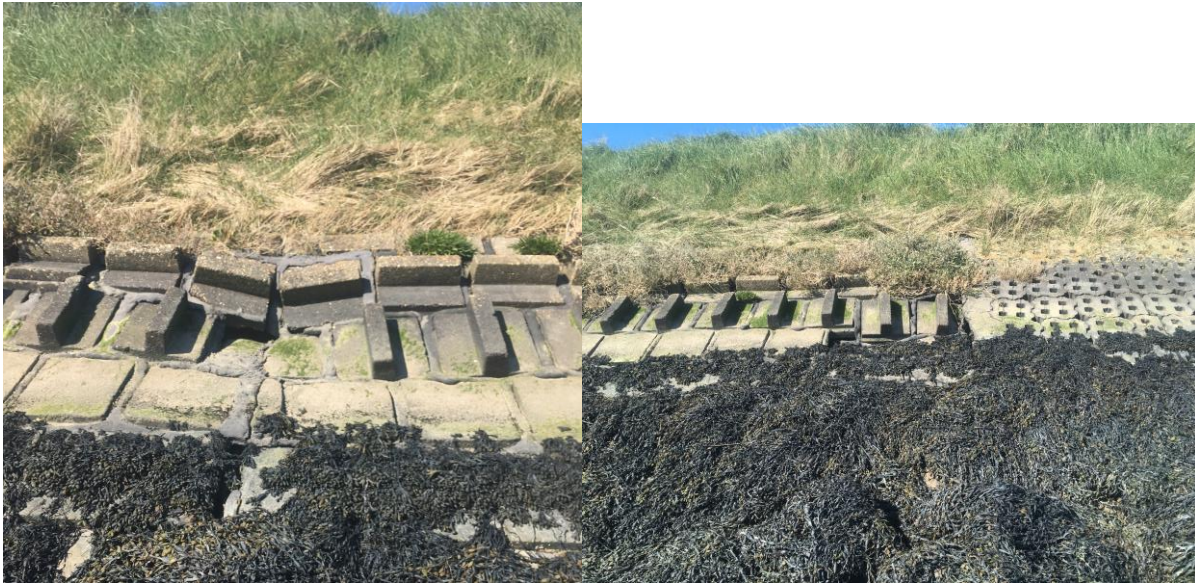
iii. start of undermining of older concrete protection at join with the new armorlok (new about 10 years ago) and old blocks collapsing at the top

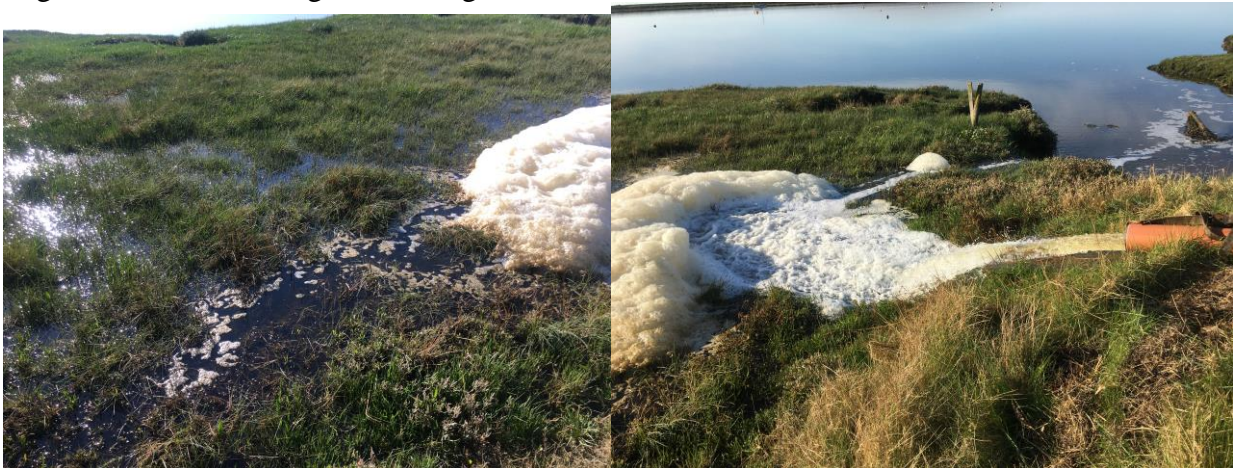
**TM 458556 Outflow from drainage ditch to west of Aldeburgh Sluice.** A new over-the-wall pipe has been installed to drain Aldeburgh Marshes of the excess winter rain but instead of going directly into the sluice exit to the river has been placed (to break the fall?) by putting the pipe outlet onto a board which then goes into the saltings and then into the river. May be good for wetter saltings but might water force damage the saltings- to be monitored.

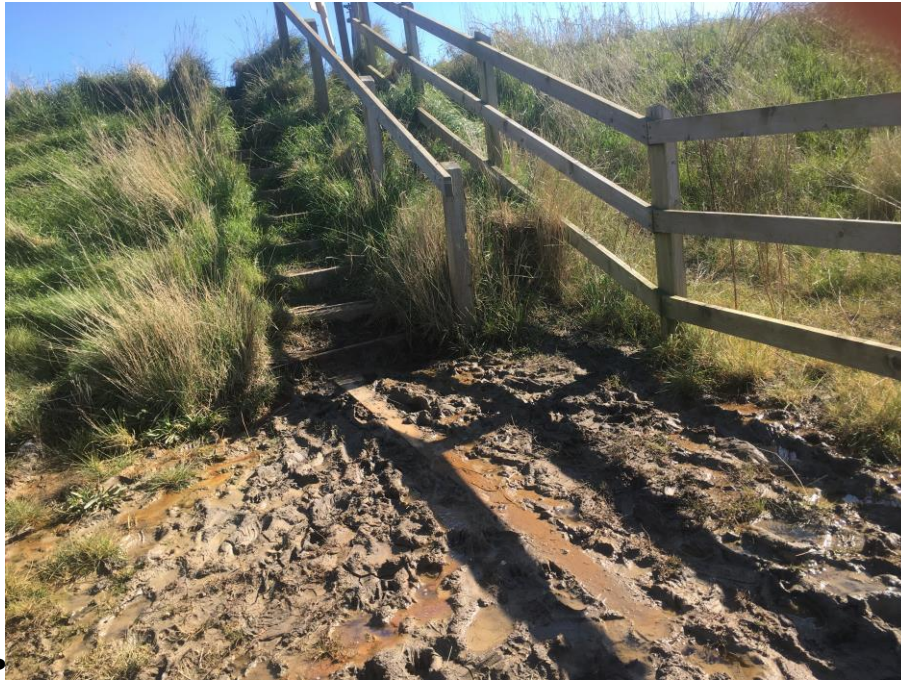
**TM456556** Puddling of mud/water at base of steps where footpath goes up from a cross field path to the start of the new wall. Is there a leak as the amount of water left after everywhere else has completely dried?

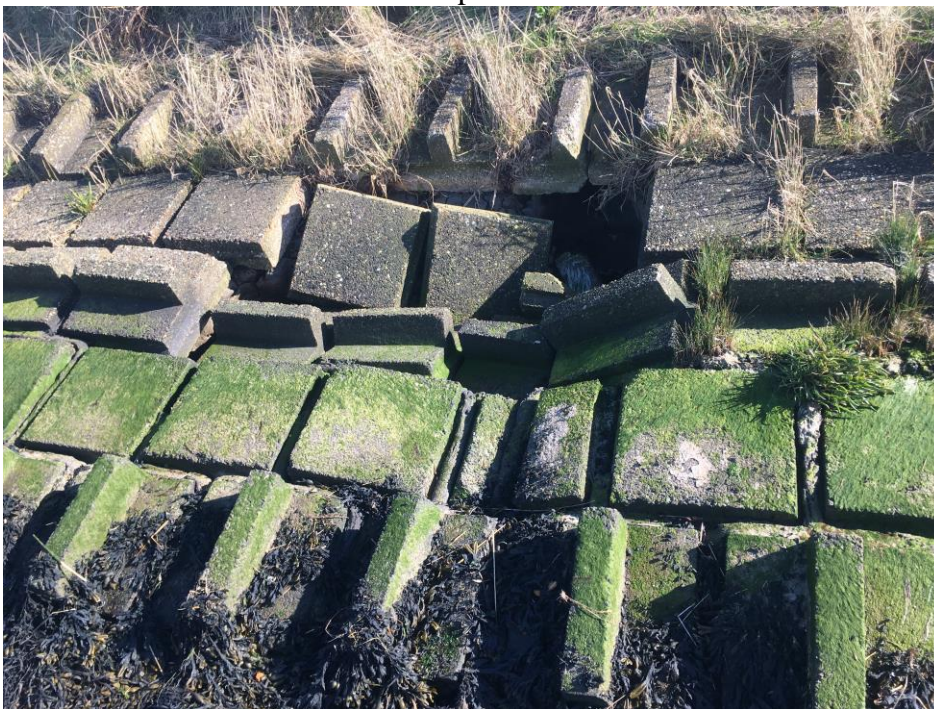
**TM449558 north of Brick Dock steps** long area of slightly sloping concrete slabs. At about 7 points (at intervals of 30-50 feet) the slab line is starting to collapse inwards and at one point concrete blocks have been undermined out of place.

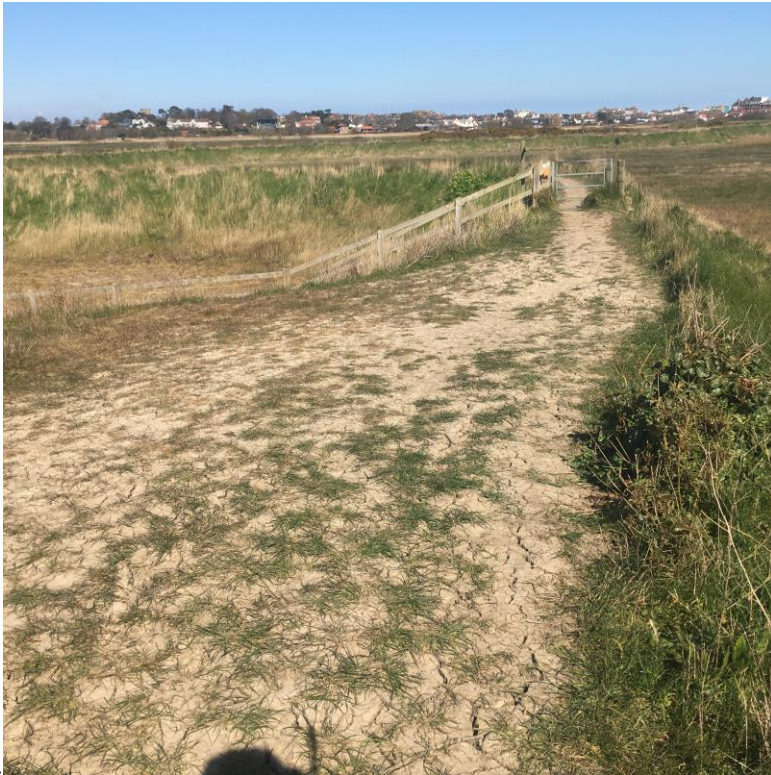
Path at Slaughden end now triple the width it was when hoggin centre laid down 15? years ago, also making wall sides lower.

Particularly at Slaughden end and on the 'new wall' in the middle section, as there was excessively heavy rain early in the year and people still walked (skated) over the surface, but has been no rain since end of February so now mud that was near impassable is a solid cake and means recovery of grass growth is severely inhibited. Considerable stretches with fairly bare earth and only a few tufts of grass. (photo of 'new wall' section southern end)
