ALDE AND ORE ESTUARY ASSESSORS REPORT

NAME[S]: R Baxter	DATE OF INSPECTION: September 2020	
FLOOD CELL:	AREA OF ASSESSMENT:	
FC2	Butley Mills

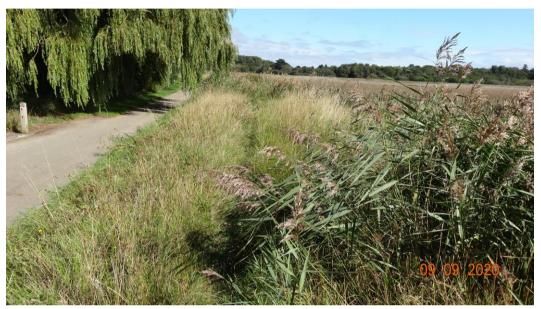
Photo 1

The wall is substantial, with good vegetation cover. Path little used and no evidence of horse damage, as in previous years.

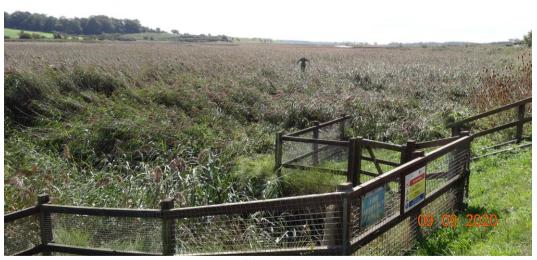
Photo 2

Reed beds are dense and cover the saltings down to the Butley river channel. Two sluices provide adequate drainage from the mill ponds.
