THE ALDE & ORE ASSOCIATION

ALDE AND ORE ESTUARY ASSESSORS REPORT

NAME[S]: A McDonald +	DATE OF INSPECTION:
FLOOD CELL: FC4.1	AREA OF ASSESSMENT: Gedgrave & Sudbourne Marshes

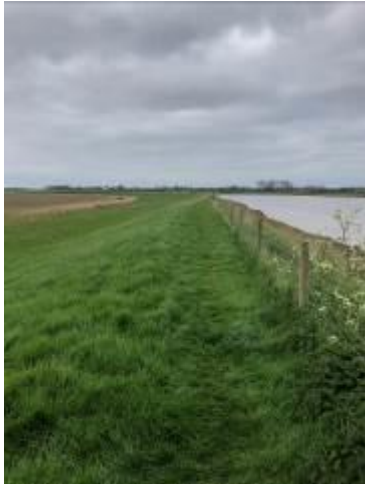
By Pinneys TM397486

Inner walls and pathway – all well grassed and no evidence of damage or change since last year; pathways occasionally showing deep cracking following a very dry month, but not slippage or decay.

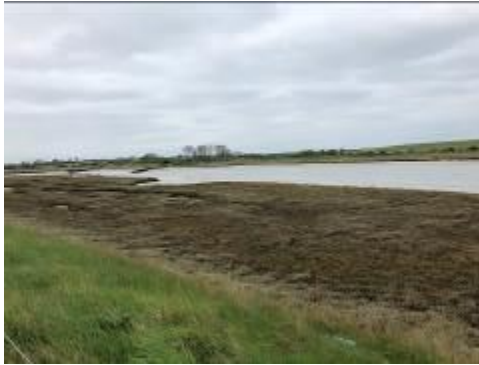
At Butley Ferry, TM 395 484

Saltings: once more, widening channels and undercutting at Butley Ferry, better elsewhere, though slight widening of inner channel along Long Gull.

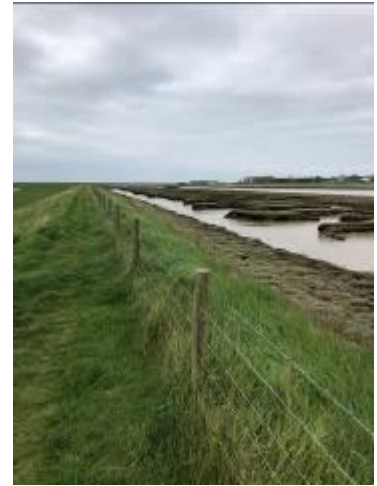
Channel widening TM394 479

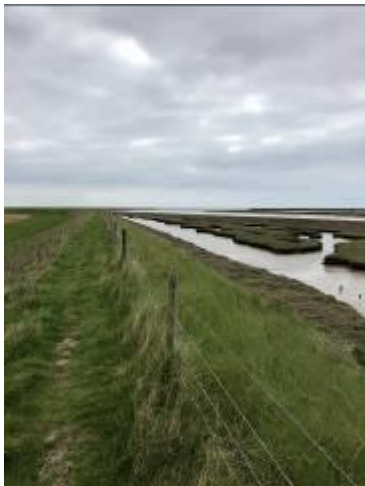
Channel above B Dock TM397 474

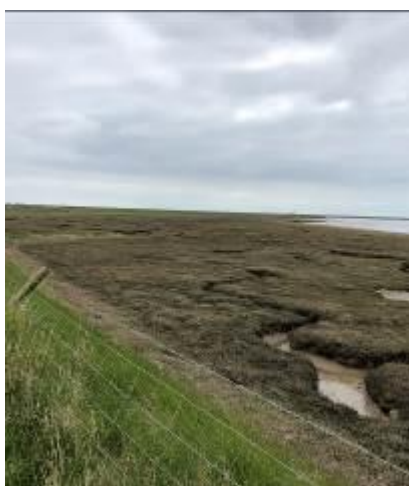
Better! Long Gull TM400 474

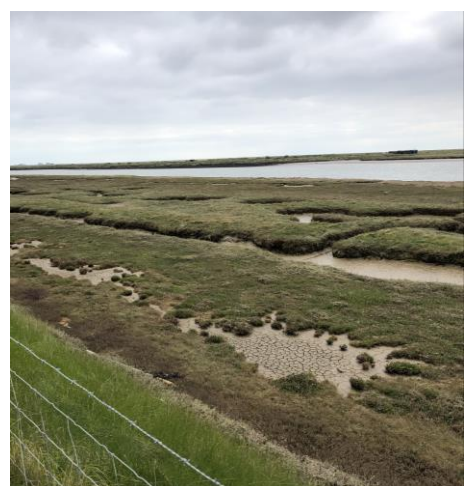
Some channel formation, undercutting: TM407 471

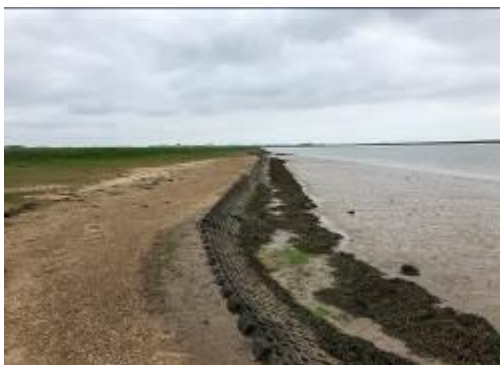
Armour at Gedgrave PS TM411 475

Outer Walls – generally good condition and no evidence of any change or deterioration
