THE ALDE & ORE ASSOCIATION

ALDE AND ORE ESTUARY ASSESSORS REPORT

NAME[S]: Frances Barnwell	DATE OF INSPECTION: 23.04.2020
FLOOD CELL: FC4.2	AREA OF ASSESSMENT: Chantry Marshes to Orford Quay [Orford Sailing Club to Short Gull Tide Gauge]

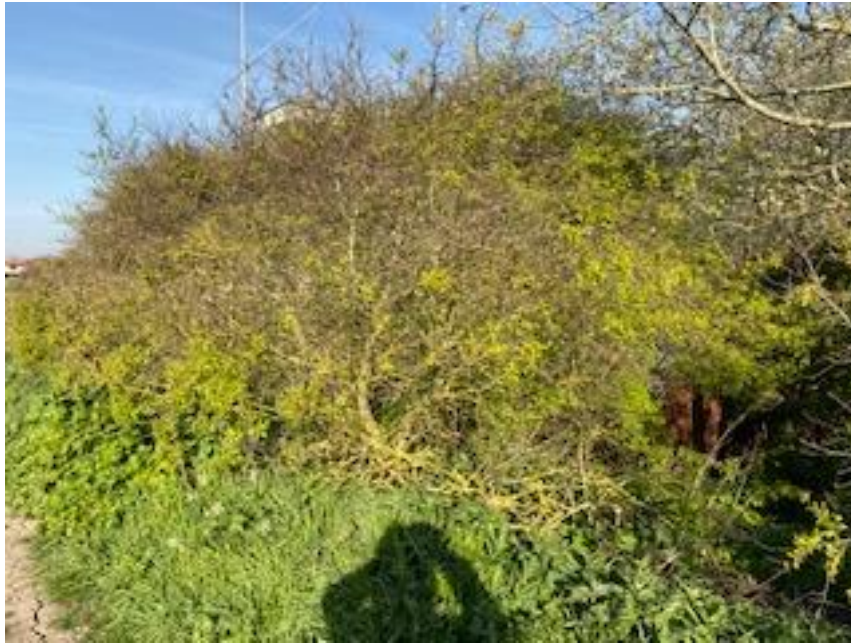
A section of the wall by the club house remains covered in shrubs. Other sections are being invaded by Alexander weed.

Photo 1 [shrubbery by Club House]
[52 05 30.509 E1 32 27.318]

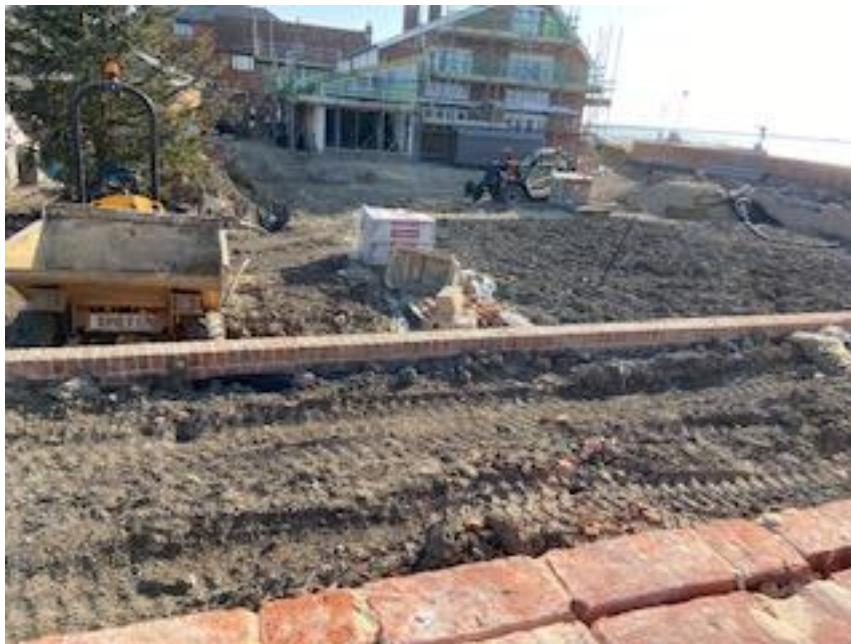
Extensive works are being carried out at Quay House abutting the river wall.

Photo 2 [Quay House]
[N52 05 26.400 E1 32 15.888]

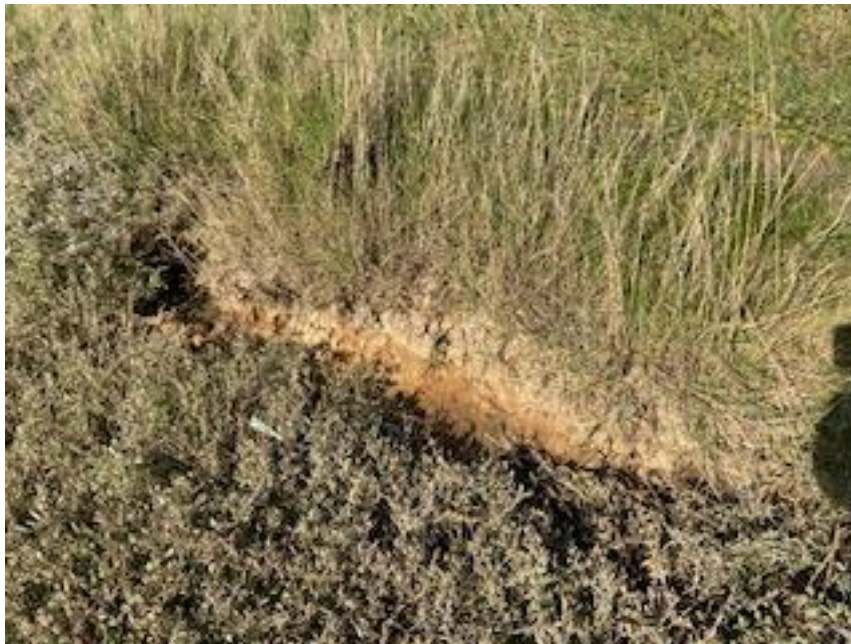
There is undercutting at the base of the wall near the village where there is no concrete armour. There is some damage to the armour itself in places but overall the amount of growth and seaweed makes it, difficult to see the detail.

Photo 3 [undercutting at base]
[N52 05 18.179 E1 32 09.948]

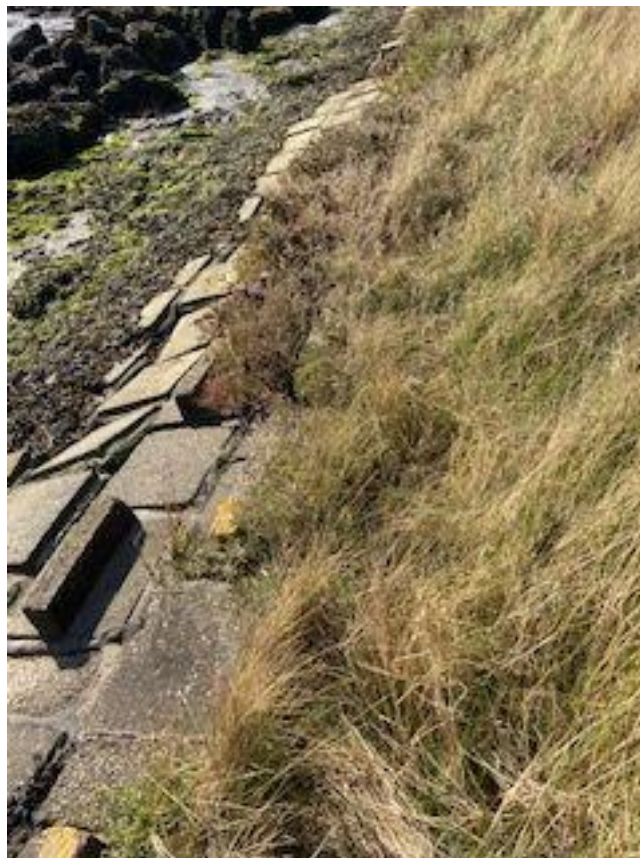
Photo 4 [armour]
[N52 05 01.030 E1 32 13.458]

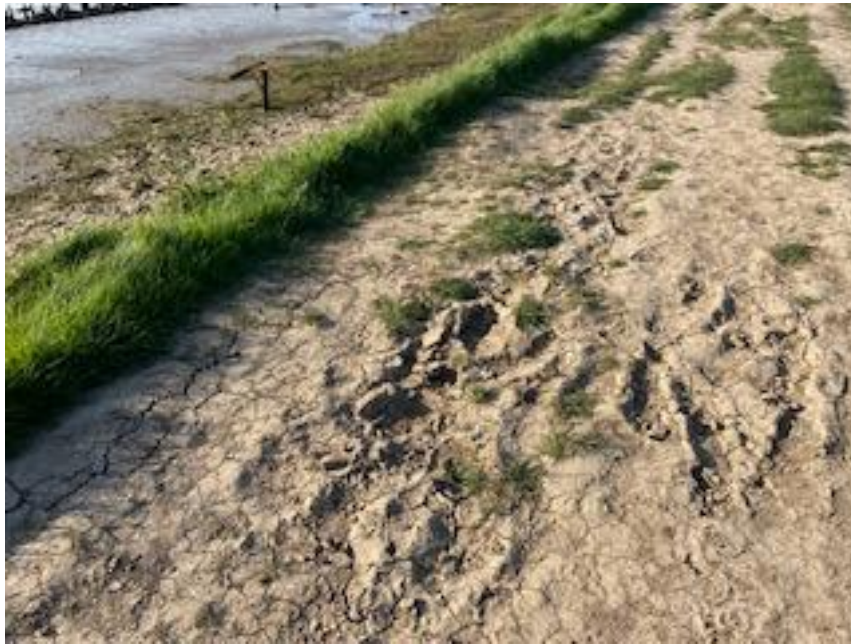
The top continues to erode, to the extent that parts are now starting to roll off at the edges. The section between the quay and the first stile is virtually unwalkable when wet and is in urgent need of attention.

Photo 5 [eroded top]
[N52 05 23.710 E1 32 09.269]

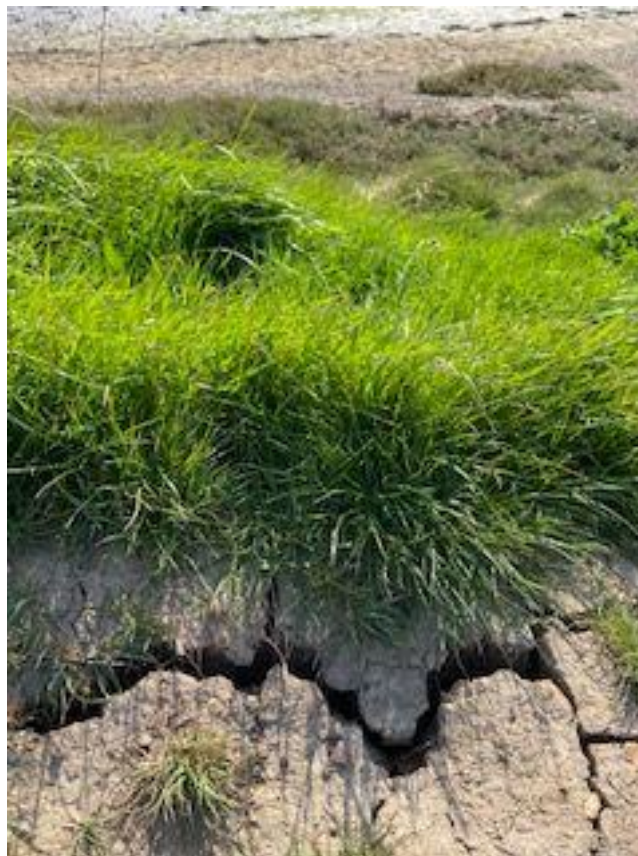
Photo 6 [cracked edge]
[N52 05 18.19 E1 32 09.750]

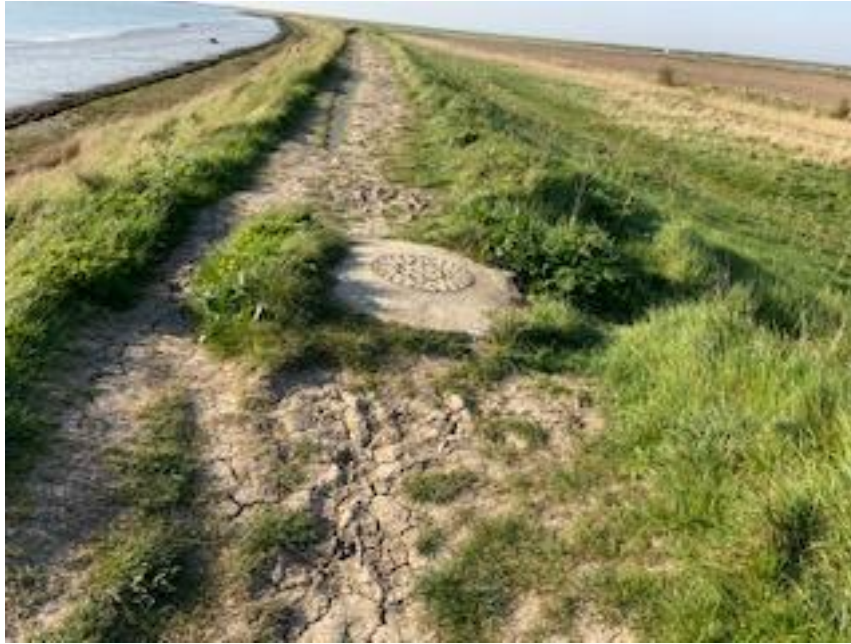
Erosion around the dip by the manhole cover is particularly pronounced and the manhole cover appears to be slightly at an angle.

Photo 7 [manhole cover]
[N52 05 14.659 E1 32 09 048]

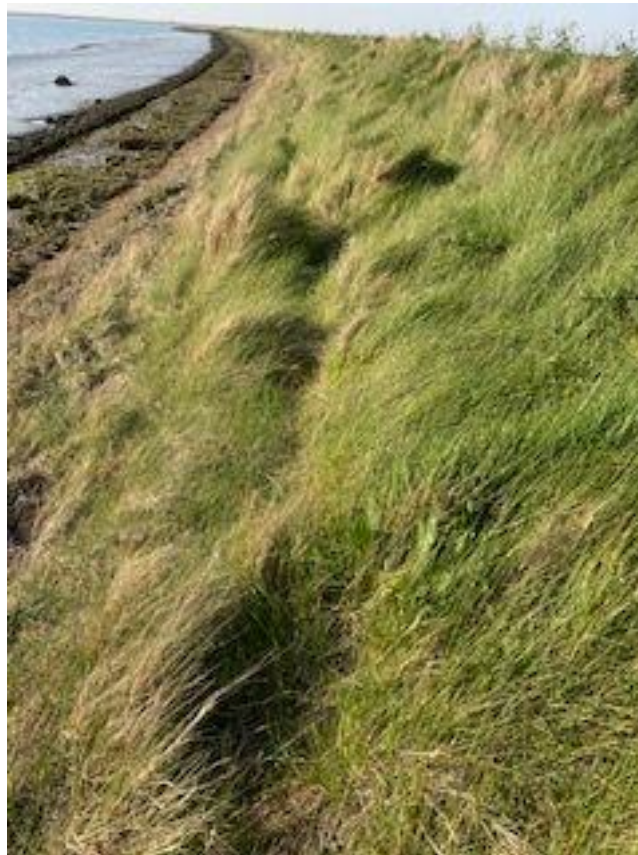
The creation of a second path on the side of the wall is progressing further as the top becomes more damaged.

Photo 8 [second path]
[N52 05 13.399 E1 32 09.402]

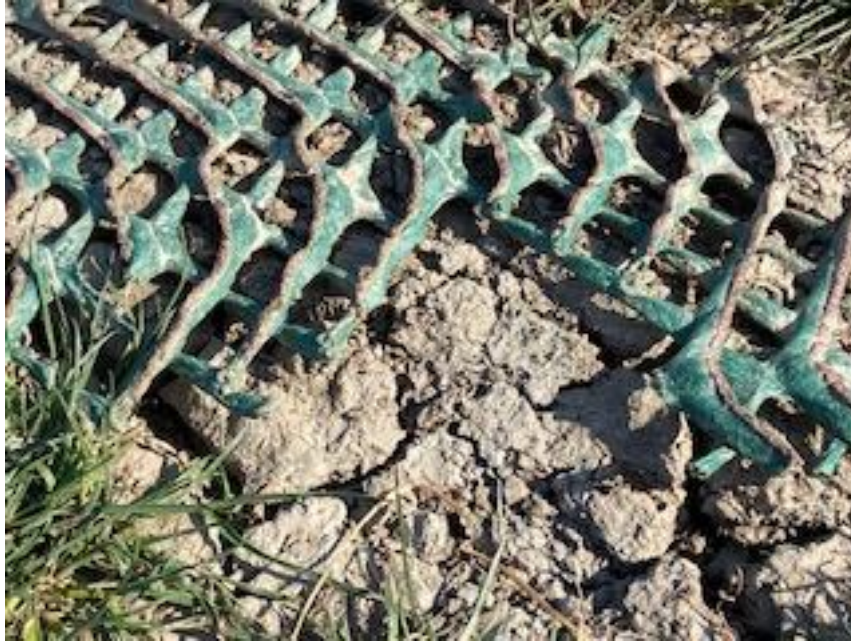
Mesh is lifting at the stile end creating a new walking hazard.

Photo 9 [mesh]
[N52 05 03 199 E1 32 12.419]
