THE ALDE & ORE ASSOCIATION

ALDE AND ORE ESTUARY ASSESSORS REPORT

NAMES: Brian Johnson Juliet Johnson	DATE OF INSPECTION: 1. 28 th March 2021 2. 18 th April 2021 3. 22 nd April 2021
FLOOD CELL: FC1	AREA OF ASSESSMENT: 1. Boyton Dock to Sparrowhill Covert 2. Chainage 1250 to Boyton Dock 3. Shingle St. pump house to Chainage 1250

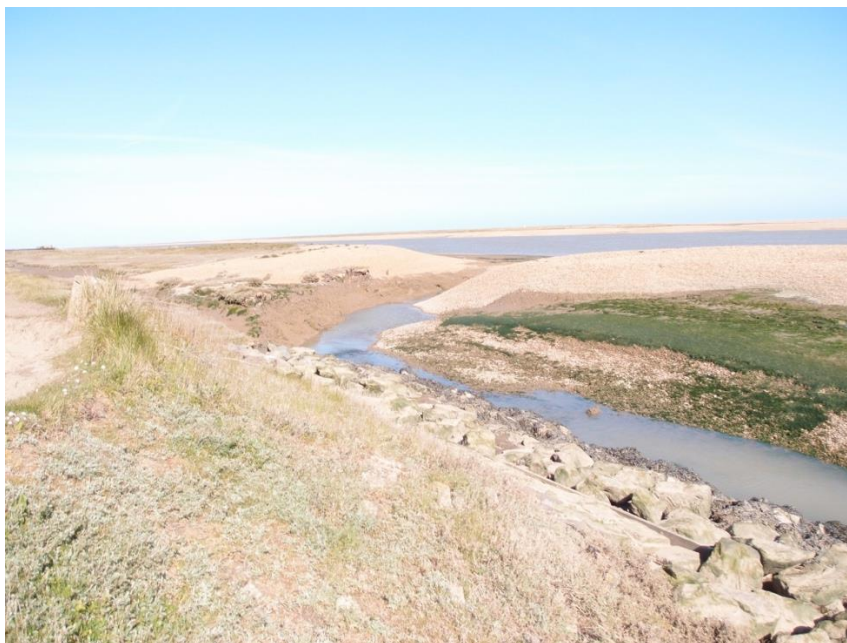
Photo 1

Little change from previous years except shingle build up on both sides of bank at junction with main river (see Photos 1 and 2).

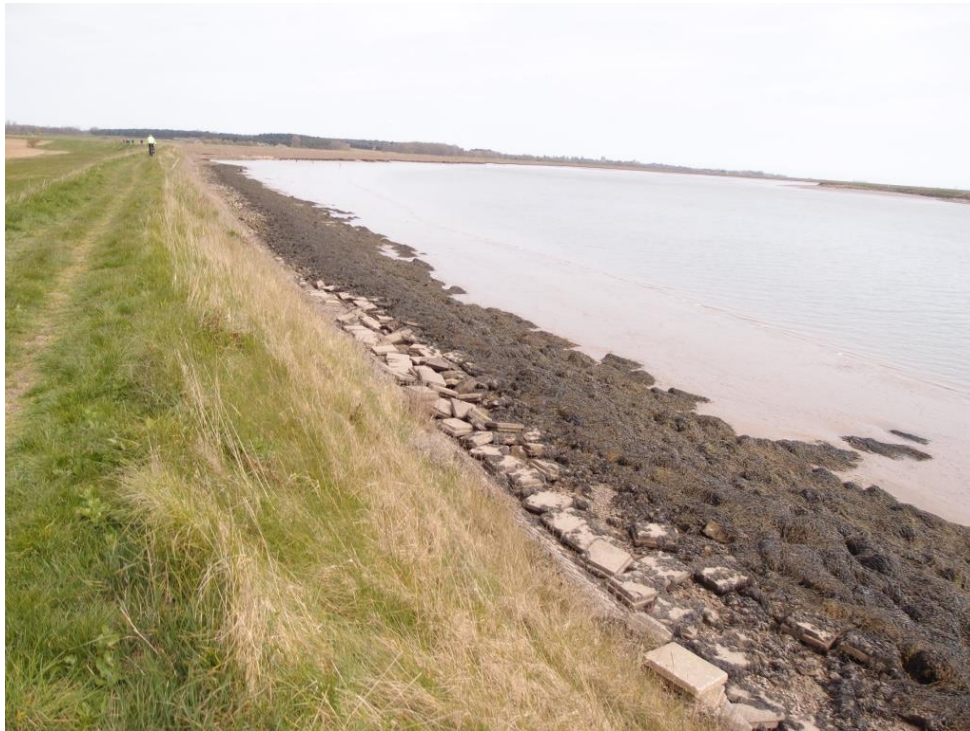
Photo 3

Varying width saltings throughout this length and into Butley River, except for short length at Flybury Point (Photo 3).

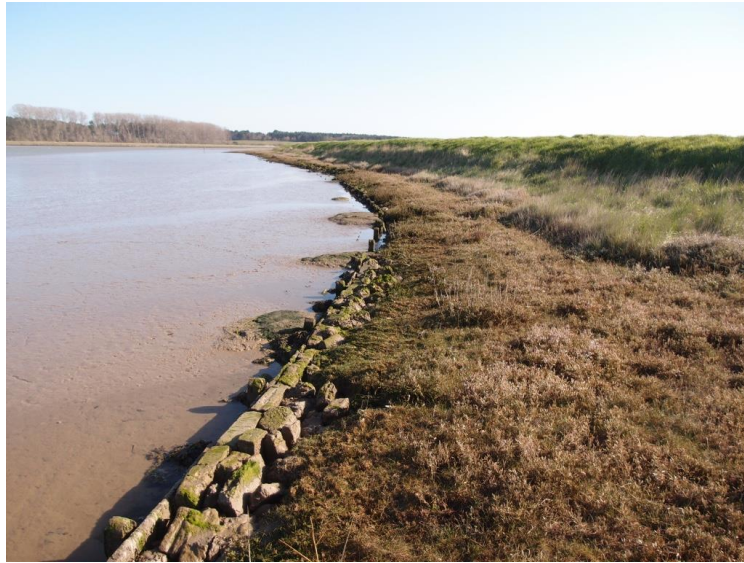
Photo 4

Saltings border the whole of this length, except for short length north of chainage 8000 where deteriorating timber edging still exists, surprisingly! (see photo 4)

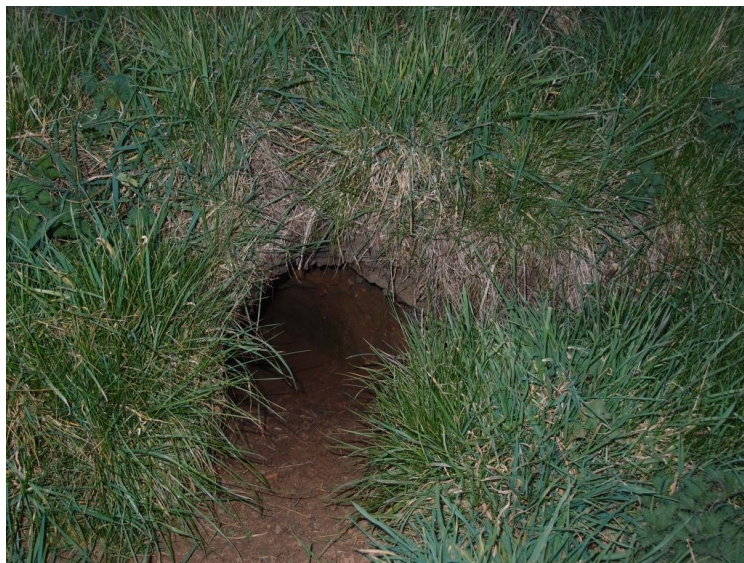
Photo 5

Near upper extent of levee, there are three large badger holes (see Photo 5).
