# THE ALDE & ORE ASSOCIATION

## ALDE AND ORE ESTUARY ASSESSORS REPORT

<b>NAME[S]:</b> A Andrews and J.C. Hodrien + B Bostrom M Hoffman	<b>DATE OF INSPECTION:</b> 24 <sup>th</sup> March 2021 8 <sup>th</sup> April supplementary viewing
<b>FLOOD CELL:</b> FC10	<b>AREA OF ASSESSMENT:</b> Slaughden Quay to Brick Dock

## Area Surveyed: TM 450568 to 465555

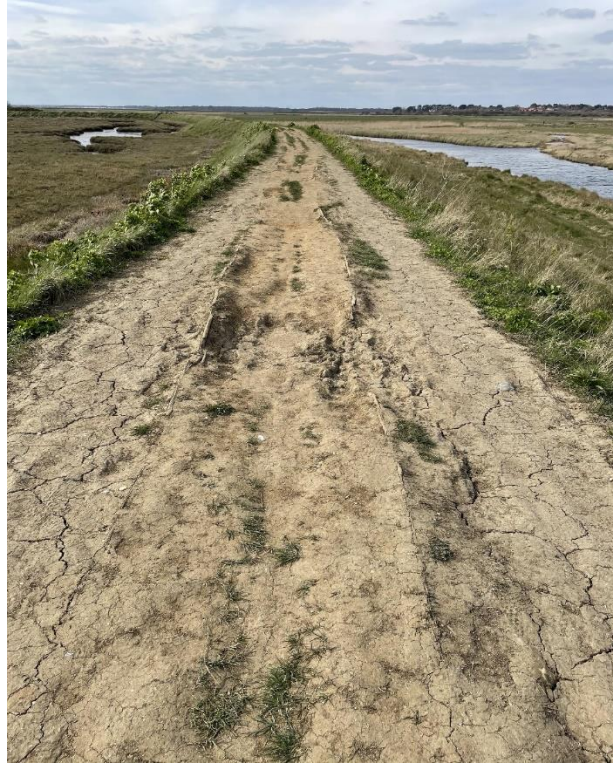
**Adverse impact of walkers: Throughout** the surveyed area the impact of walkers, particularly from walking in wet winter conditions, is significant widening and treading down of the wall top as the footpath has extended to the top edges of the river wall along the whole length. This prevents grass growth and promotes surface erosion. In particular the most heavily used stretch, at 464555 and leading to the steps at 459558, is badly worn and the wall less than 1.75m high in places, at its lowest now only 1.5 metres above the salting level. See photo|

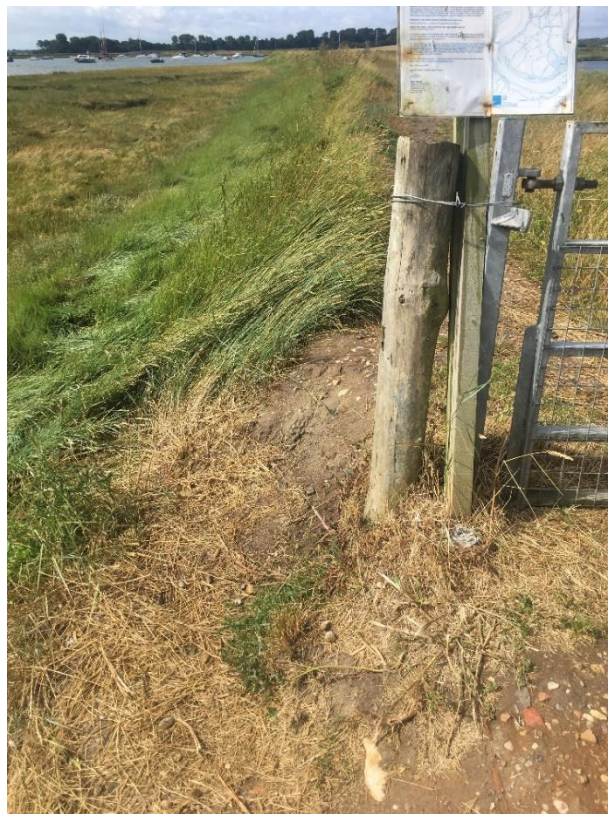
**Wear beside gates:** In three places at least walkers have chosen not to open the gate but step to the side of the gate and have considerably worn down the bank. Can remedial action to stop side stepping be taken? See photo

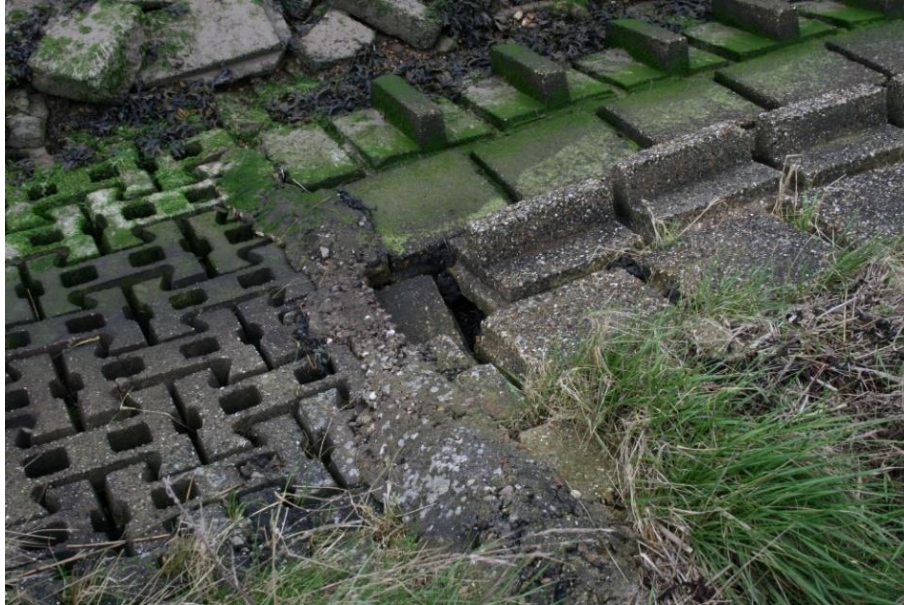
- i. In some instances, these were associated with the end of the protective shielding wall, or with the change in type of brick defence adopted e.g., at 445563 (photo below)

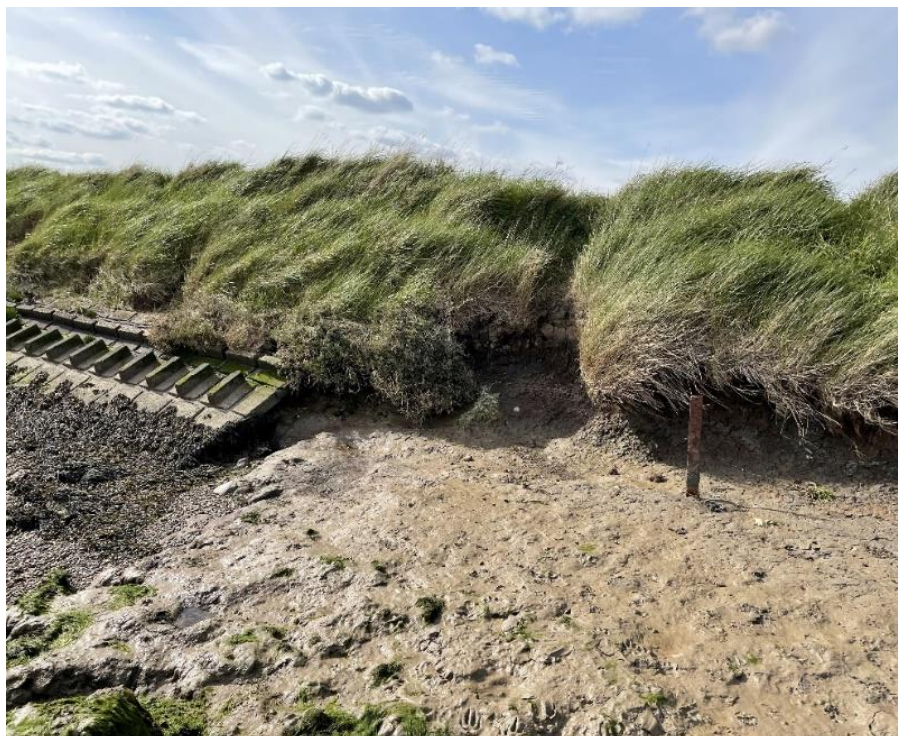
- ii. Between the gate with steps to Dump Road at 458557 and Corporation Sluice the low protective wall ends. At this point two 'caves', identified in previous reports, remain, one now 3' wide v x3'6'' high, visible in photo below, and one 3' x2'high 15 yards to the west barely 2' below the top of the wall and is now undercutting beneath the footpath. Photo below

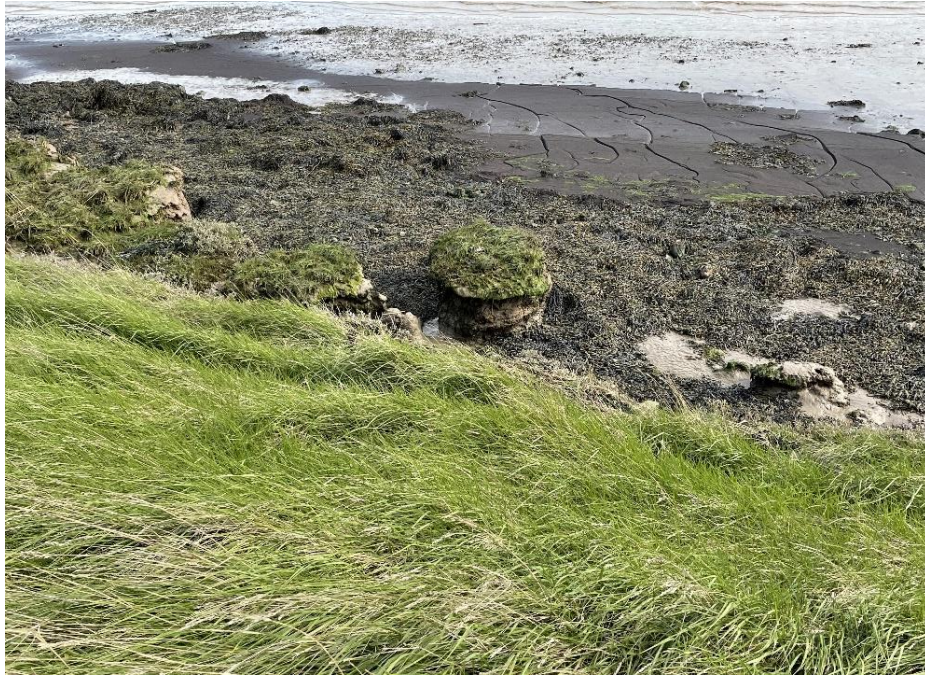
In places the high tide debris build up has made close investigation of the wall impossible (see below).

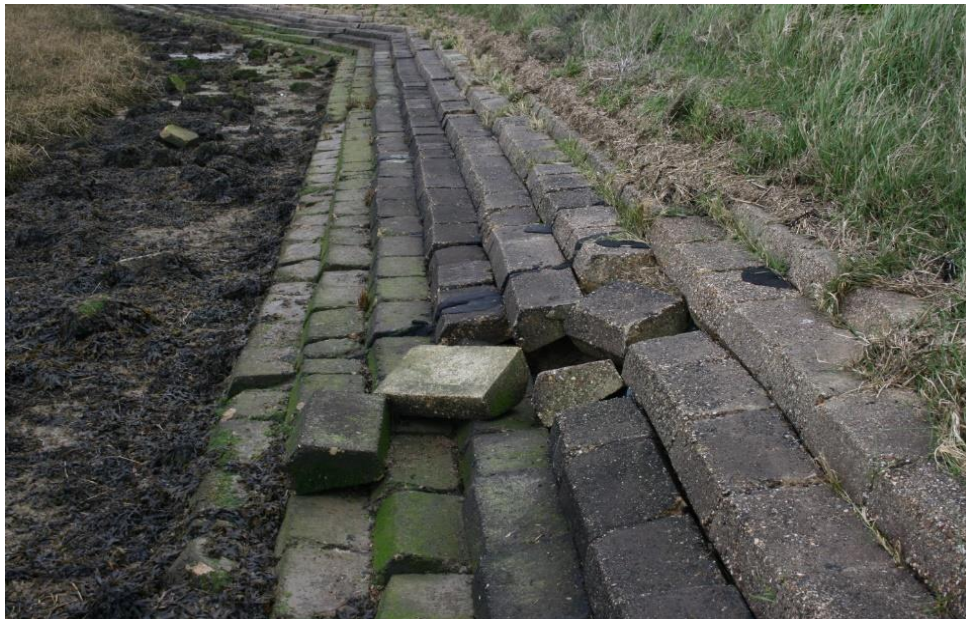
- iv. The worst stretch requiring attention is the most northerly stretch of wall particularly between 450565 and Brick Dock jetty 449569. This is a stepped block arrangement and faults and buckling are evident at regular intervals. Example photo below.

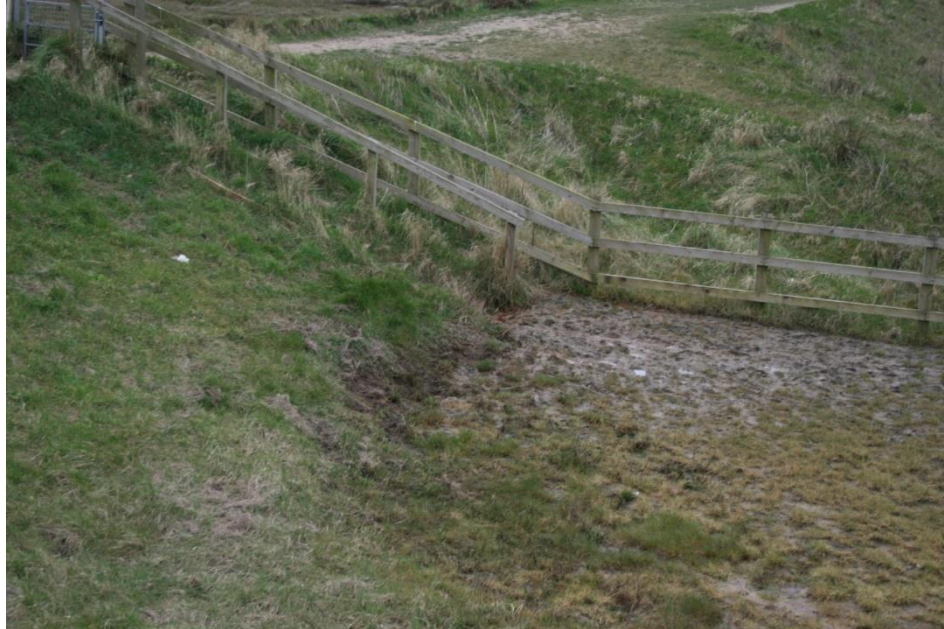
Despite no rain for at least a month, in two places there was the suggestion of water seepage beneath the land side of the wall. At approx. 454555 steps lead to a footpath across the town marshes, here there is evidence of a flush of water at the foot of the wall. There may be some mild slumping of the wall but the visible 'damage' is apparently limited to a 10m sq. patch of muddy ground. The lack of vegetation here also suggests this is not seasonal. See photo below.

In a second instance, at the gate at 445560, opposite Stanny Farm, the land is higher than the adjacent ponds but there is significant puddling at the foot of the wall. This has been highlighted in earlier reports.

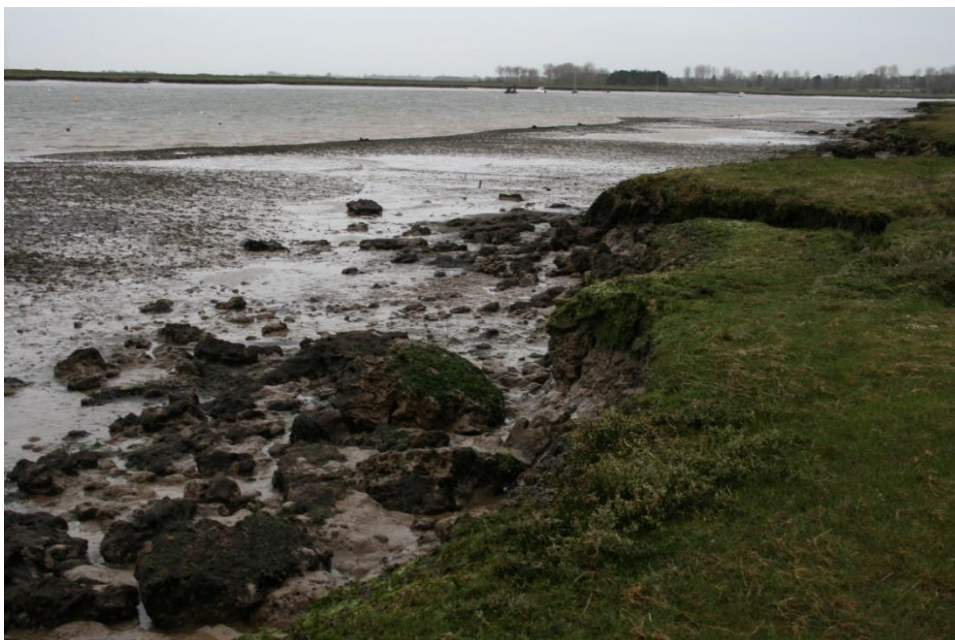
The saltings offer both a significant ecosystem and protection. In width they vary between a few meters and 40m in width. In some places along the whole stretch of the surveyed wall, the saltings edges are being eroded. See photo below.

It is difficult to quantify the annual loss and it is recommended that local efforts are supported to measure the loss more accurately.

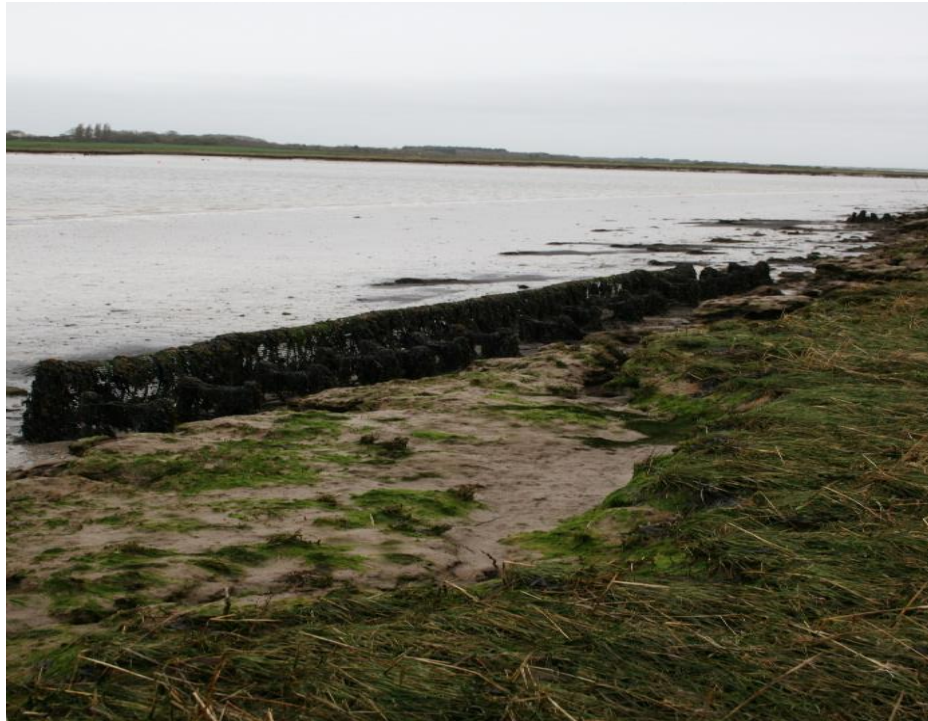
The Alde and Ore Estuary Partnership pilot projects sought to reduce the saltings erosion by chestnut stakes holding hazel bunds or plastic mesh fencing to promote the build-up of silt, but the hazel has been washed away (although renewed and still intact at the Ionia site)). In Ionia site the apparent accumulation of silt ( from looking at a distance) suggests that these could play a role albeit they need replacing at regular intervals. Elsewhere, in near 445558 and on the most northerly stretch of the wall the efforts have been unsuccessful and only help measure that since their construction around 2016 the saltings have receded by possibly 30-50cm

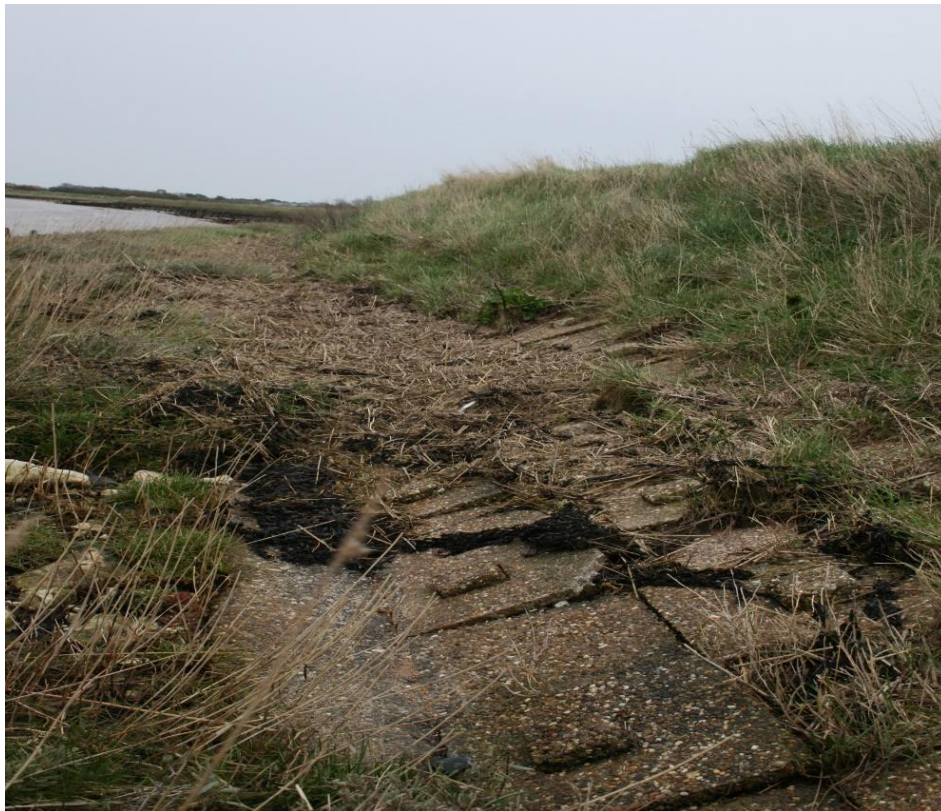
In November 2020 there was a significant high water surge. At the time of this survey, less than 5% of the length surveyed is affected by the build-up of high-water debris comprising largely seaweed and broken reed material. Inevitably the build-up of debris is worse in the slower reaches and bends of the River. At around 445562 to 448564 there is significant debris that made investigation of the protecting wall lying beneath it impossible. In part this is suppressing vegetative growth.

At the start of Westrow Reach the high tide line there is a significant build-up of debris, largely seaweed.
