THE ALDE & ORE ASSOCIATION

ALDE AND ORE ESTUARY ASSESSORS REPORT

NAMES: Jonathan Evans Richard Kihl Roger Baxter	DATE OF INSPECTION: September 2021
FLOOD CELL: FC7	AREA OF ASSESSMENT Snape Bridge to Blackheath

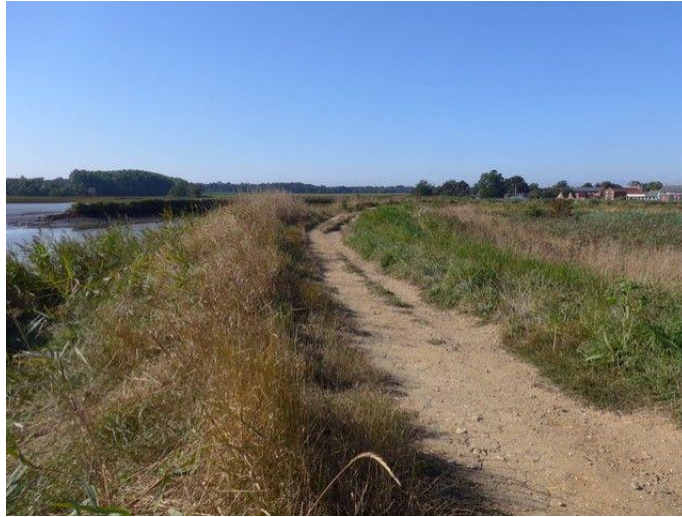
Wall with well used path and good vegetation each side

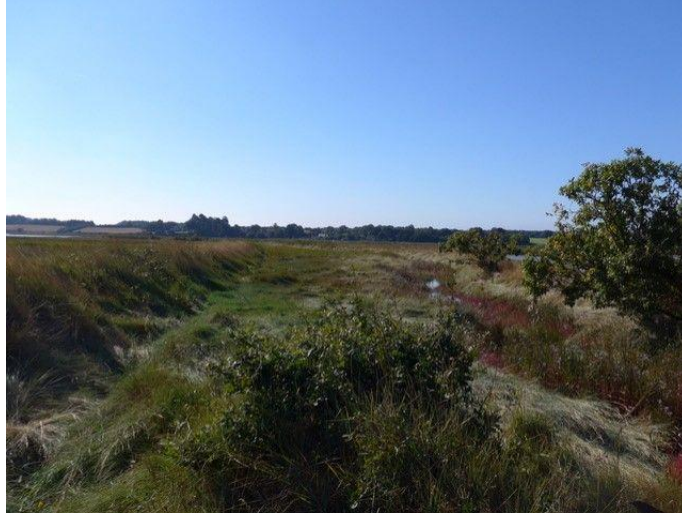
Inner slope (N) on to marsh land and pasture

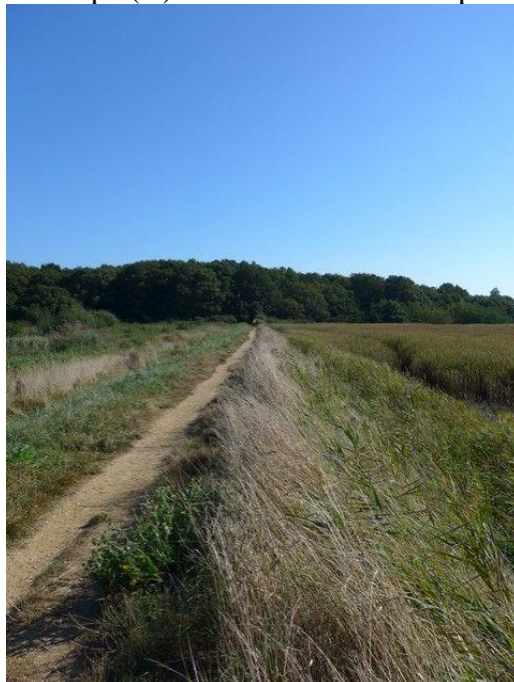
River wall looking towards Snape Warren. Reed beds in abundance.

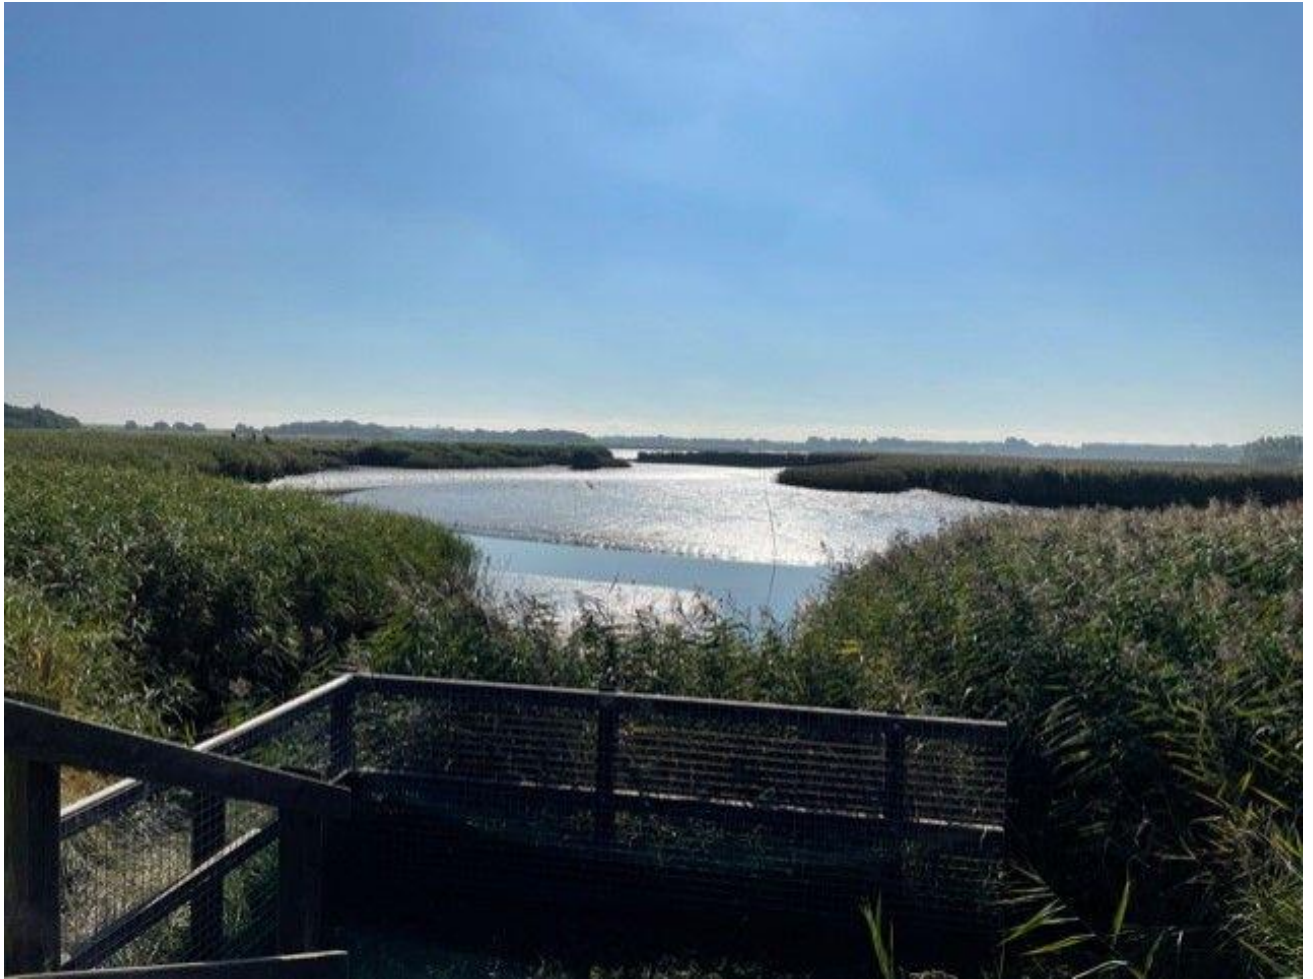
River channel showing mud flats at low tide

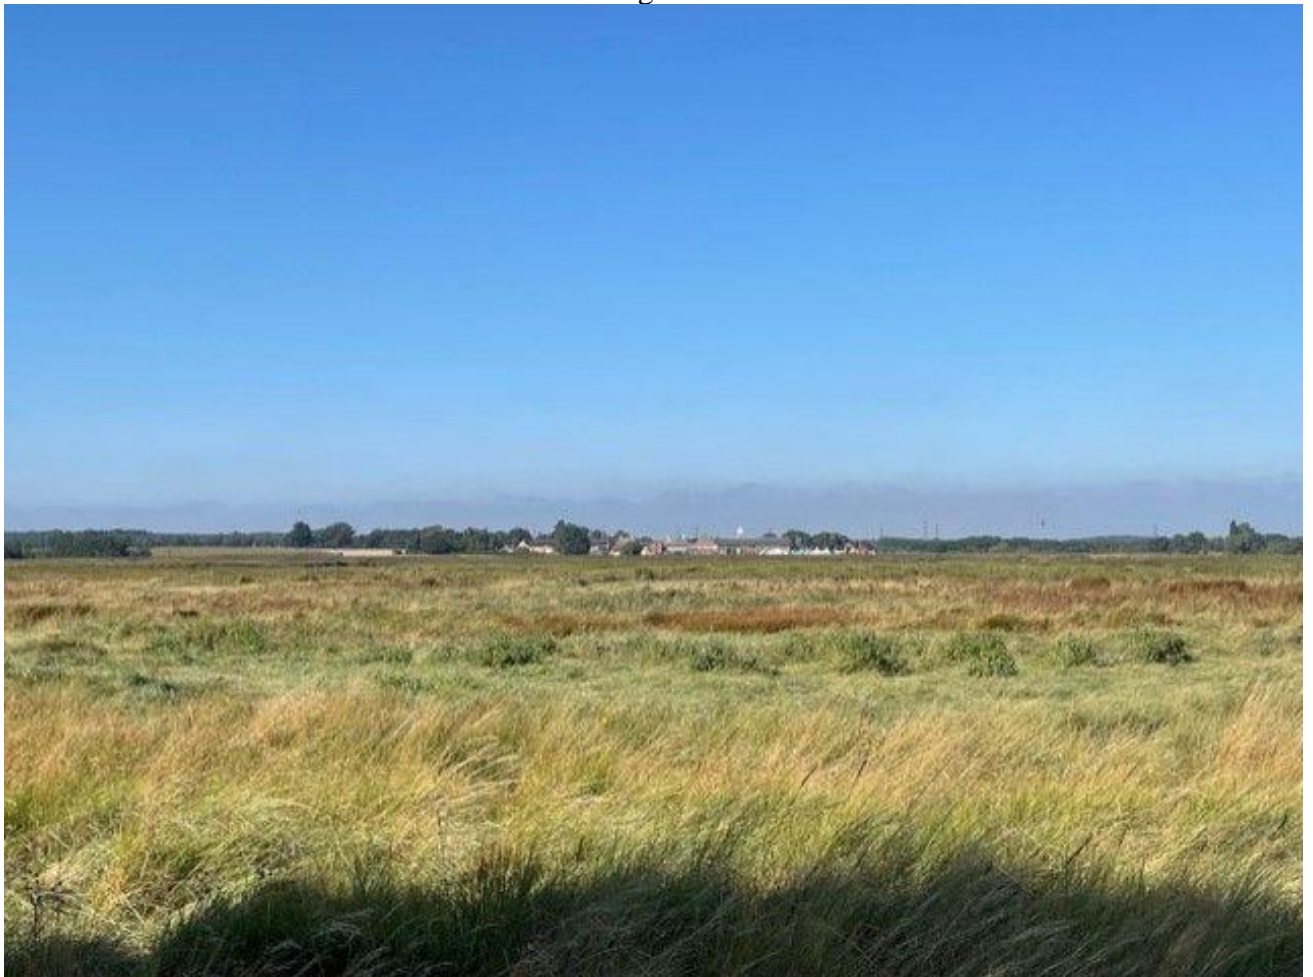
Marsh and saltings at Snape Warren
