THE ALDE & ORE ASSOCIATION

ALDE AND ORE ESTUARY ASSESSORS REPORT

NAMES: Jonathan Evans Roger Baxter	DATE OF INSPECTION: Spring and Summer 2021
FLOOD CELL: FC9	AREA OF ASSESSMENT: Brick Dock to Hazlewood Marsh

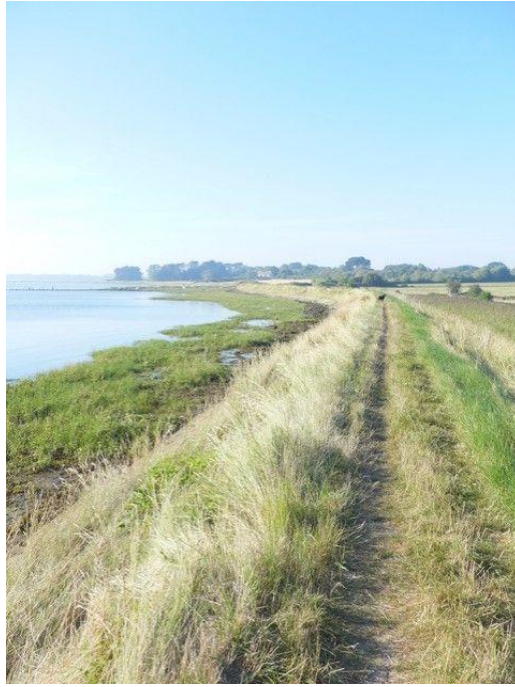
River Wall looking towards Brick Dock

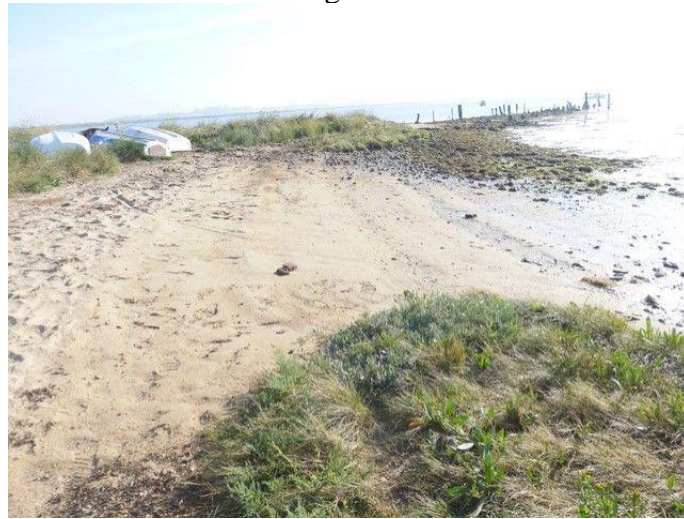
Beach and Jetty

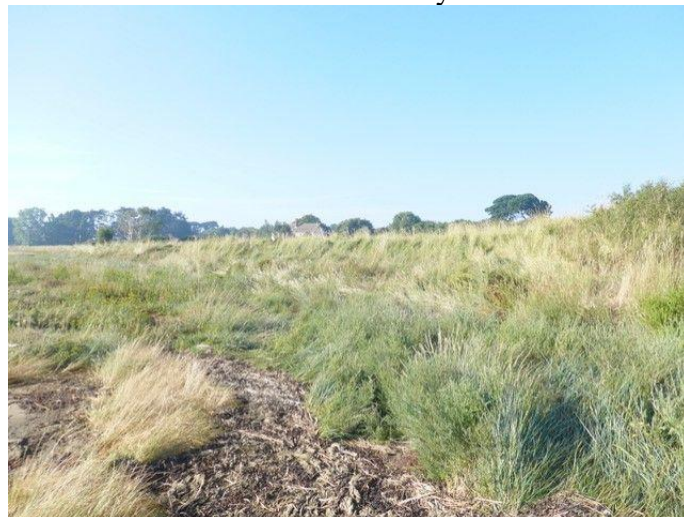
Debris with wall behind, Good vegetation. Rising ground beyond.

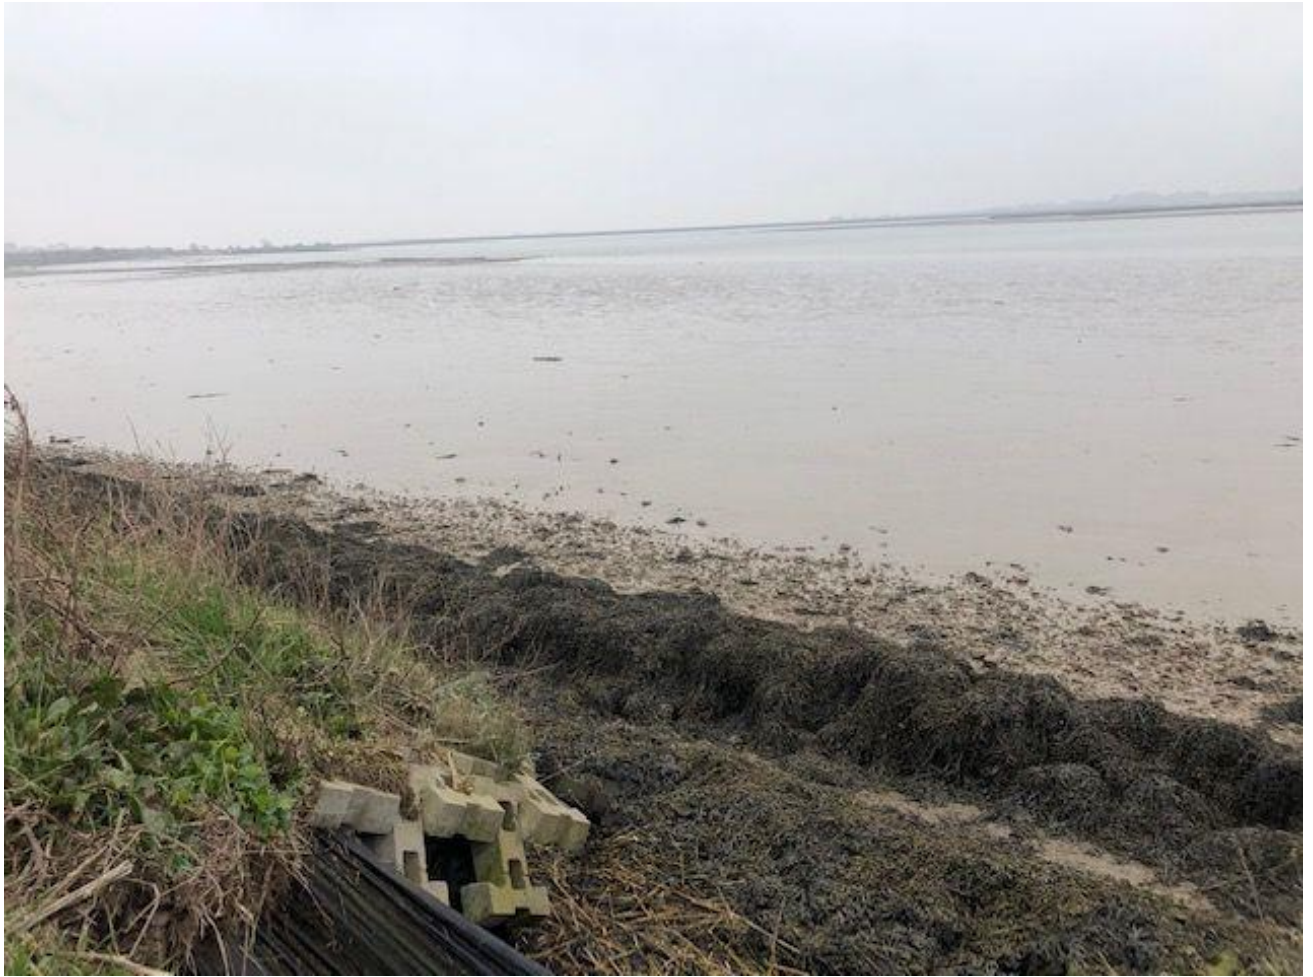
Broken armour

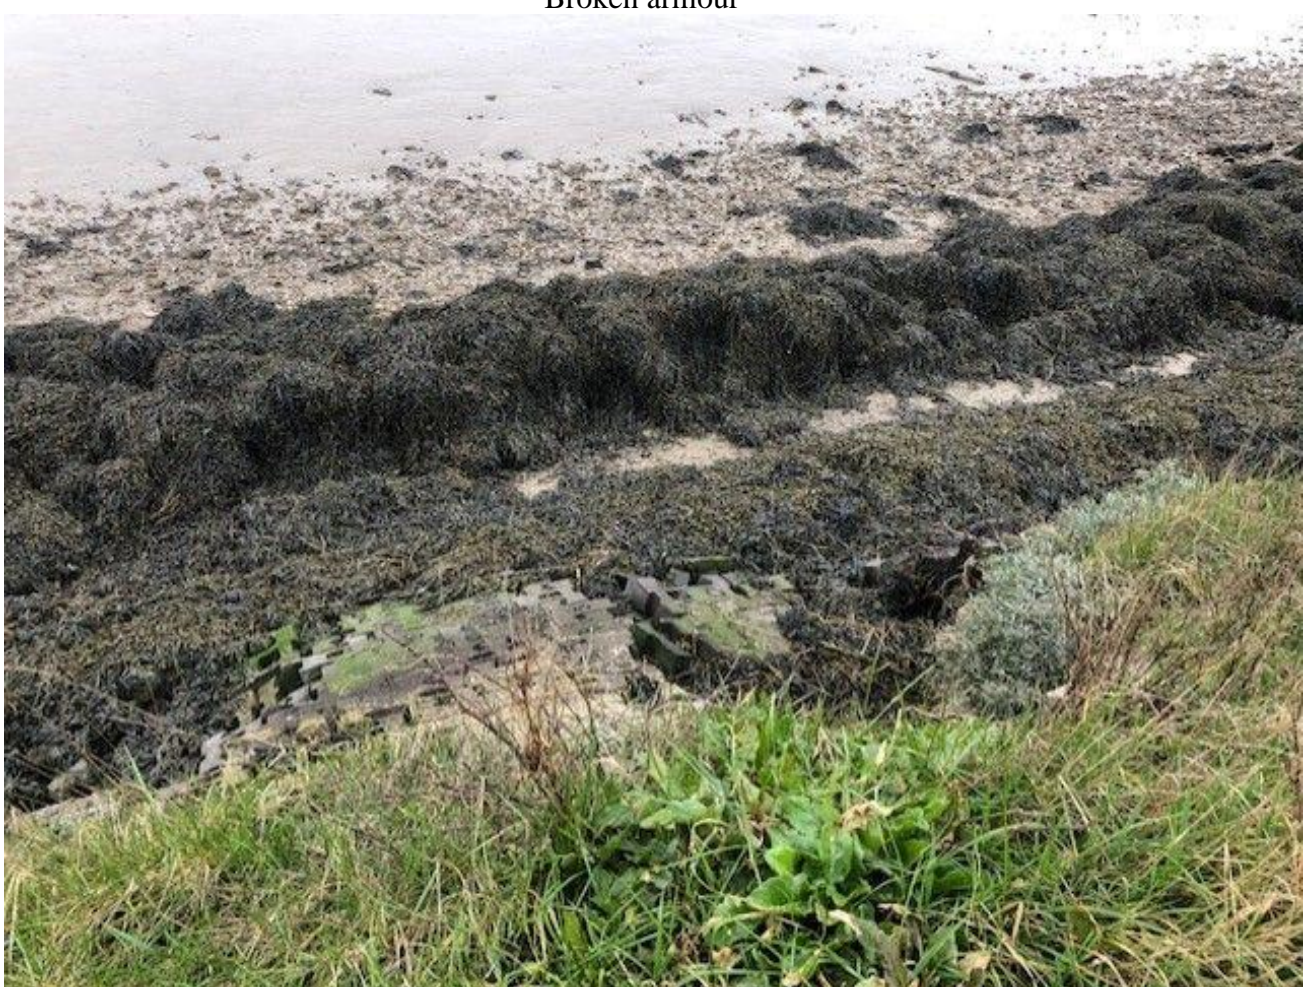
Broken armour at base of wall

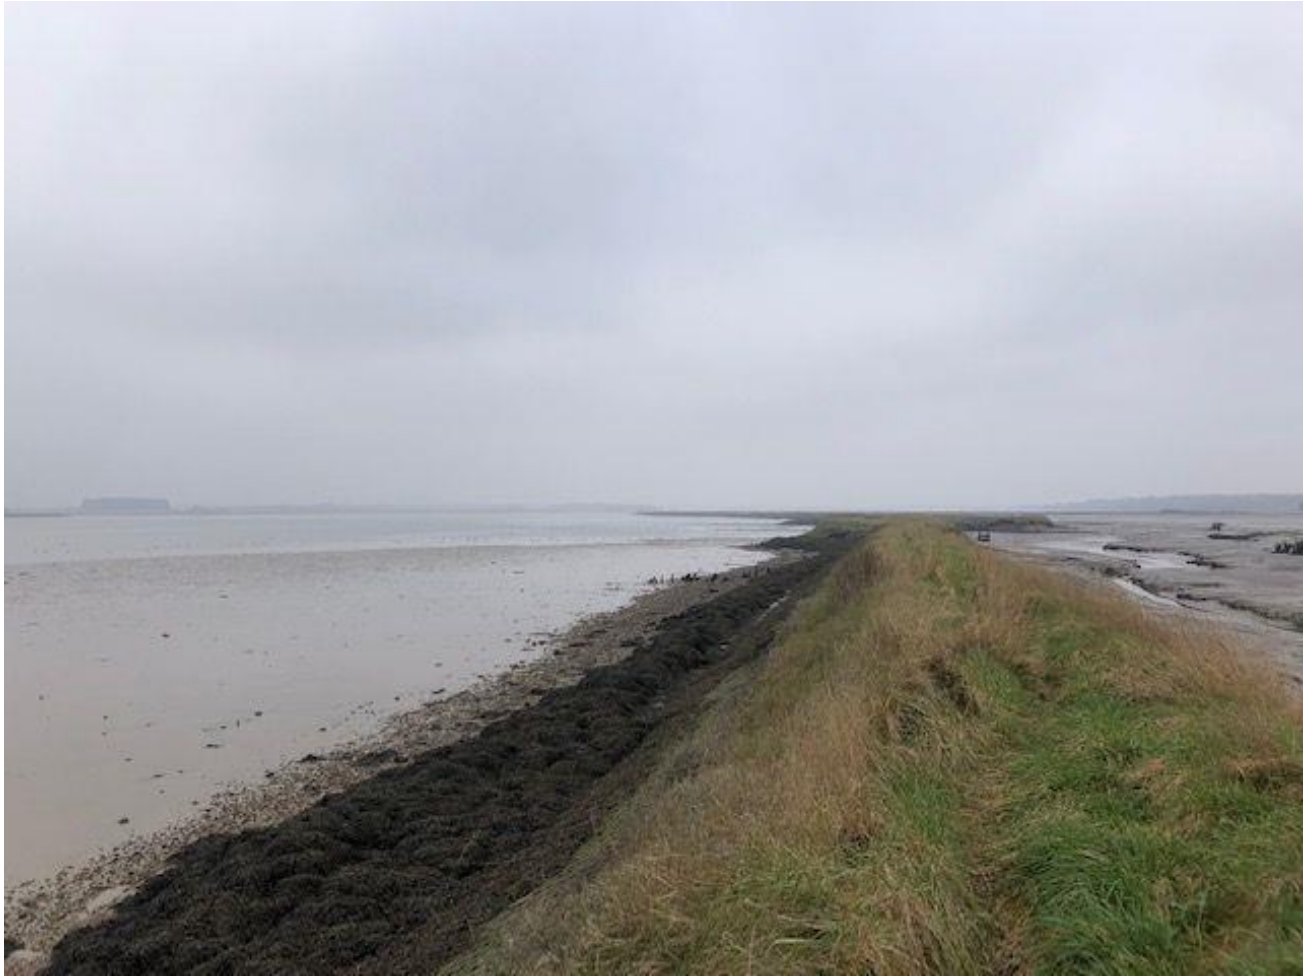
Wall separating river from marsh looking upstream towards Colliers Hole.
Yarn Hill in the distance.
