# THE ALDE & ORE ASSOCIATION

## ALDE AND ORE ESTUARY ASSESSORS REPORT

<b>NAME[S]:</b> A McDonald Sue Skeen	<b>DATE OF INSPECTION:</b> 27/10/2021
<b>FLOOD CELL:</b> FC4.1	<b>AREA OF ASSESSMENT:</b> Gedgrave & Sudbourne Marshes

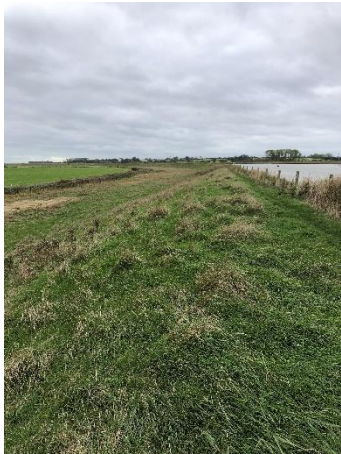
By Pinneys TM397486

**Inner walls and pathway** – all well grassed and no evidence of damage or change since last year; pathways past the pumping station showing some cracking despite recent rain and the lateness of the survey, but no slippage.

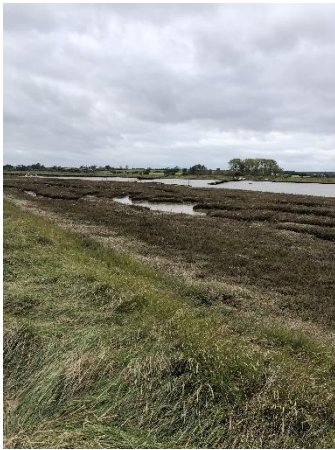
At Butley Ferry TM 395 484

**Saltings:** Further widening of channels and more undercutting around the Ferry; not so bad further downstream though inner channel along the LG still widening, some new undercutting.

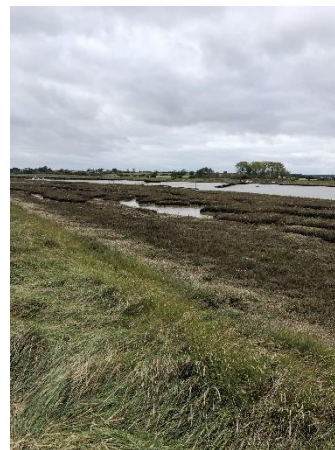
Channel Widening TM 394 479

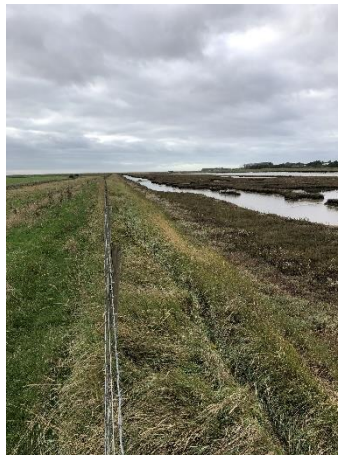
New undercutting and widening TM 407 471

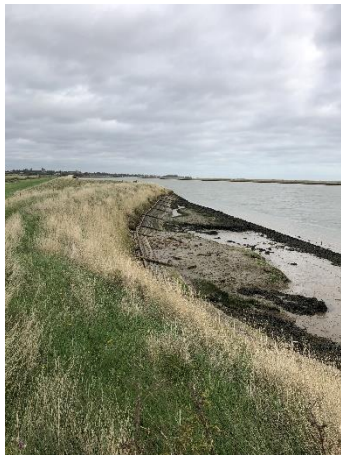
Armour at Gedgrave PS TM411 475

**Outer Walls** – generally good condition and no evidence of any change or deterioration
