## ALDE AND ORE ESTUARY ASSESSORS REPORT

<b>NAME:</b> Frances Barnwell Christopher Gill Jane Maxim Richard	<b>DATE OF INSPECTION:</b> <p style="text-align: center;">14.04.2021</p>
<b>FLOOD CELL:</b> <p style="text-align: center;">4.2</p>	<b>AREA OF ASSESSMENT:</b> <p style="text-align: center;">Chantry Marshes to Orford Quay          [Orford Sailing Club to Short Gull Tide Gauge]</p>

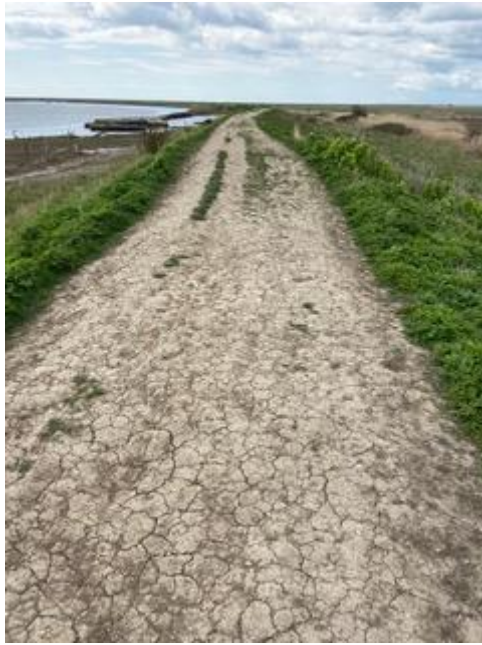
Photo 1

Showing the way in which the footpath is encroaching on the side of the wall

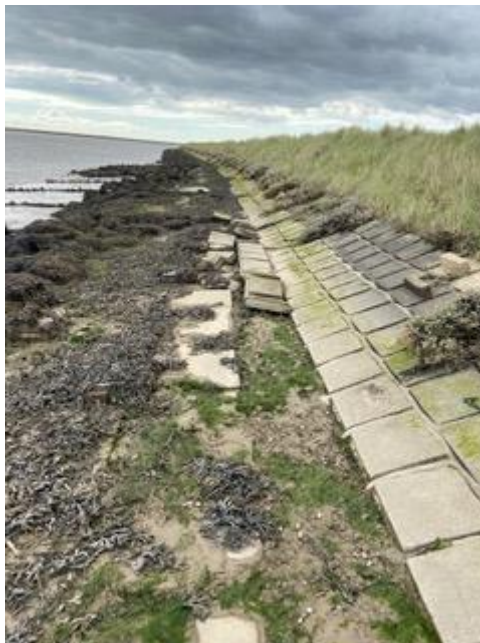
Photo 2  
State of the armour

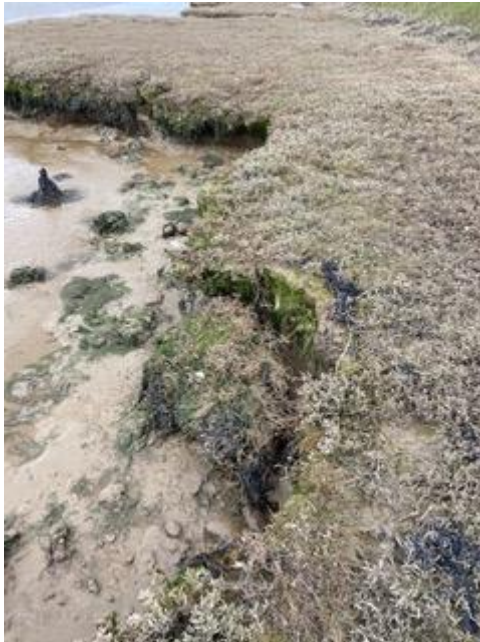
Photo 3  
Showing a piece of saltmarsh detaching

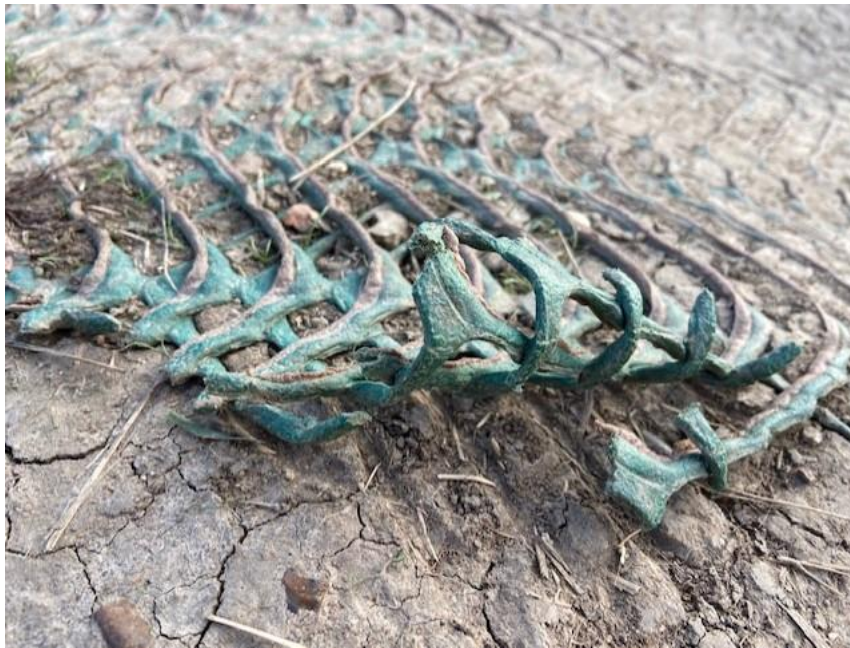
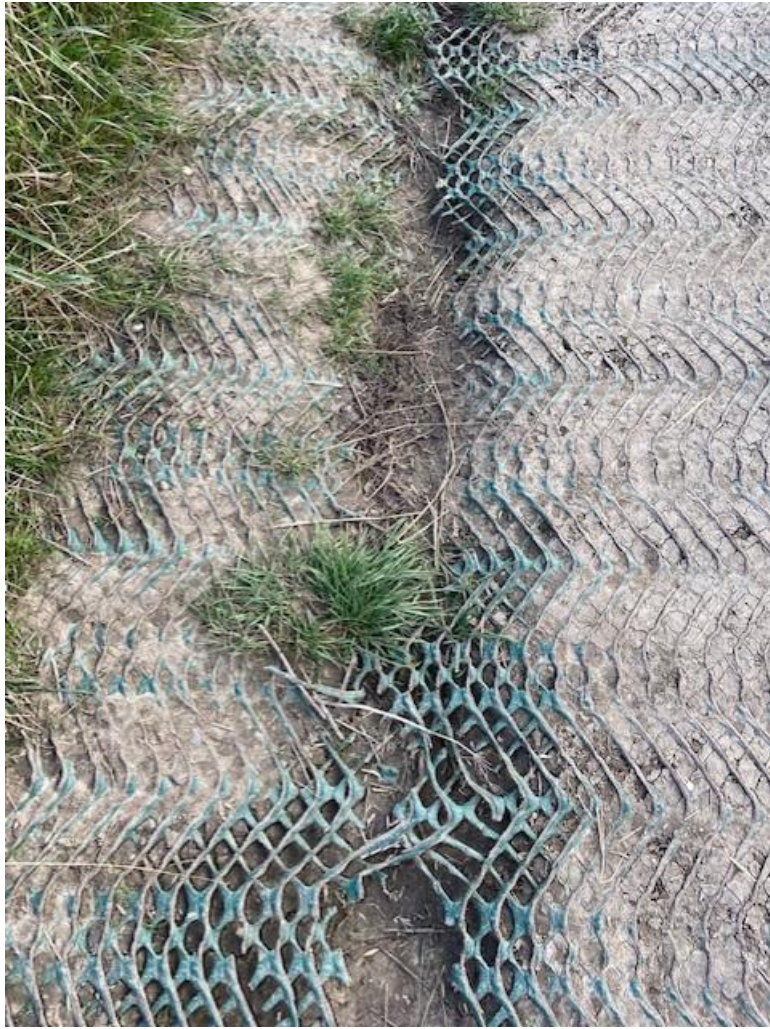
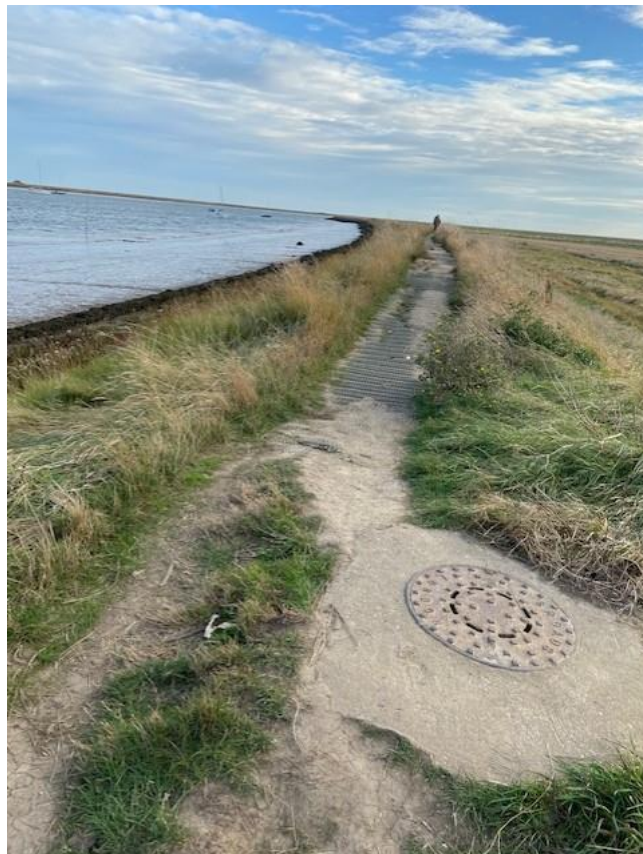
Photo 4  
[and following photos] shows the condition of the webbing and possible trip hazards

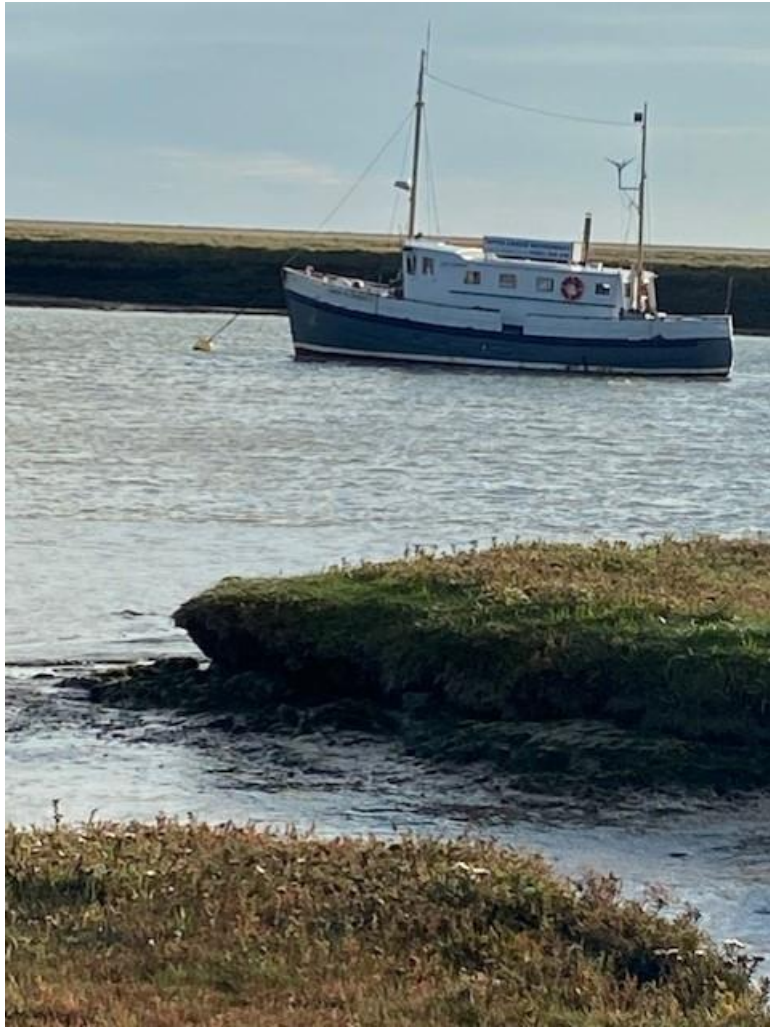
Photo 7  
Saltings Erosion
