THE ALDE & ORE ASSOCIATION

ALDE AND ORE ESTUARY ASSESSORS REPORT

NAMES: Brian Johnson Juliet Johnson Brian Johnson Bobby Rusak	<ol style="list-style-type: none">1. 24th March 20222. 28th March 20223. 5th May 20224. 16th May 2022
LOCATION: Flood Cell 1	AREA OF ASSESSMENT: <ol style="list-style-type: none">1. Butley Mills to chainage 90002. Chainage 9000 to Boyton Dock3. Boyton dock to chainage 30004. Shingle Street to chainage 3000

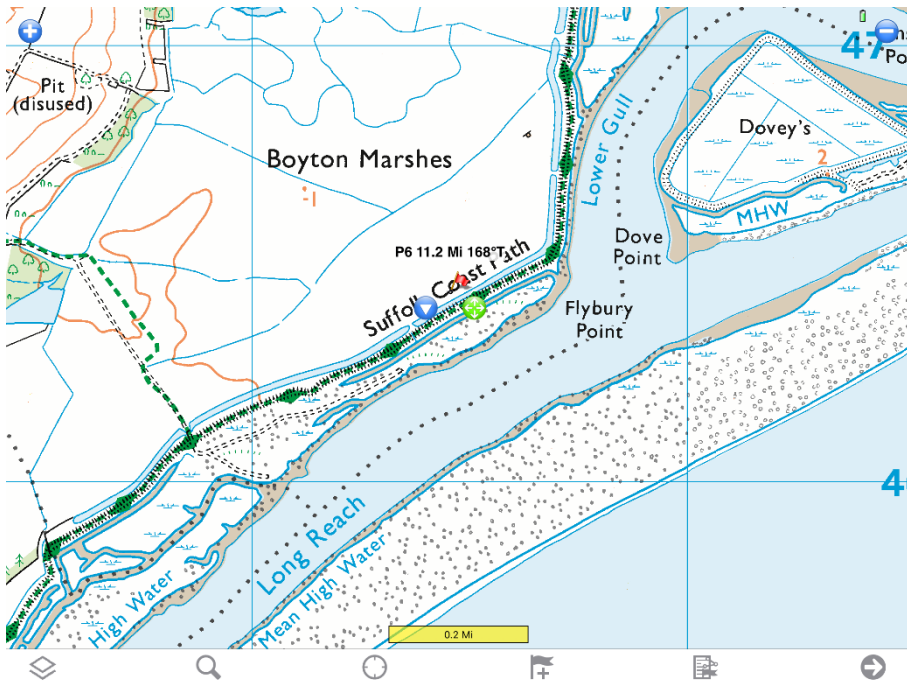
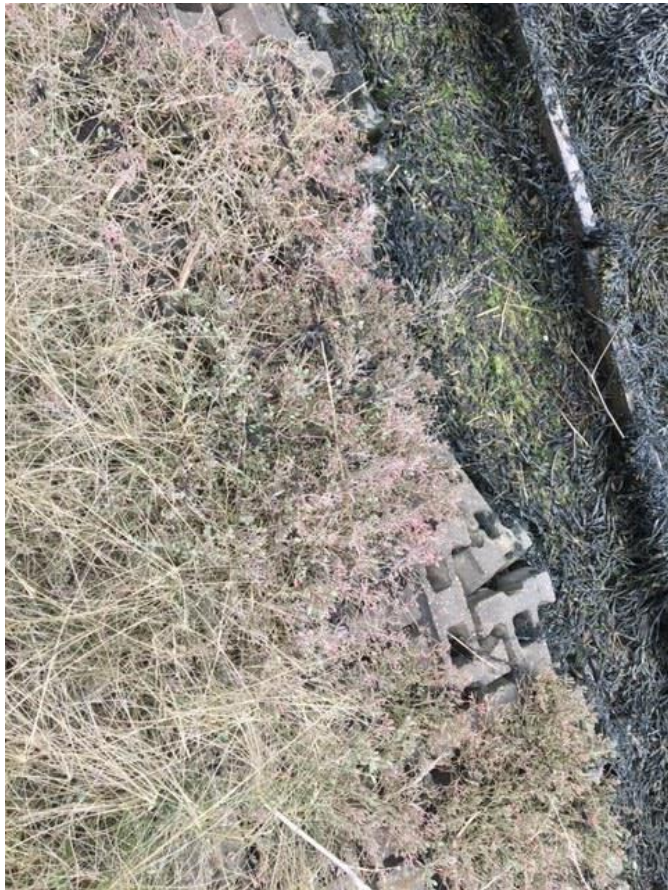
At Flybury Point the river side of wall is faced with concrete blocks of varying patterns, some footings are in timber, some concrete. The blocks in some places are bulging and maybe loose. For location see OS map and see photographs 1 and 2.
