THE ALDE & ORE ASSOCIATION

ALDE AND ORE ESTUARY ASSESSORS REPORT

NAMES: A McDonald J Maxim	DATE OF INSPECTION: 02/04/2022
FLOOD CELL: FC4.1	AREA OF ASSESSMENT: Gedgrave & Sudbourne Marshes

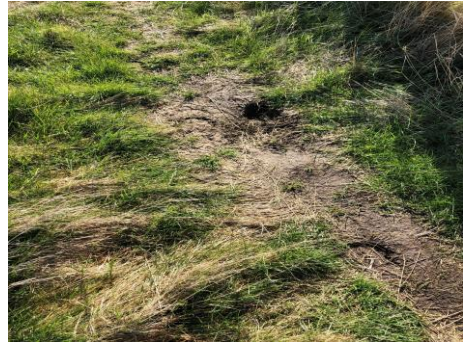
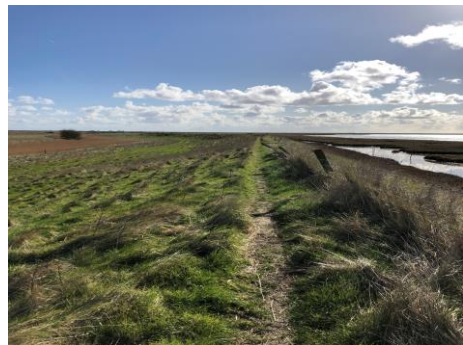
Worn Path
TM 397 474

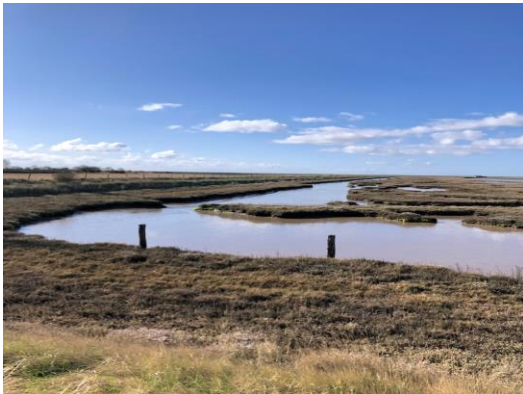
Inner Channel above Boyton Dock
TM 394 482

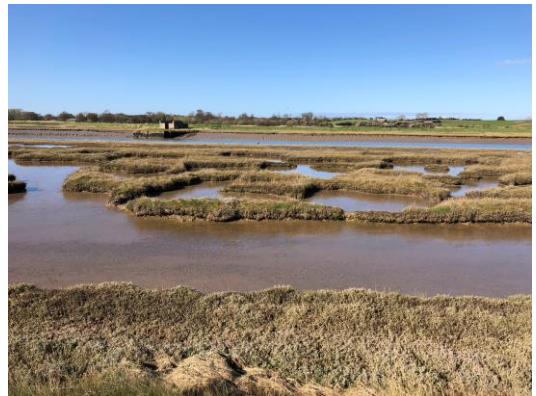
Widening Channel
TM 395 474

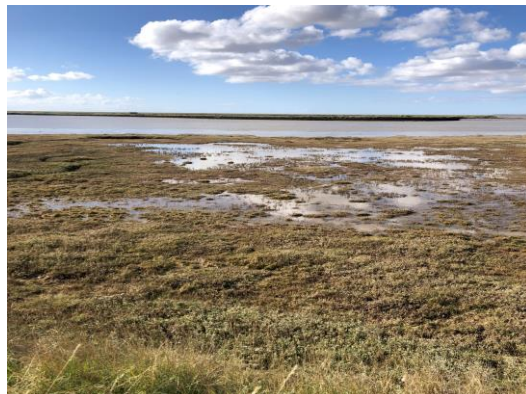
Tidal Water in Saltings
TM 403 473

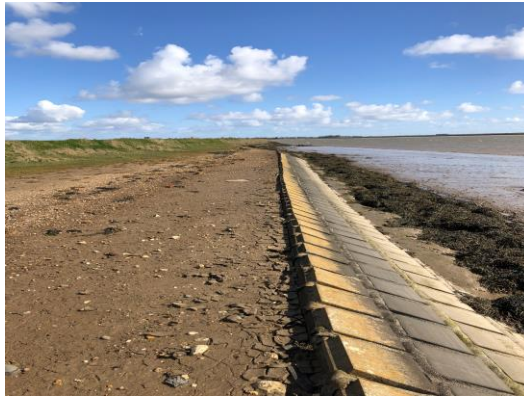
Armour Upstream of Pumping Station
TM 411 475
