# THE ALDE & ORE ASSOCIATION

## ALDE AND ORE ESTUARY ASSESSORS REPORT

<b>NAMES:</b> Nicholas Russell Robert Rusack	<b>DATE OF INSPECTION:</b> 10 <sup>th</sup> May 2024
<b>FLOOD CELL:</b> FC1	<b>AREA OF ASSESSMENT</b> Hollesley pumping station to Butley Ferry
<b>TIDAL HIEGHT AT TIME OF INSPECTION</b> 30 mins after high water Shingle Street	<b>WEATHER:</b> Sunny with occasional high cloud and a force 2 southerly wind

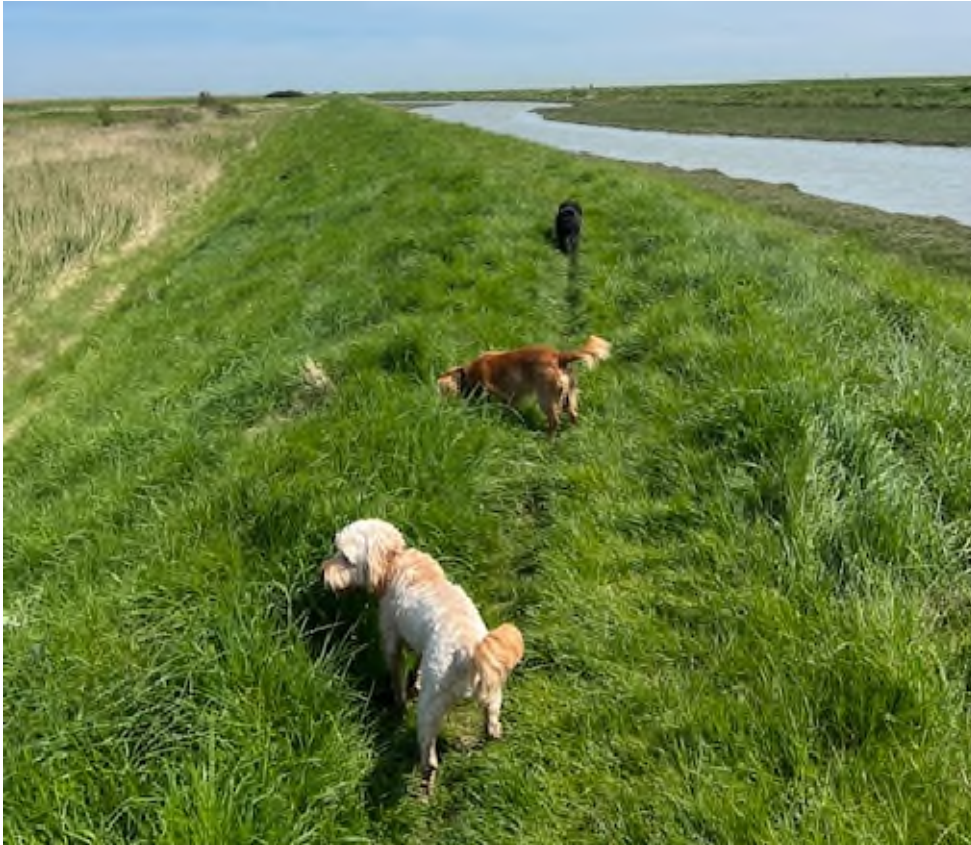
- Generally good condition. See photo 1 and grid reference 52°04.381'N, 1°45.701'E below.
- However, at the location of grid reference 52°04.856'N, 1°46.293'E just before the 2<sup>nd</sup> WW look out post and river bank reinforcement, where the Barthorp's creek from Hollesley pumping station runs into the main river, the river wall defences have starting to crumble into the creek. See photos 2 & 3 and grid reference below.
- Top only wide enough for a single person to walk on. Used, but not extensively. See photo 4 below.
- Banks all have good vegetation. See Photo 5 below.

Photo 1 – Grid reference 52°04.381'N, 1°45.701'E. - Walls generally good condition

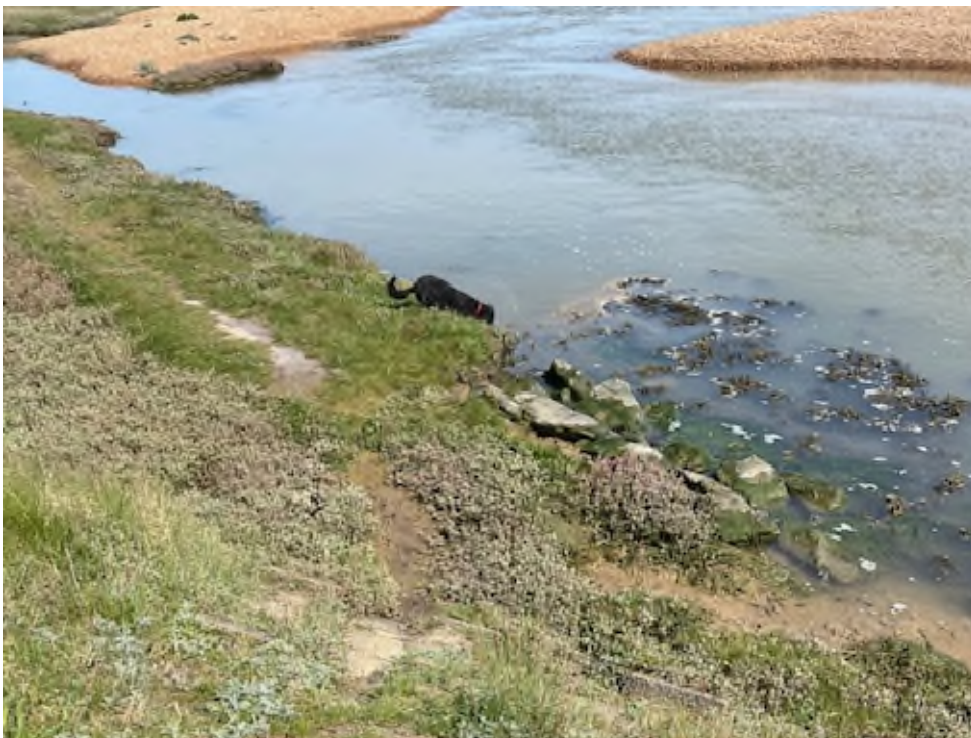
Photo 2 - Grid reference 52°04.856'N, 1°46.293'E. - Signs of wear, where creek joins main river

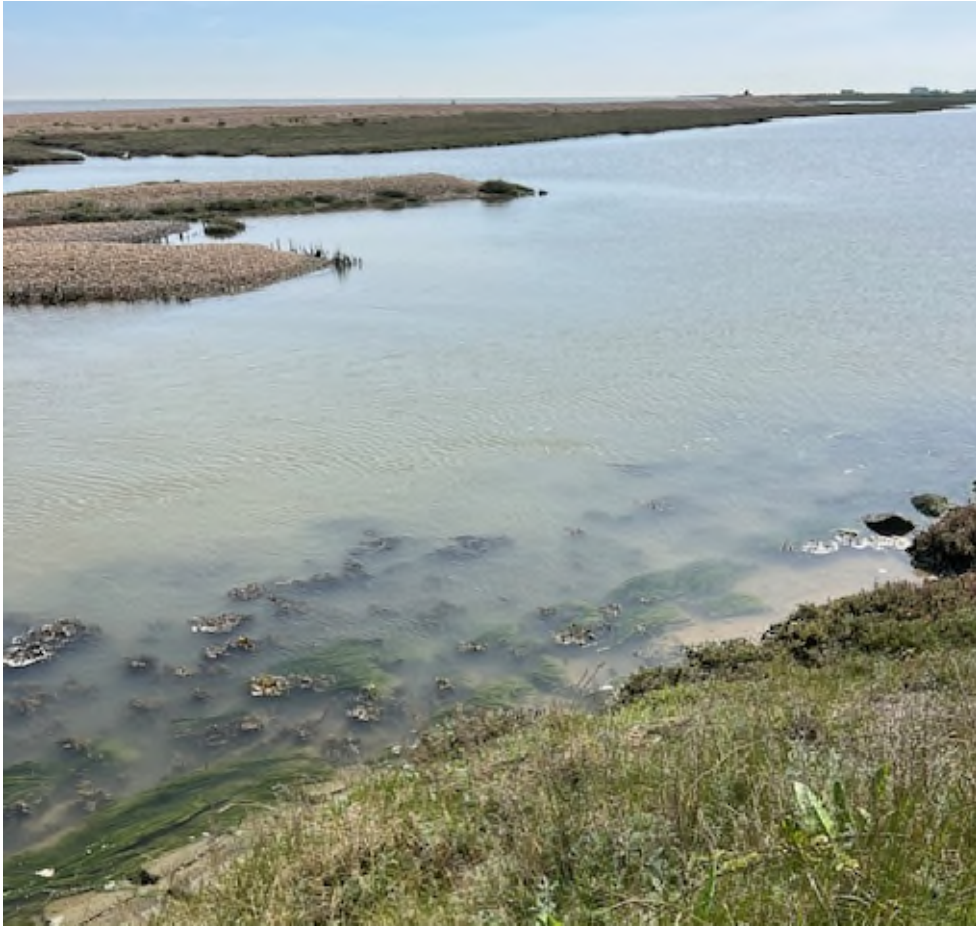
Photo 3 - Grid reference 52°04.856'N, 1°46.293'E. - Signs of wear, where creek joins main river

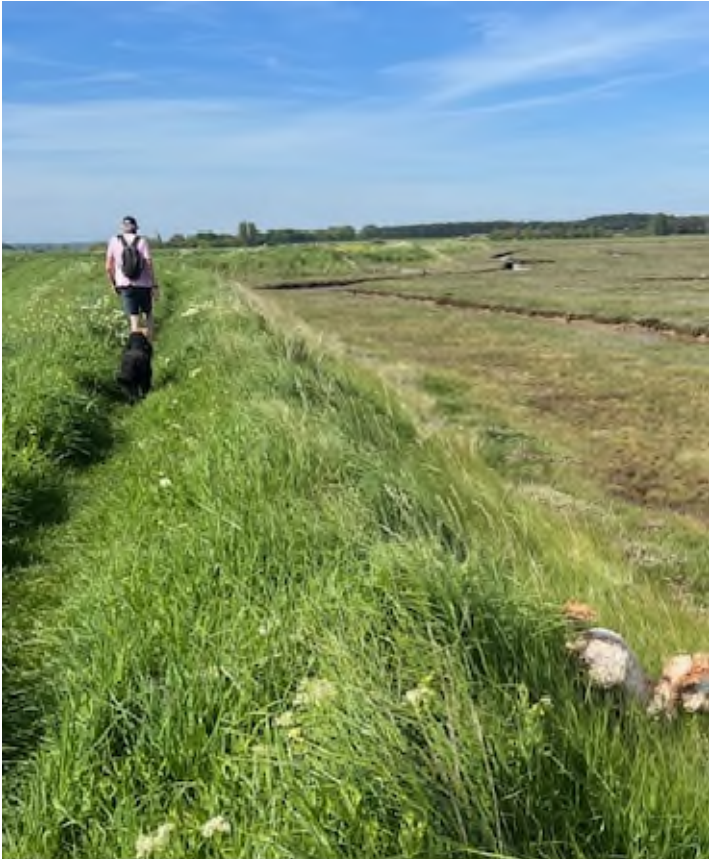
Photo 4 – Path wide enough for a single person

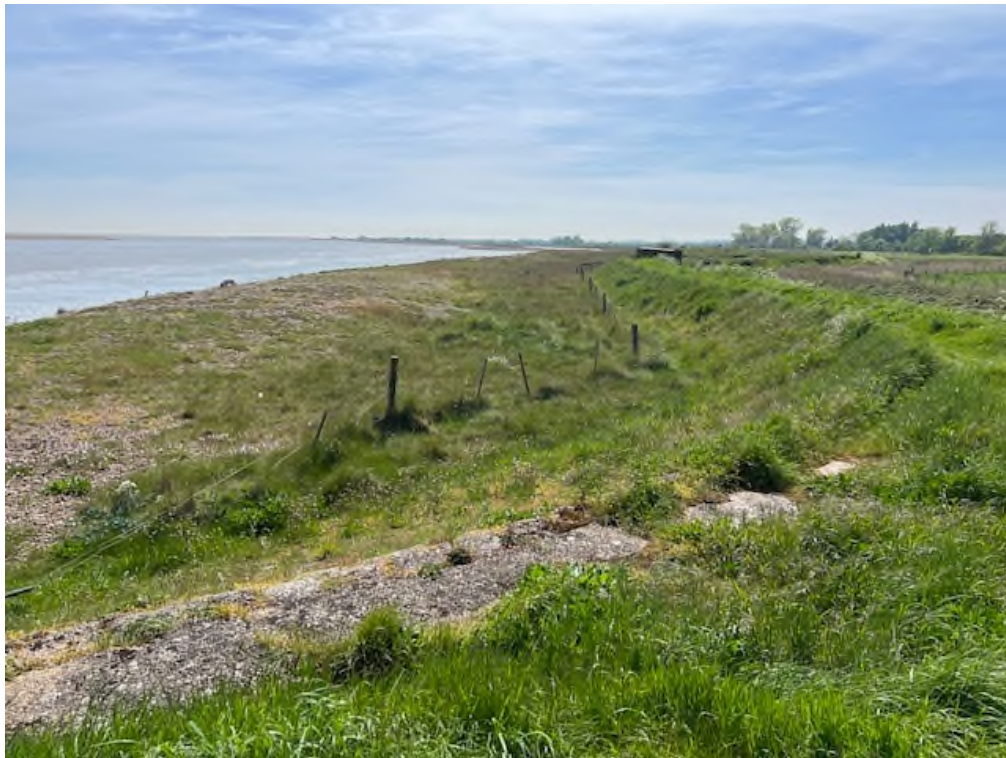
Photo 5 – Good vegetation

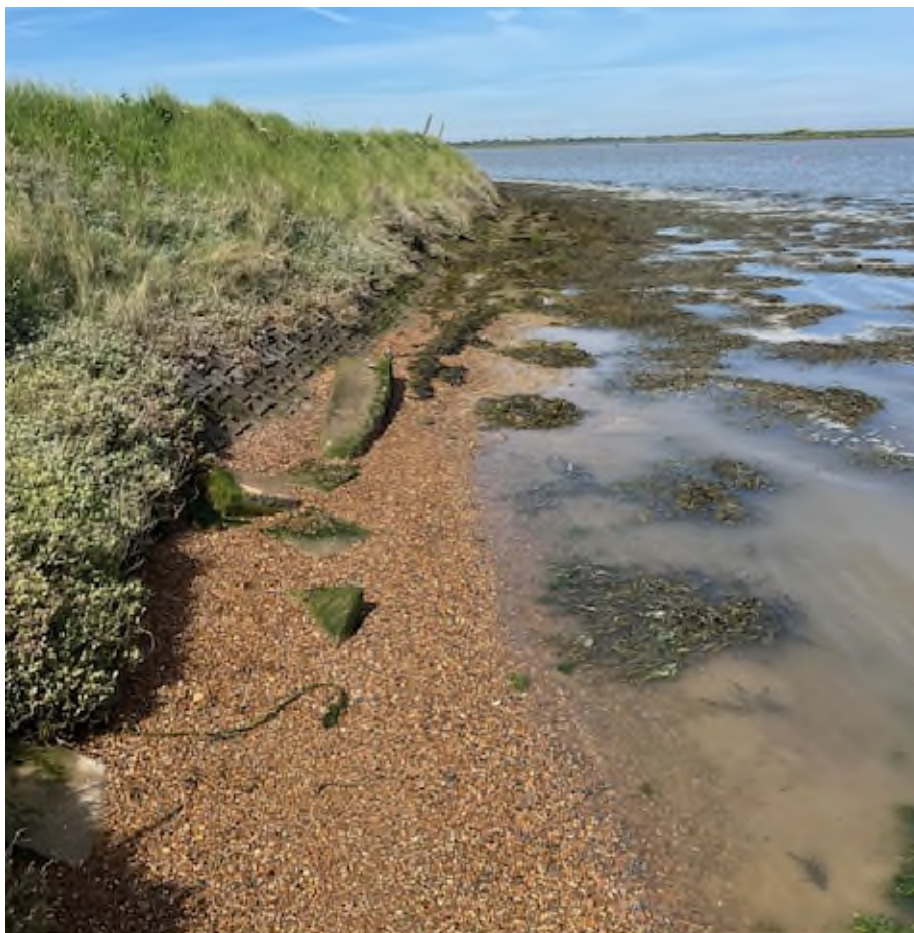
- At grid reference 52°03.920'N, 1°29.758'E the river wall defences from the corner of Dove Point to half way along to the entrance to the Butley River are showing extensive signs of wear, where the river wall reinforcement has and is falling onto the edge of the river. See Photos 6, 7 and 8 and grid reference below.

Photo 6 – Grid reference 52°03.920'N, 1°29.758'E – Dove Point - showing extensive signs of wear

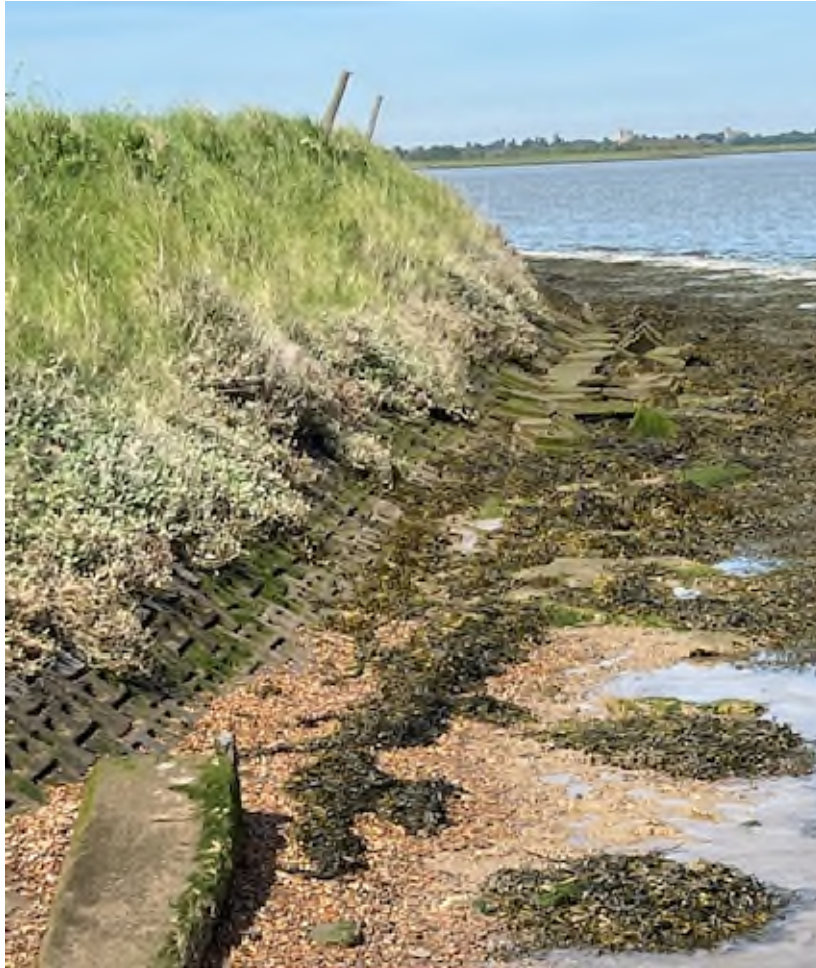
Photo 7 – Grid reference 52°03.920'N, 1°29.758'E – Dove Point - showing extensive signs of wear

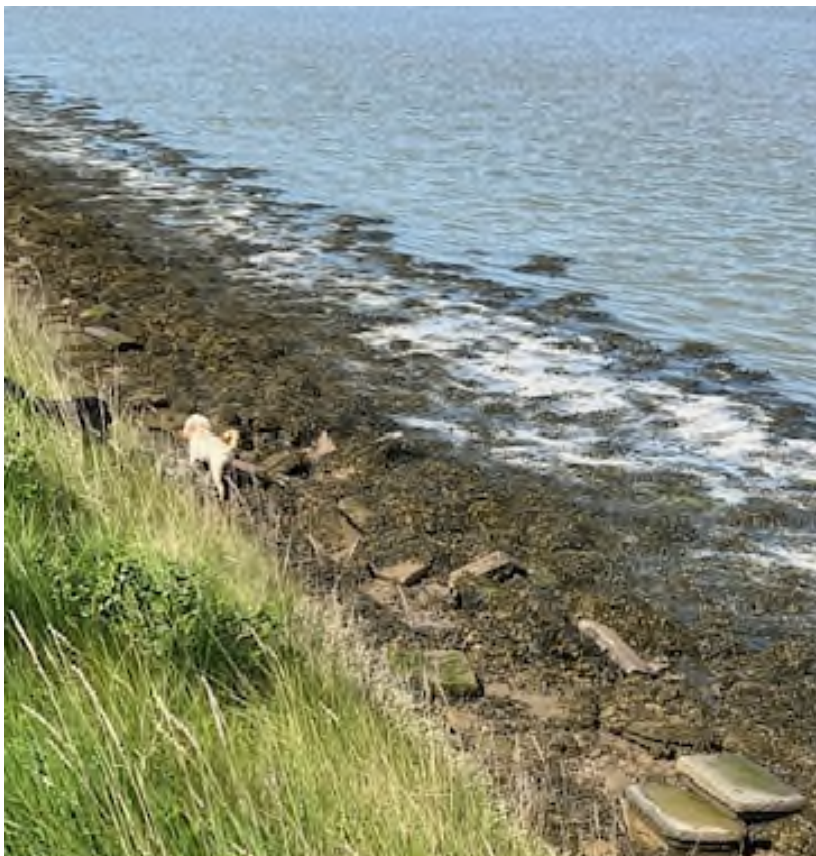
Photo 8 – Grid reference 52°03.920'N, 1°29.758'E – Dove Point - showing extensive signs of wear

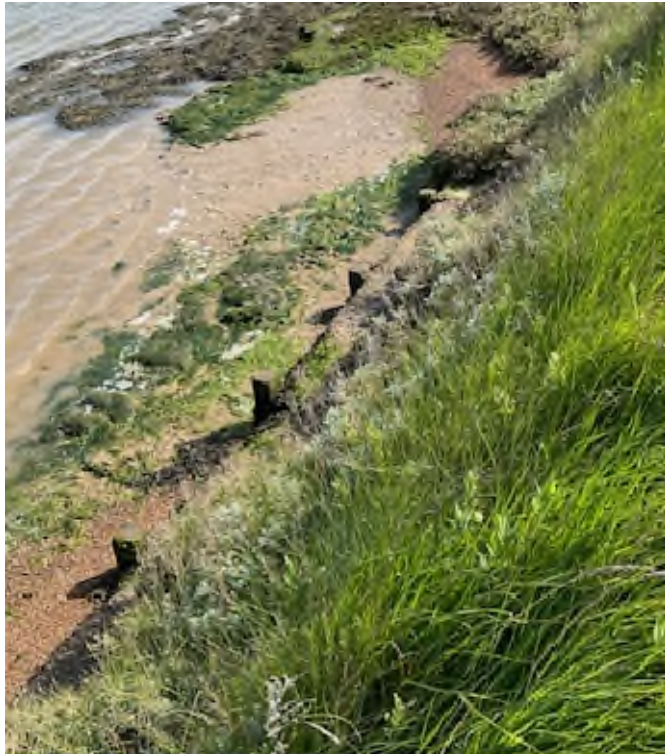
- There also signs of previous repairs now being damaged and overtopped. – See photo 9 below.
- Along the same area the far side of the bank has a mass of rogue rape seed growing into the banks of the wall. Rape seed has not been sewn in the adjacent fields for many years and the roots may be undermining the river wall. See photos 10 and 11 below

Photo 9 – Overtopping occurring to previously repaired river wall between Dove Point and the Butley river

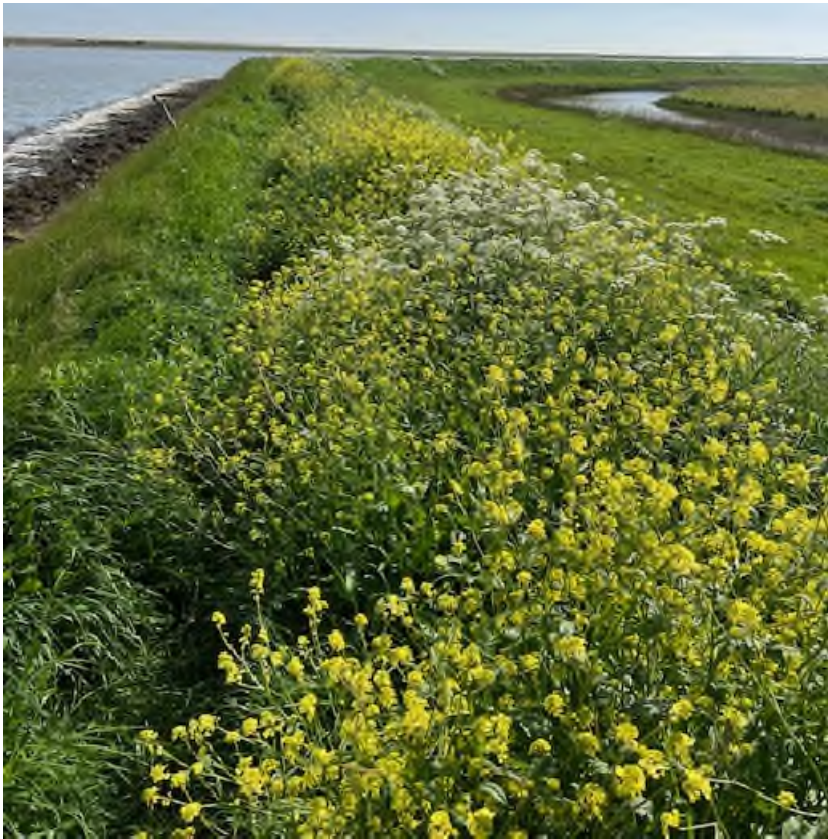
Photo 10- Rogue rape seed between Dove Point and Butley entrance

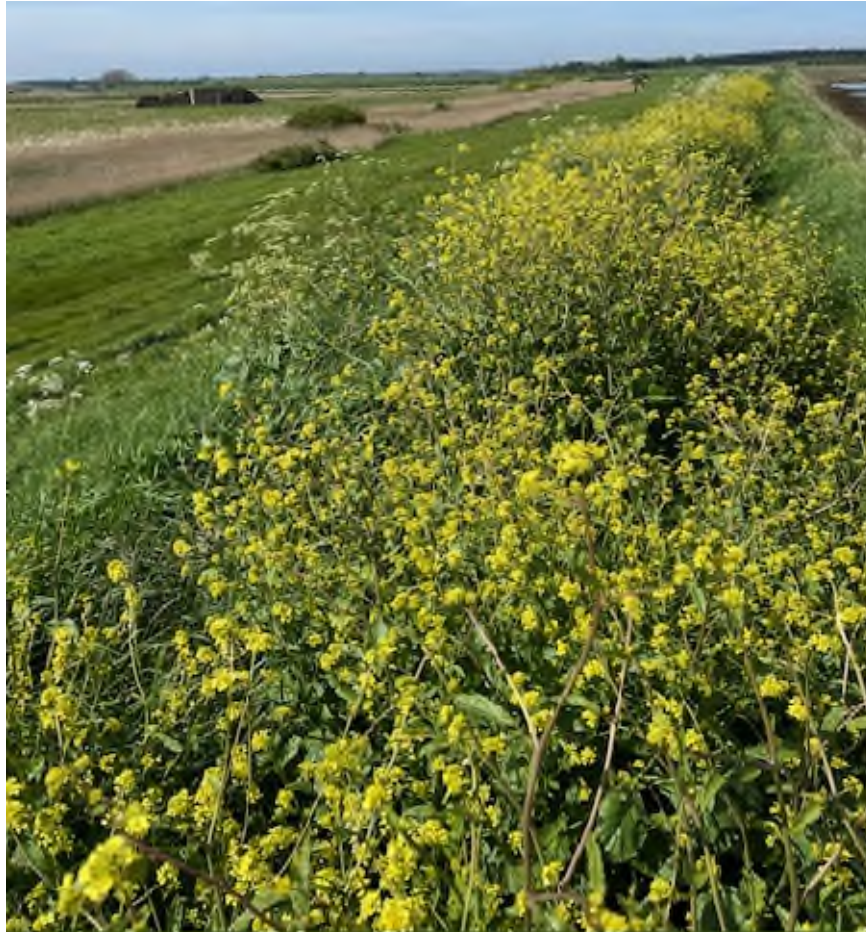
Photo 11 - Rogue rape seed between Dove Point and Butley entrance

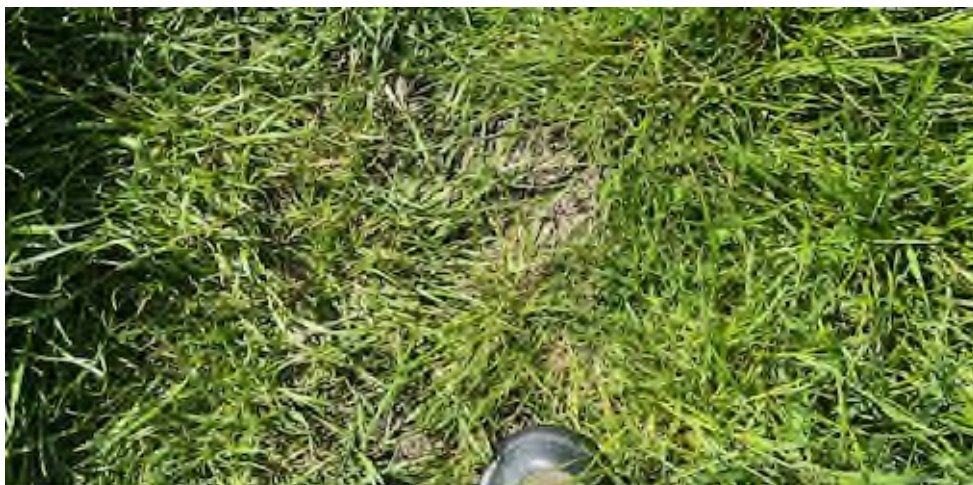
- At grid reference 52°04.251'N, 1°29.745'E, between the mouth of the Butley River and Boyton Dock, a considerable number of 'sink holes' were found underfoot, mainly hidden by vegetation, with an amount of cracking showing in the river wall. This is thought to be due to rodents burrowing through the side of the wall and then the area above collapsing. See photos 12 and 13 and grid reference below.

Photo 12 – Grid reference 52°04.251'N, 1°29.745'E. - Cracking appearing between Butley entrance and Boyton dock

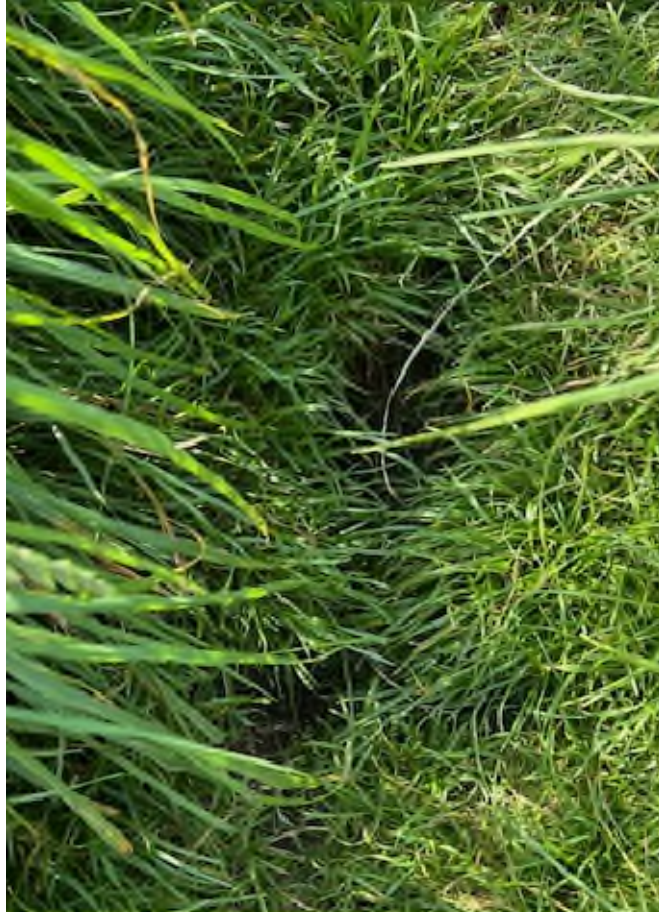
Photo 13 - grid reference 52°04.251'N, 1°29.745'E. – quite a few ‘Sink holes’ appearing between Butley entrance and Boyton dock. A lot hidden by vegetation.

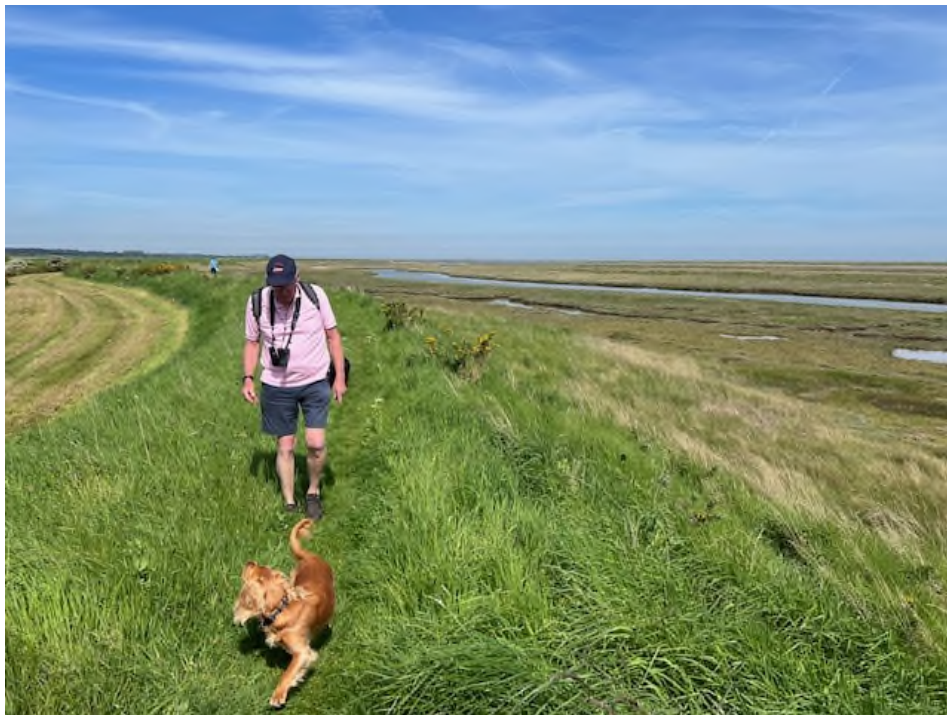
- The Simpson Saltings all looked to be in good condition with plenty of healthy marsh between the river and the river wall – See photo 14 and grid reference below.
- The creek that runs behind the 2<sup>nd</sup> WW infantry Pillbox was running well with plenty of healthy marsh between the river and the creek and the creek and the river wall.
- The saltings running along the Butley river and out to the entrance of the Butley river between the river and the wall where in good condition.

Photo 14 - Grid reference - 52°03.085'N, 1°28.035'E - Simpson Saltings in good condition with plenty of healthy marsh between the river and the river wall

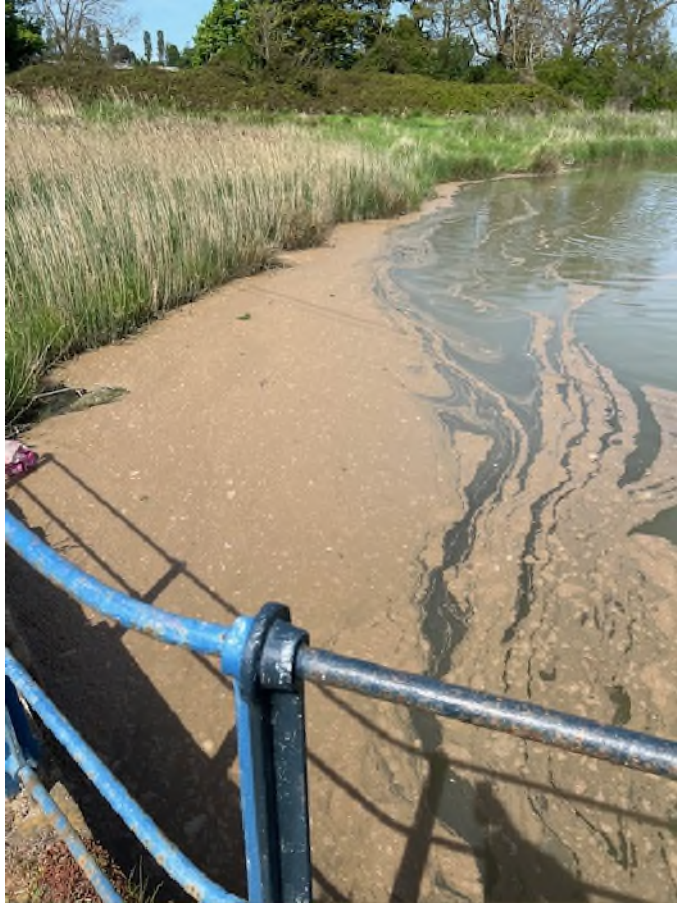
- Low. Little evidence other than at the bridge near Hollesley pumping station that had bad floating deposits – See final photo 15 below.

Photo 15 – Grid reference 52°04.406'N, 1°45.105'E. Floating debris near Hollesley Pumping Station
