# THE ALDE & ORE ASSOCIATION

## ALDE AND ORE ESTUARY ASSESSORS REPORT

| <b>NAME[S]:</b> A Andrews<br>+<br>J.C.Hodrien | <b>DATE OF INSPECTION:</b> 7 <sup>th</sup> April 2026 |
| <b>FLOOD CELL:</b><br><br>FC10 | <b>AREA OF ASSESSMENT:</b><br><br>Slaughden Quay to Brick Dock |

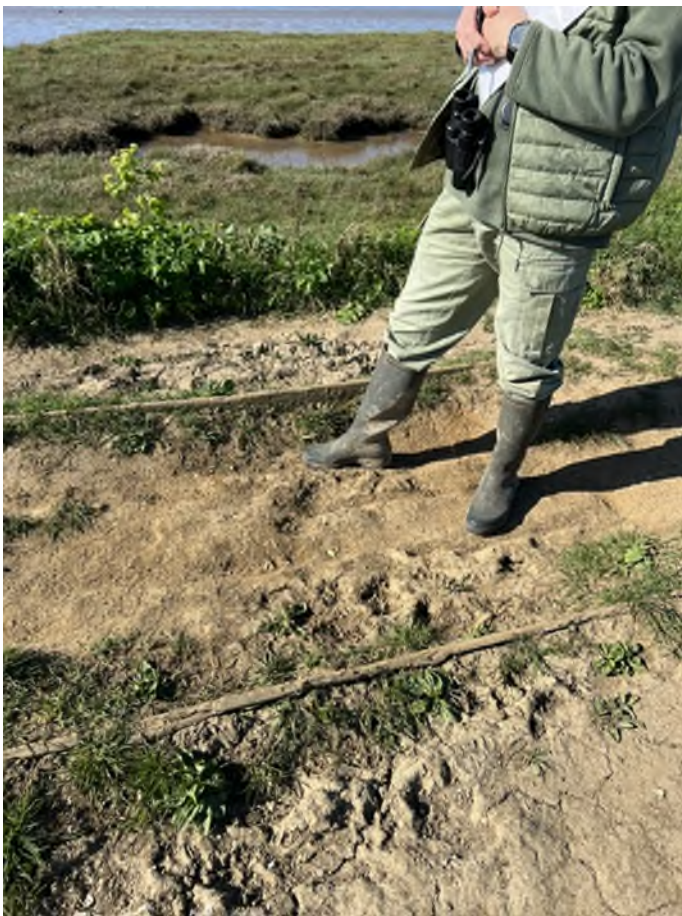
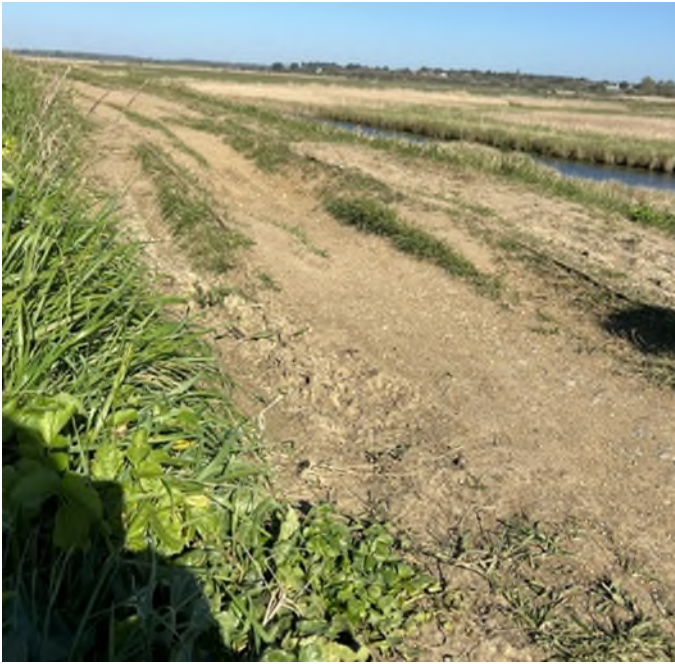
Although, the winter months were wet, the top surface of the wall has completely dried out. The evidence of the erosive effect of a very high number of walkers is clearly evident particularly in the first stretch that leads from the sea wall 464556 to the footpath crossing the Town Marsh at 459557 (Westrow Reach). Significant depressions, of more than 6 inches regularly occur at approximately 5m intervals. Last year our visual inspection suggested the erosive effect of walkers to have reduced the height of the wall, on the river side, in one place 462/4557 to around 1.8m. Our estimate this year suggests it is even lower.

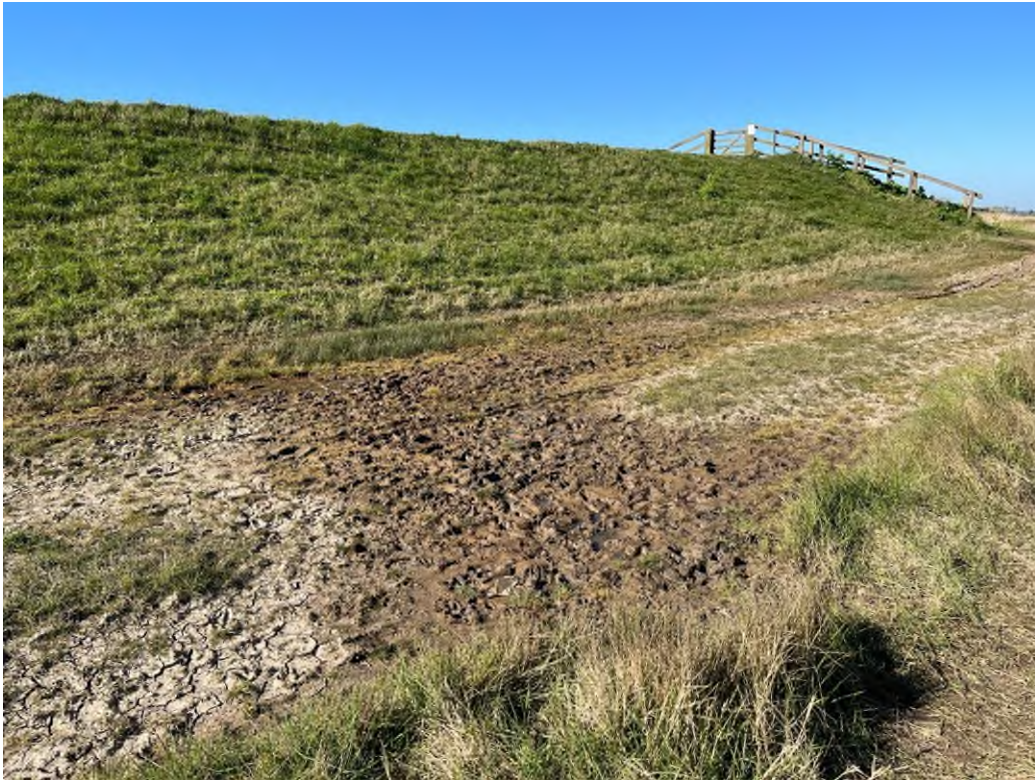
**There is a new are of puddling not seen in previous years at 462557. This is almost directly on the landward side below where the top of the wall has been worn, perhaps slumped to its lowest level . It is recommended that this in professionally investigated at an early opportunity. See photo below.**

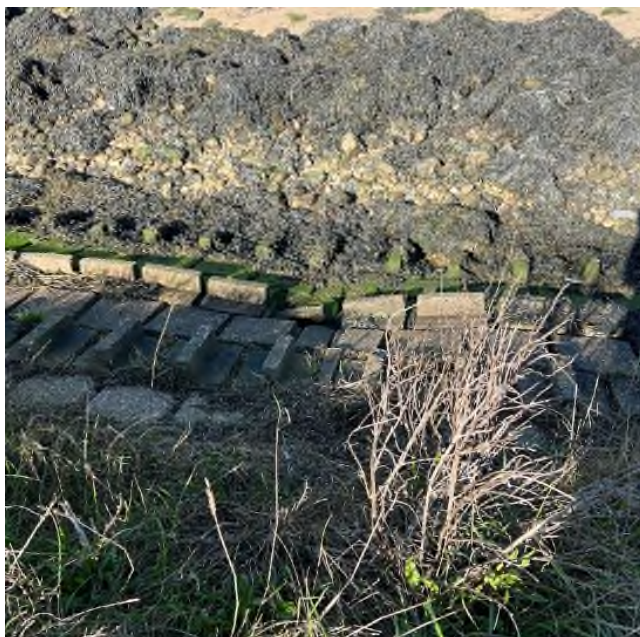
The disruption of the blocks at 2-4 metre intervals for 20 metres or more remain about the same as last year as in the photo below at TM 449564

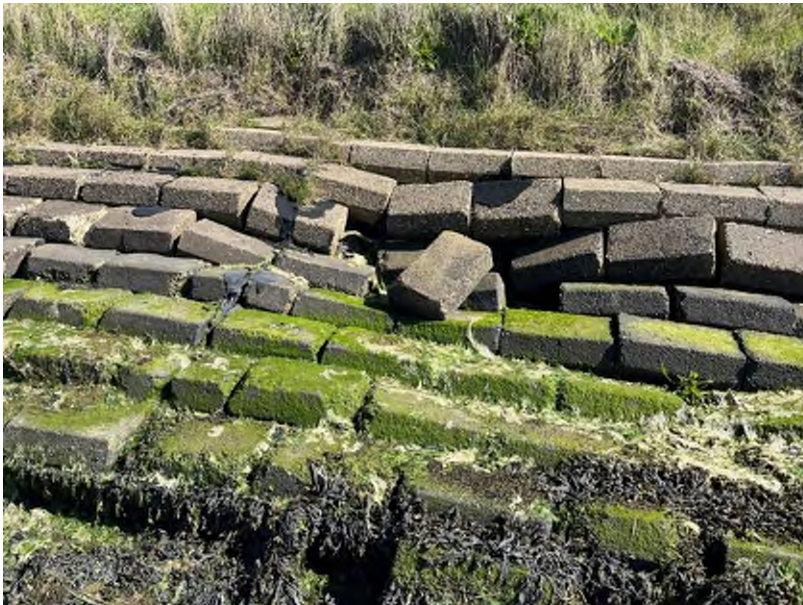
Also 3-5 weak places between Brick Dock steps and Brick Dock Jetty--Photo of one at TM450567, below
